# CITY OF IQALUIT

WATER QUALITY EMERGENCY

MAY 5TH, 2022

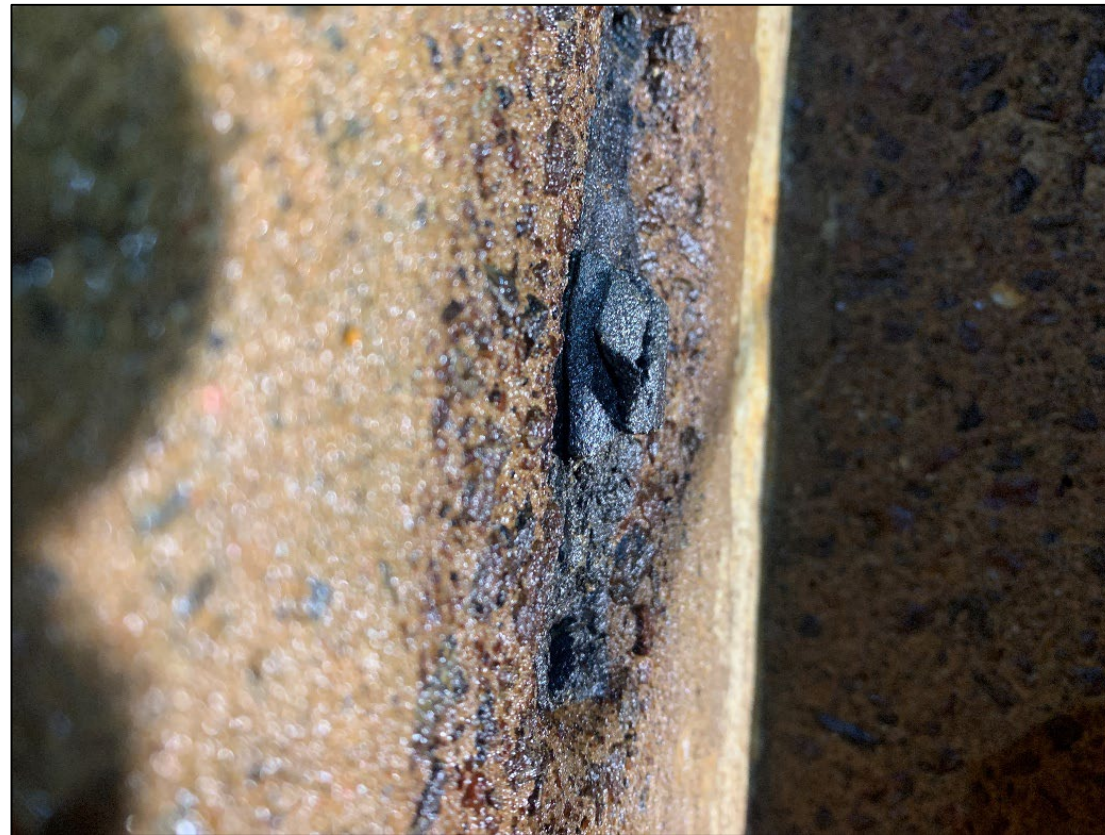
### Close-up of black tar-like substance

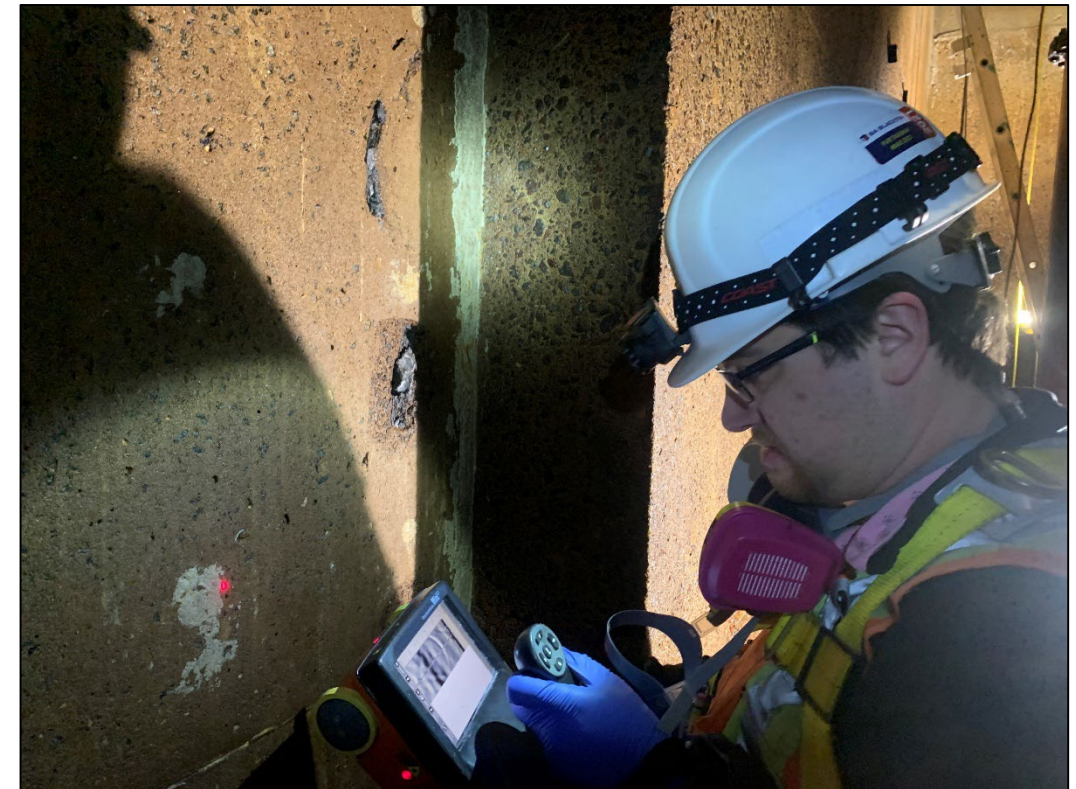
TAR-LIKE SUBSTANCE

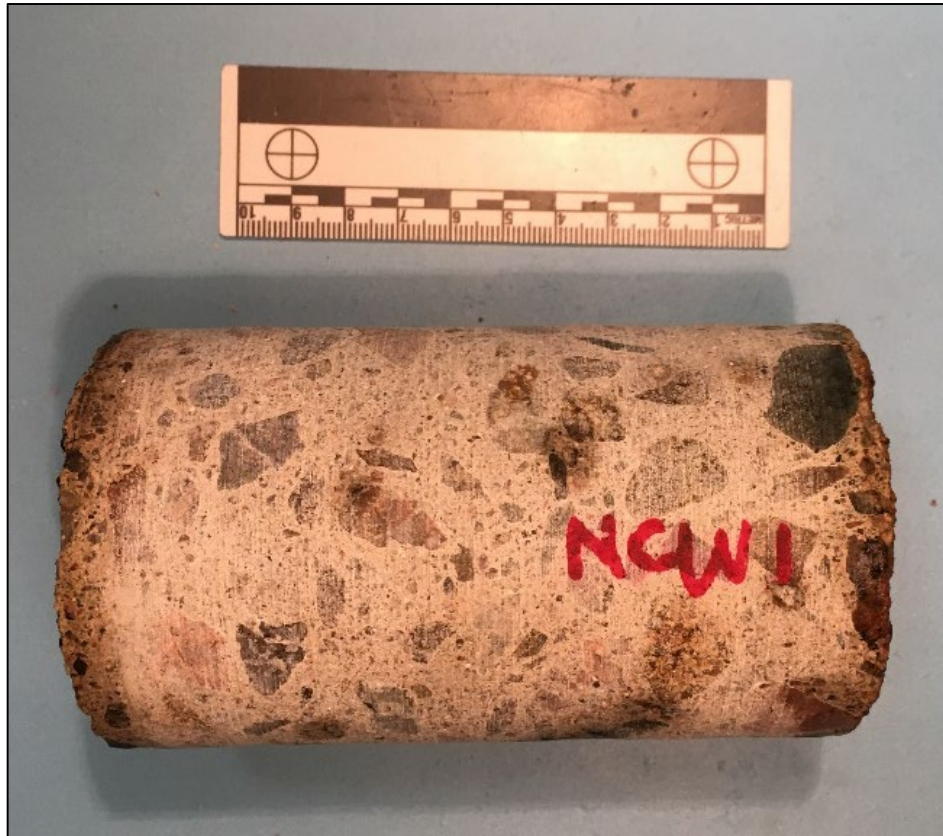
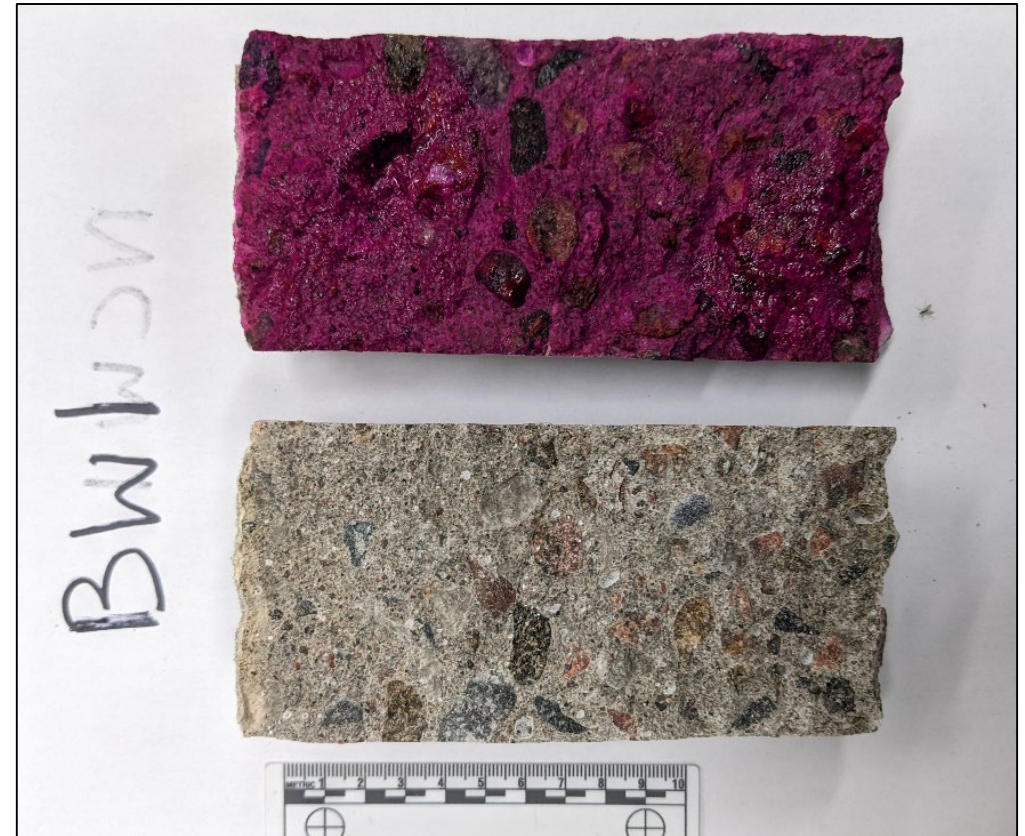
No detectable hydrocarbons in concrete
