Project # OTT-00248529-A0
Water Distribution Network Issues – Lower Iqaluit Loop

Table 1.1 – Lower Iqaluit Loop Structures

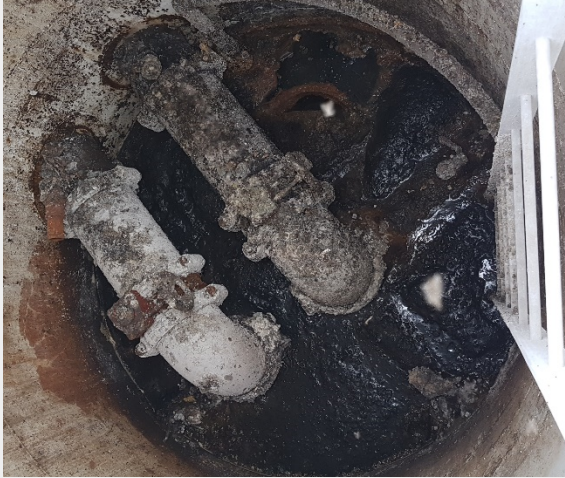
Structure	Comment	Photo	Action Required
AV 305	<ul style="list-style-type: none"> • Sewer Cleanout not installed • Evidence of previous backups and surcharges • Requires cleaning and pumping

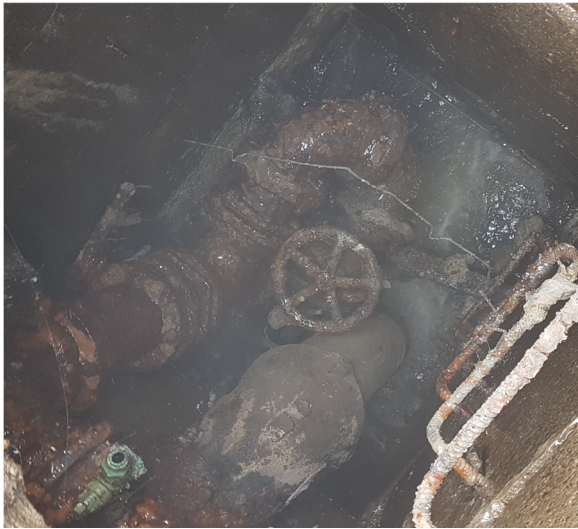
No
MH 9	<ul style="list-style-type: none"> • Water servicing removed from MH 9 in 1985 (approx.) and was replaced with AV 9A • Sewage dropping into structure at very high flow rate • Appears to have extensive corrosion, potential that mechanical components don't operate as intended

No

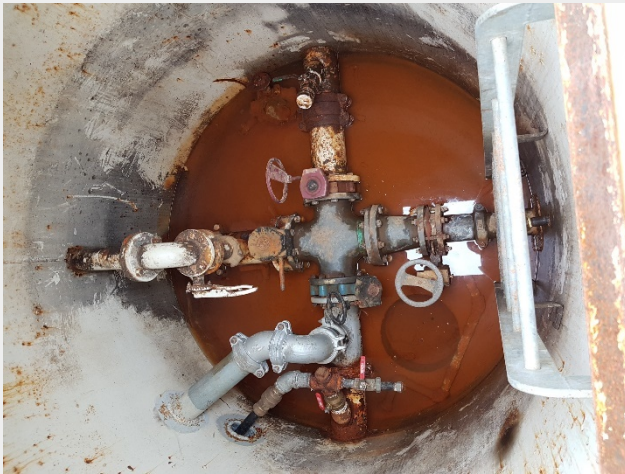
AV 9A	<ul style="list-style-type: none"> • Piping under ladder is believed to be a service, no recirculation piping visible, may be outside structure. • Piping going to MH 84 (going up, vertically in the photo) is supposed to be abandoned. Cannot tell configuration of valve. • Large service connection visible, return piping installed on laterolet

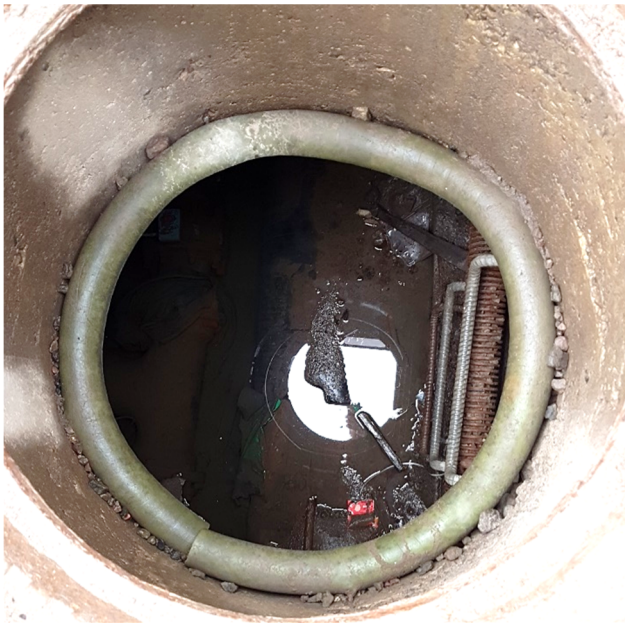
Yes – confirm valve going to MH 84 is closed
MH 8	<ul style="list-style-type: none"> • Key structure in Lower Iqaluit network as the water supply loops back and ties into the structure, thus completing the loop • Originally constructed with open sewer benching • Requires pumping and cleaning • Water level suggests possible downstream sewage issues • Access does not appear adequate • Piping from MH 8 to AV 11 is supposed to have been abandoned • Electrical equipment (heater and sump pump) still in place but probably not functional

Yes – Modify access and determine source of water, leak or infiltration

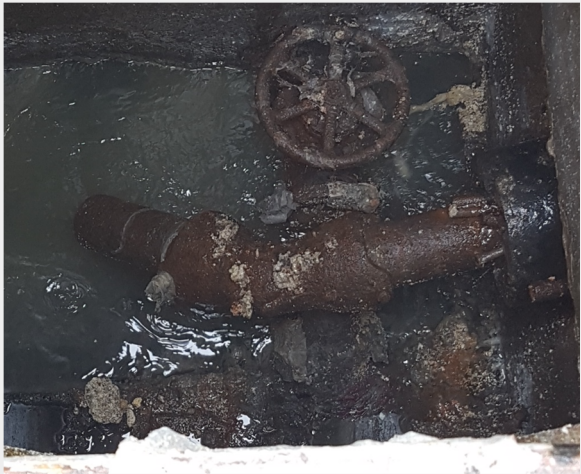
MH 7	<ul style="list-style-type: none"> • Originally constructed with open sewer benching • Appears to have extensive corrosion, potential that mechanical components don't operate as intended • Requires pumping and cleaning • Water level suggests downstream sewage issues • Upper pipe appears to be sewer from AV 10, water line coming from AV 10 was previously abandoned

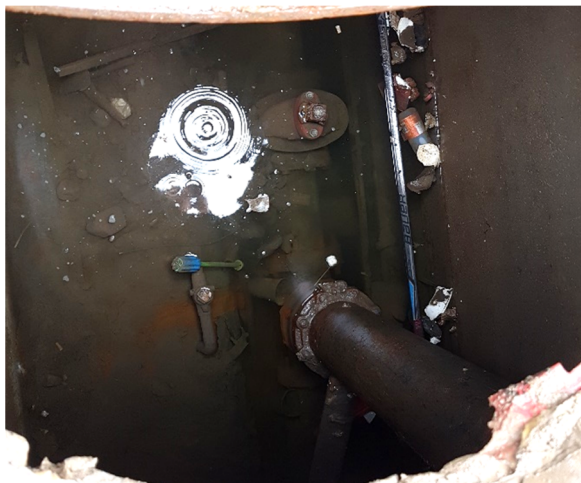
No
PT A2	<ul style="list-style-type: none"> • Low visibility • Requires cleaning and draining

Yes – determine source of water, leak or infiltration

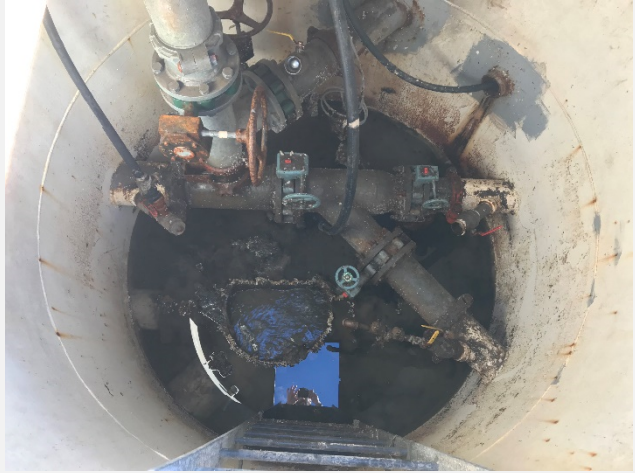
AV 400 – see image in Table 1.1 – This is a key structure/junction in Lower Iqaluit Loop. Water is transmitted from AV 9A to AV 400 and then over to the 222 Building to have heat added. However, as seen in the image, it appears the valve on the piping that is coming from AV 9A is closed. Confirmation of this closure is required. If it is closed, the Lower Iqaluit Loop is not being supplied as designed

AV 400	<ul style="list-style-type: none"> • Sewage backup issues present • Cleanout cover not installed • Appears to have various jumpers installed • Furthest Valve to the right appears to be closed, this valve should be open as the supply for Lower Iqaluit is supposed to come through this piping • Bleed present but not active, appears to have backflow preventer

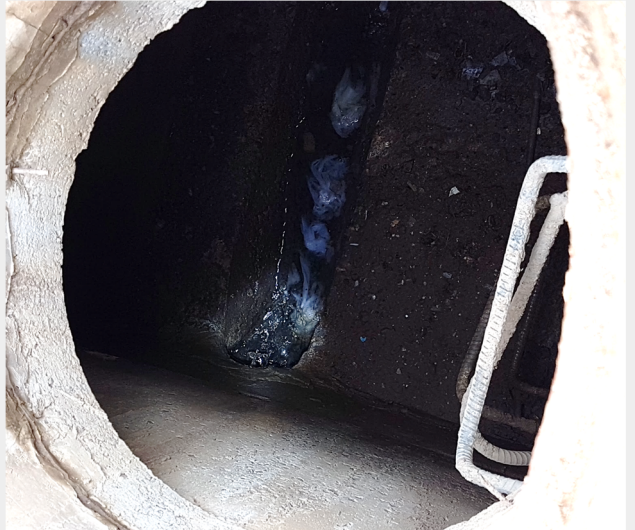
<p>Yes, confirm that the valve is in the closed position. If closed, discuss with Public Works why this was shut, frozen pipes? Or?</p>
MH 6	Could not locate structure, possibly buried		Locate and investigate
MH 14	<ul style="list-style-type: none"> • Open sewer benching • Little information can be gathered without entry into structure

<p>Yes – determine source of water, leak or infiltration</p>

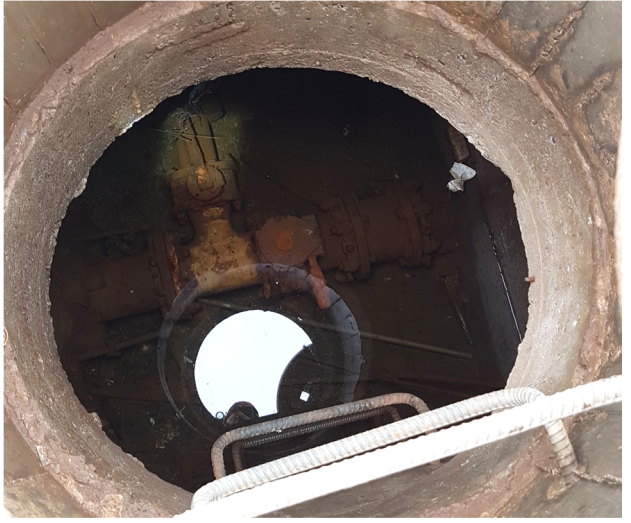
MH 15	<ul style="list-style-type: none"> • Requires pumping • Clear water inside structure, probably groundwater but possibly potable • Low visibility, further information not obtainable without pumping

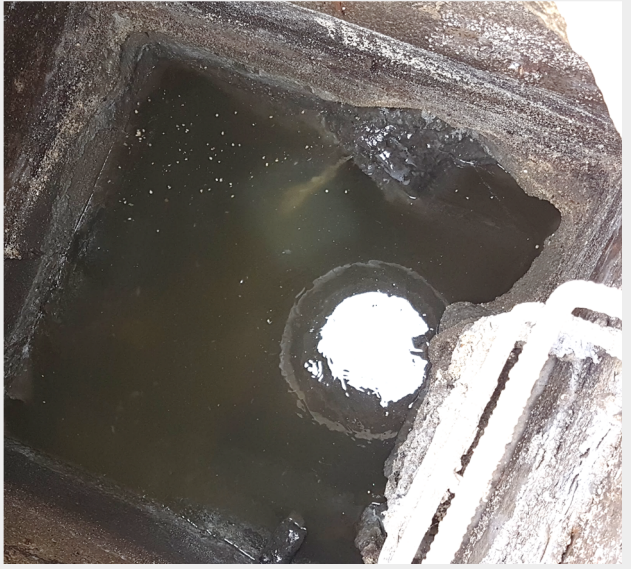
Yes – determine source of water, leak or infiltration
MH 13	<ul style="list-style-type: none"> • Contains valving to control water flow direction • Requires pumping and cleaning as none of the internals visible • Internal condition suggests sewage back-up to substantial depth

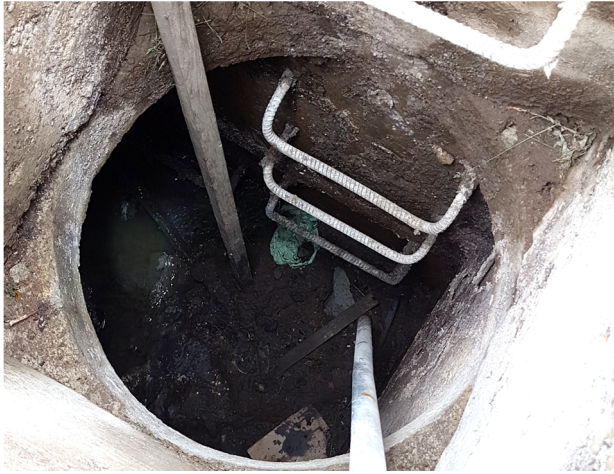
MH 22 – see image in Table 1.1 – During the investigation, it was noted, that audible sounds were observed that seemed to be representative of a leak. Structure requires cleaning and further investigation to confirm the cause of the noise. If a leak is identified, repair.

MH 13	Previously reviewed, see above		
MH 22	<ul style="list-style-type: none"> Requires pumping and cleaning Audible sounds suggest water flow present Further internal observations required

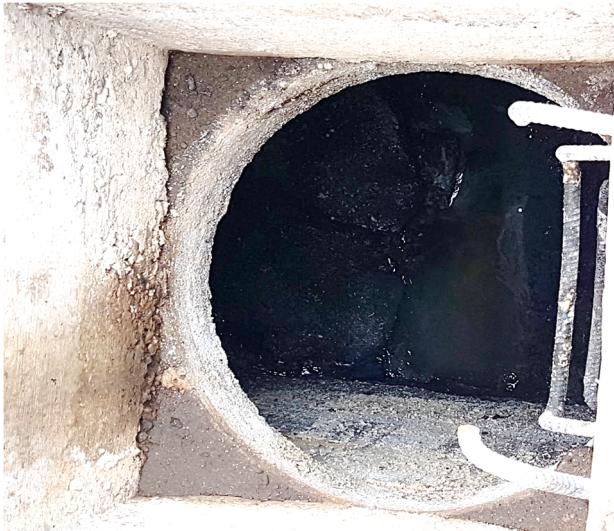
Yes – access to determine causes of noise and repair
MH 21	Could not open, frame and cover seized together.		Yes – Fix access issue and gather information
MH 20	<ul style="list-style-type: none"> Requires pumping and cleaning Open sewer benching Structure access damaged Internal conditions could not be observed Requires internal access and re-inspection

Yes – Fix structure access, investigate structure after cleaning and pumping

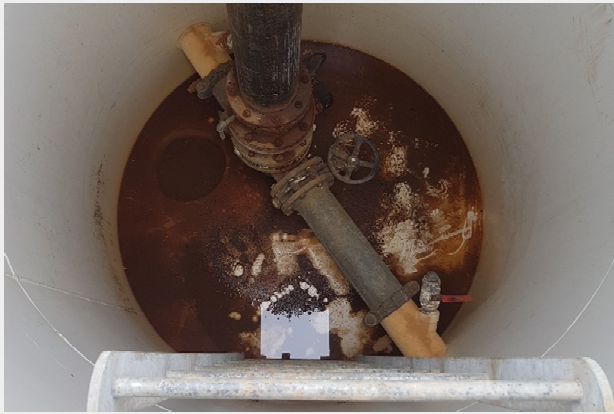
AV 19A	<ul style="list-style-type: none"> • No exceptions noted

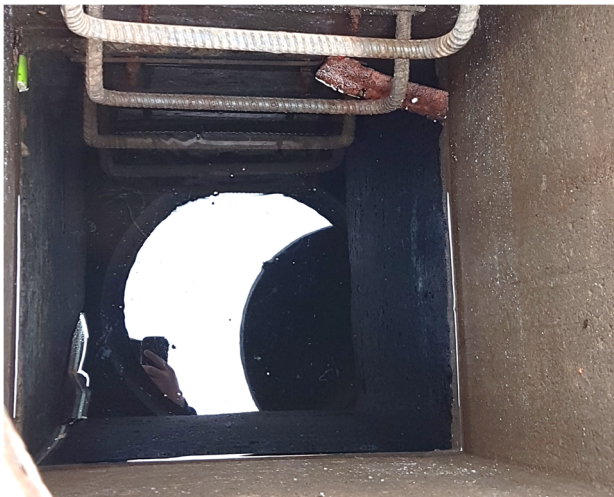
No
MH 23B	<ul style="list-style-type: none"> • Requires pumping and cleaning • Internal conditions could not be evaluated due to internal water

Yes –Investigate structure after cleaning and pumping, determine source of water

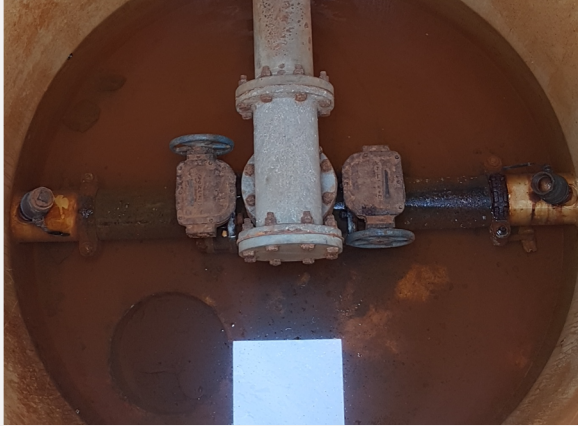
AV 23A	<ul style="list-style-type: none"> • Requires pumping • Installed to separate water from sewer • High humidity due to standing water is damaging coatings • Piping going to MH 33 is to have been abandoned.

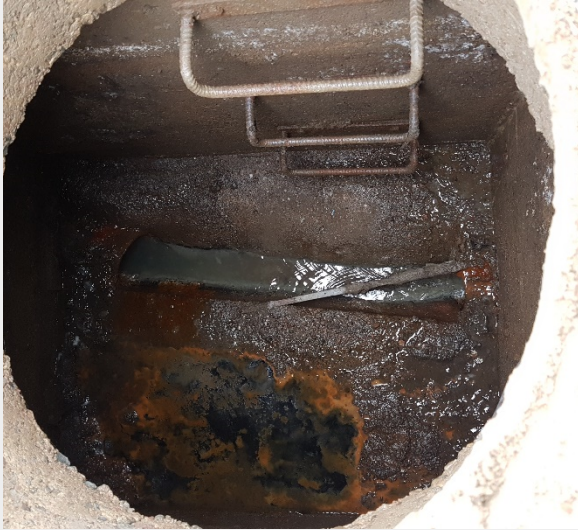
No
MH 30	Could not locate; probably buried		Locate and investigate
MH 31	<ul style="list-style-type: none"> • Requires cleaning and disinfection • Open sewer benching • Indications of sewage back-up to near surface elevation • Watermain is not visible, supposed to be a 150mm ductile iron pipe

Yes – investigate water piping after cleaning

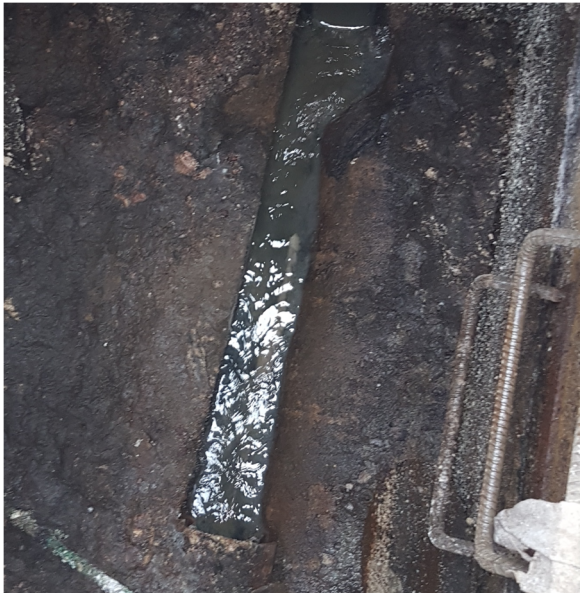
MH 32	<ul style="list-style-type: none"> • Requires cleaning and disinfection • Open benching • Indications of sewage back-up to near surface elevation • Watermain is not visible, supposed to be a 150mm ductile iron pipe

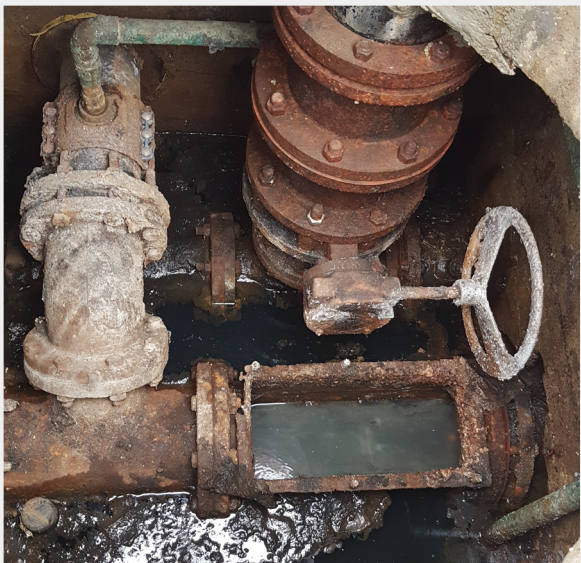
Yes – investigate water piping after cleaning
MH 32A	<ul style="list-style-type: none"> • Requires pumping and cleaning • Clean-out cover missing • Copper piping probably for sump pump that is no longer in service

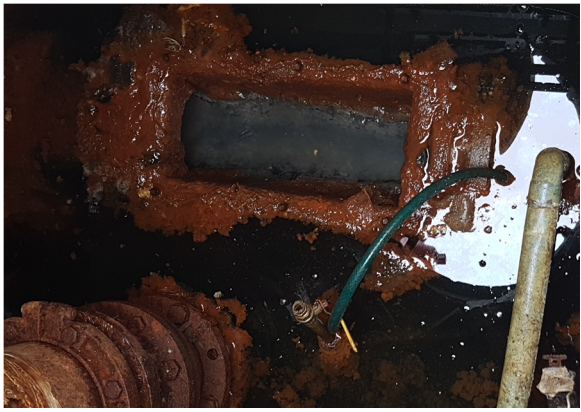
MH 32B	<ul style="list-style-type: none"> • Requires pumping and cleaning • Clean-out cover missing • Appears to previously have used garden hose for bleed; currently broken from nozzle. • Does not appear to have back flow prevention • Copper piping for sump pump; not in service

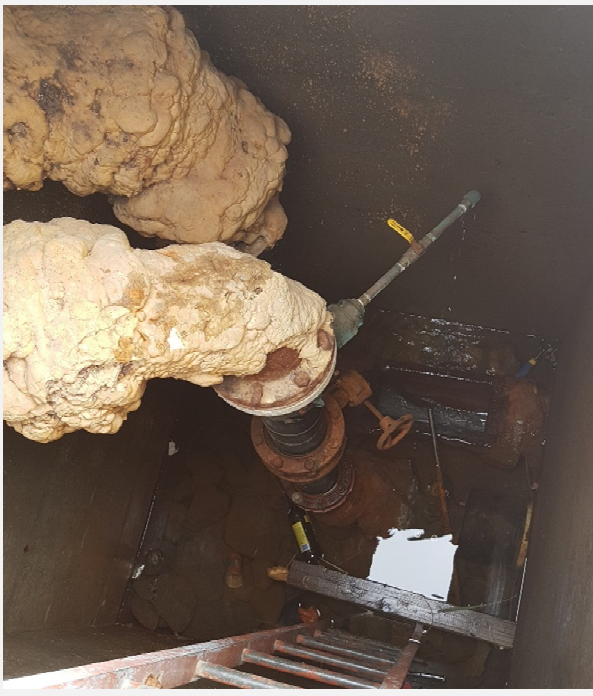
<p>Yes – if bleed is utilized, backflow preventer required. After pump out investigate watermain</p>
MH 63A	<ul style="list-style-type: none"> • Clean-out cover missing • Water and Sewer both drop vertically • Insulation added for additional freeze protection • Water present at bottom of structure, probably groundwater but could be potable • Bleed installed with missing backflow preventer • Minor leak from end of bleed, structure has water in it upto top of clean out

<p>Yes – if bleed is utilized, backflow preventer required</p>

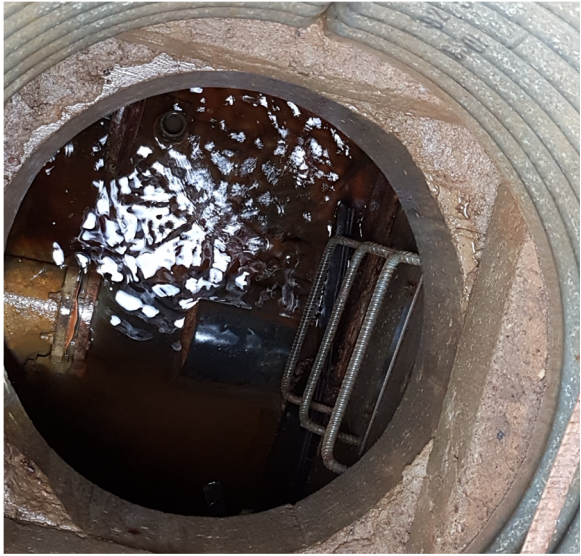
<p>MH 63</p>	<ul style="list-style-type: none"> • Requires pumping water at bottom • Frame and cover raised using a combination of CSP and concrete collar. • Inadequate structure access • This is an important junction/structure within Lower Iqaluit loop. • Structure has quite a bit of water that appears transparent, possible leak or groundwater.

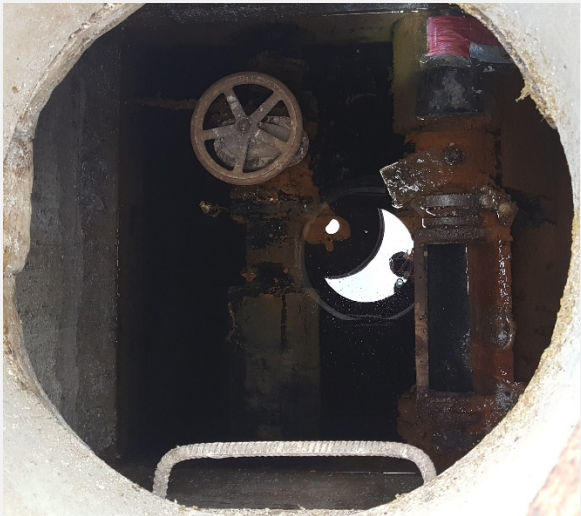
<p>Yes – repair access, investigate source of water in structure.</p>
<p>MH 65</p>	<ul style="list-style-type: none"> • Structure access appears inadequate • Structure has water that appears transparent, possible leak or groundwater • Cleanout cover not installed

<p>Yes – repair access, investigate source of water in structure.</p>

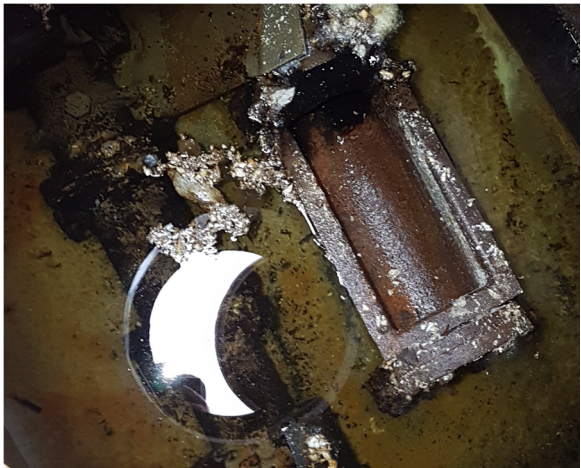
MH 66	<ul style="list-style-type: none"> • Transparent water within structure, appears to be ground water infiltration but could possibly be a leak • Pumping and cleaning required • Appears to be top of sewer run

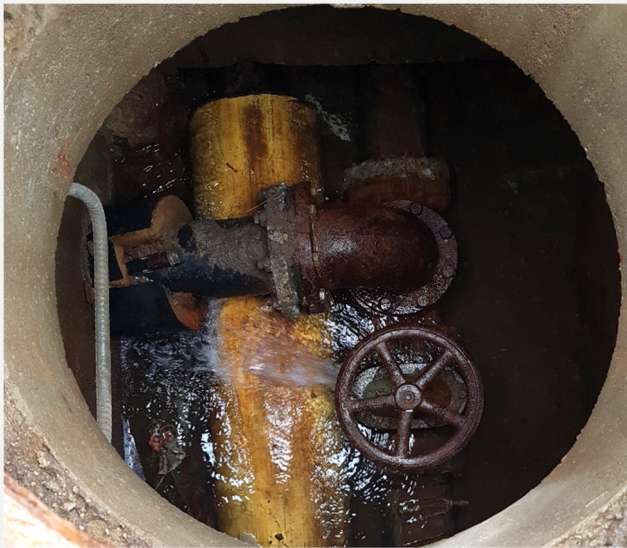
MH 39 – see image in Table 1.1 – Major leak identified at the valve, repair the leak.

Yes – investigate source of water in structure.
MH 39	<ul style="list-style-type: none"> • Large structure with 2 access points • Significant leak at valve • Water pipe going to MH 48 should be out of service • Electrical equipment still present but probably not functional

Yes – repair major leak

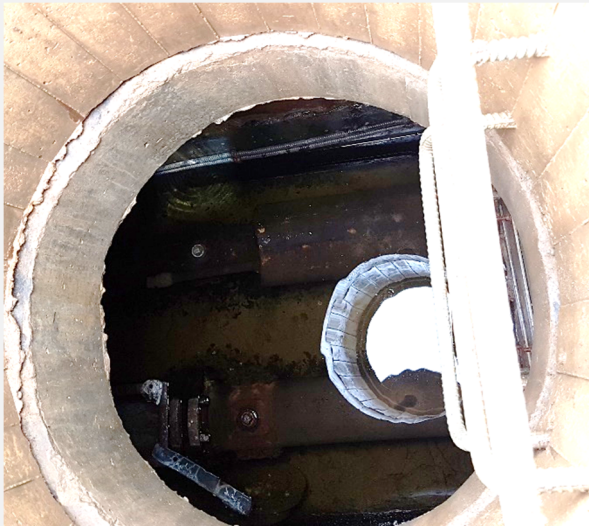
MH 37	<ul style="list-style-type: none">• Requires pumping and cleaning• Structure appears to have relatively clear water, possible leak or groundwater

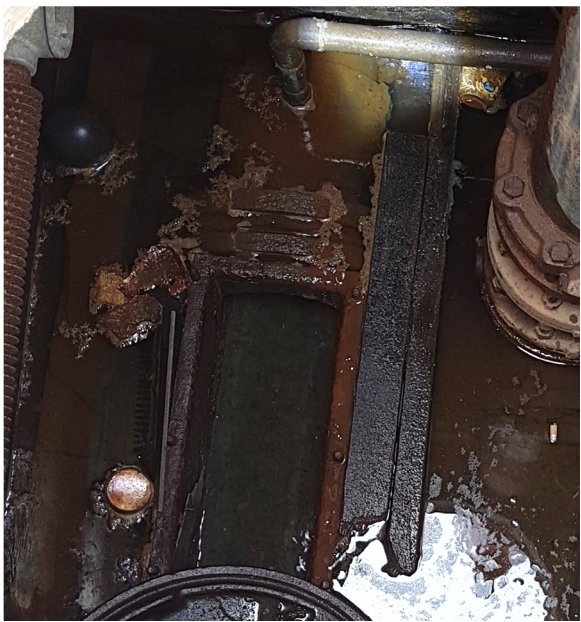
Yes – investigate water source within structure
MH 36	<ul style="list-style-type: none">• Requires pumping, removal of debris and cleaning• Clean-out cover missing• Sewer appears to have previous backups• Sump pump and heater present but probably not functional

Yes – investigate water source within structure

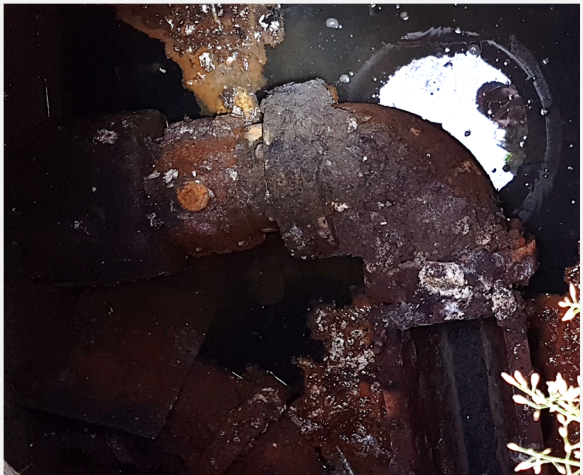
MH 61	<ul style="list-style-type: none"> • Requires pumping and cleaning • Significant corrosion, indicative of long standing water issues • Appears to have experienced sewage back-up and surcharge • Further comment requires cleaning and re-inspection

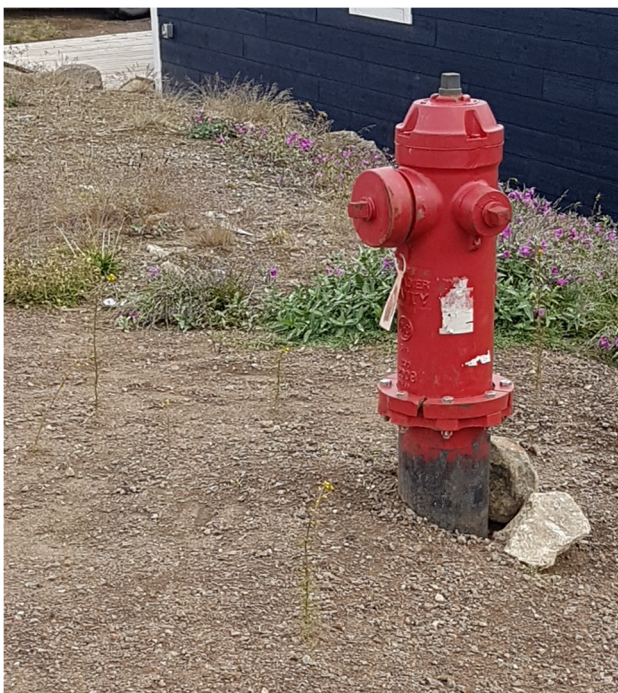
Yes – investigate water source within structure
MH 60	<ul style="list-style-type: none"> • Access appears to be buried • Internal inspection not possible • Important junction in water network

Yes – Uncover access and investigate

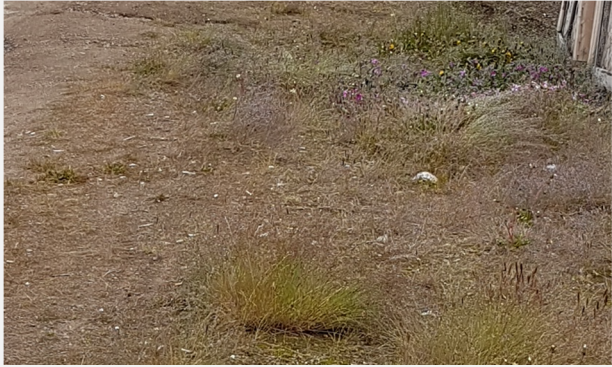
MH 59	<ul style="list-style-type: none"> • Structure appears to be buried • Internal inspection not possible

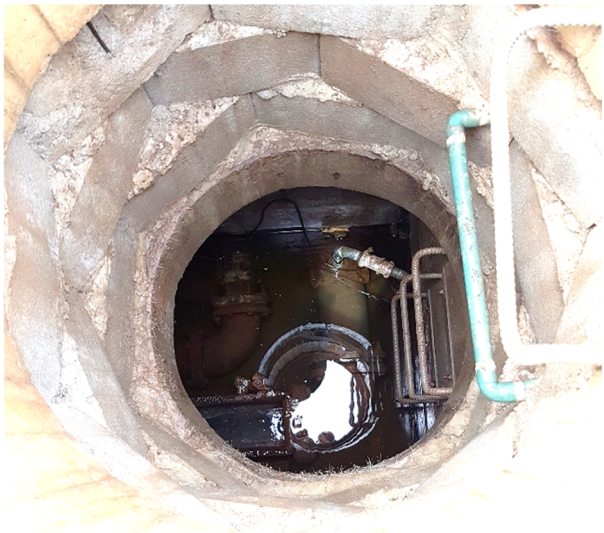
Yes – Uncover access and investigate
MH 48	<ul style="list-style-type: none"> • Large structure with 2 access points • Sump pump installed but probably not functional • Piping to MH 39 should have a valve that is in the closed position • Cleanout cover not installed • Relatively clear water present, possible leak or infiltration

Yes – investigate water in structure and ensure valve to MH 39 is closed

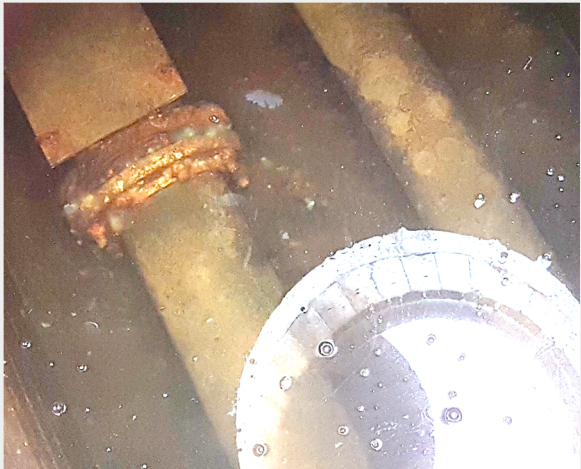
MH 47	<ul style="list-style-type: none"> • Requires pumping • Clean-out cover in place

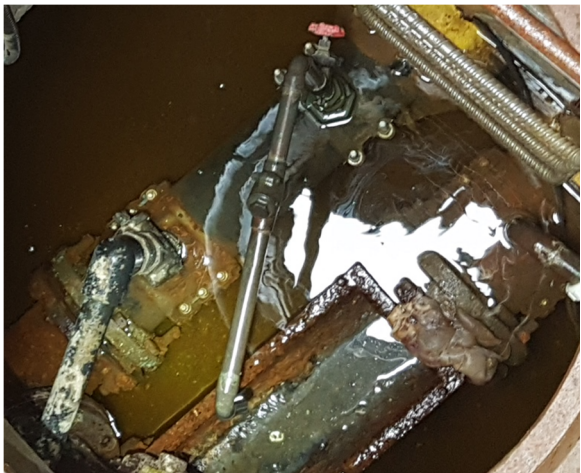
Yes – investigate water source within structure
MH 46	<ul style="list-style-type: none"> • Requires pumping • Clean-out open • Piping in place for a bleed, not operating during inspection • Structure needs to be accessed to see other piping which connects to watermain

Yes – investigate water source within structure

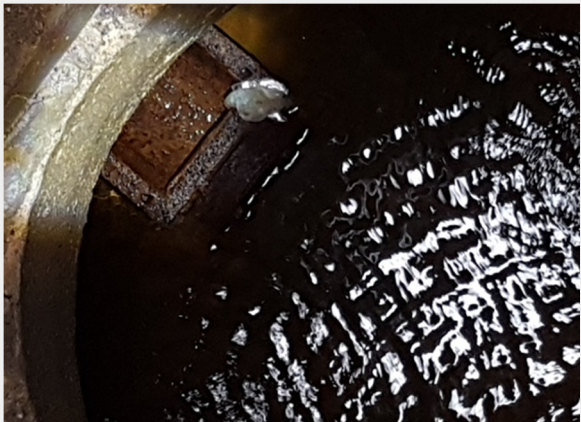
MH 58	<ul style="list-style-type: none"> • Requires pumping • CSP riser installed over concrete structure • Clean-out open, water inside structure is filled to rim of clean-out; draining into sewer • Watermain not visible

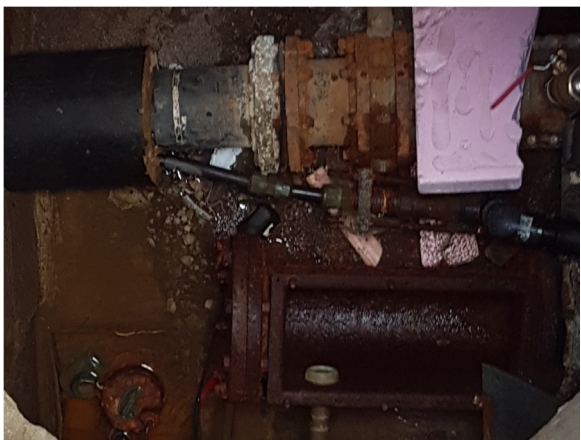
Yes – Investigate water source, groundwater or leak
MH 46B	<ul style="list-style-type: none"> • Unused electrical equipment remains in place <ul style="list-style-type: none"> • Sump pump, electric heater, connection to thaw tube • Clean-out cover missing, start of sanitary run • Requires cleaning • Structure generally dry • Newer ball valve installed, assuming it was used as a bleed.

Yes – if using ball valve as a bleed, install backflow preventers

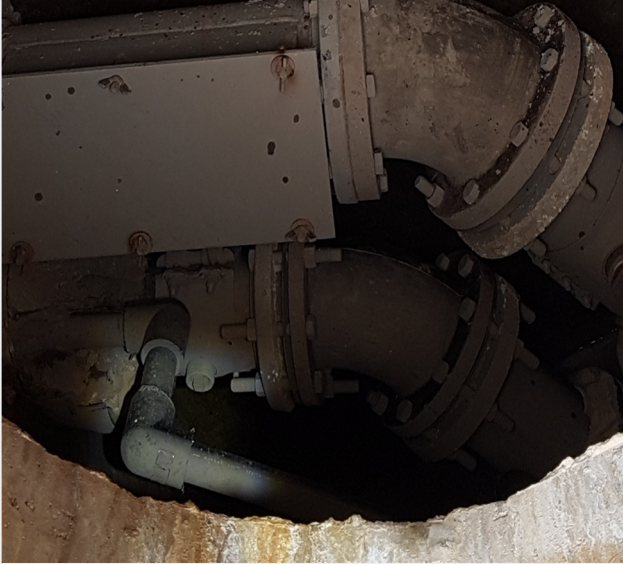
MH 46A	<ul style="list-style-type: none"> • Clean-out cover appears to be in place <ul style="list-style-type: none"> • Appears to be a retro-fitted cover • Thaw tube still in place • Requires pumping

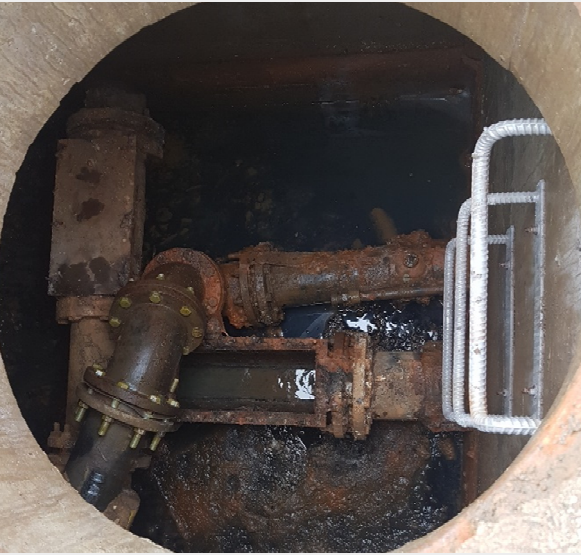
No
MH 45	Structure not visible; probably buried		Yes – Locate and uncover
MH 43	<ul style="list-style-type: none"> • Requires pumping and cleaning • Clean out cover removed • Watermain crosses over sewer main • Evidence of previous backup and surcharges

No

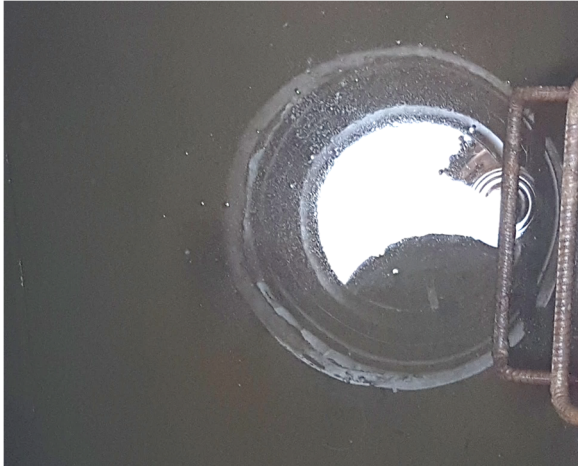
MH 42	<ul style="list-style-type: none"> • Requires pumping and cleaning • Important junction in watermain network • No internal observations possible

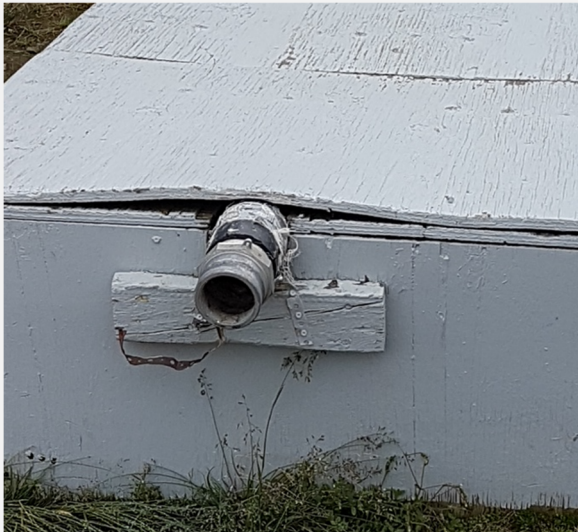
Yes – clean and investigate
PT A	<ul style="list-style-type: none"> • Could not open wooden box; inspection not possible

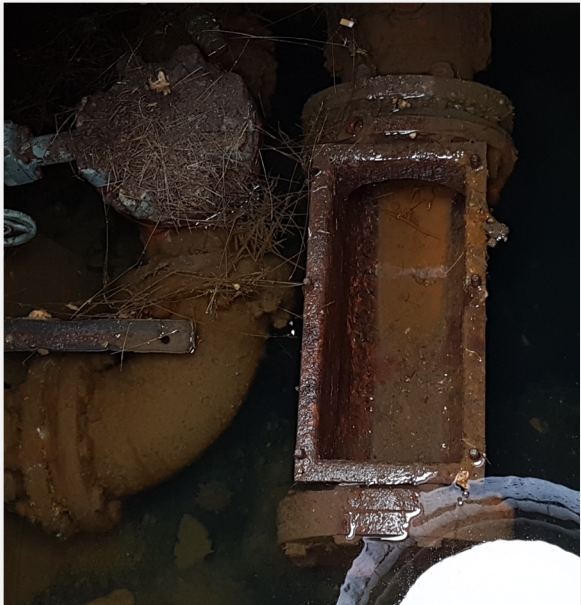
MH 41	<ul style="list-style-type: none"> • Requires pumping and removal of debris • Clean-out cover missing • Appears filled with groundwater to clean-out rim • Top end of sewer system • No evidence of sewage back-up

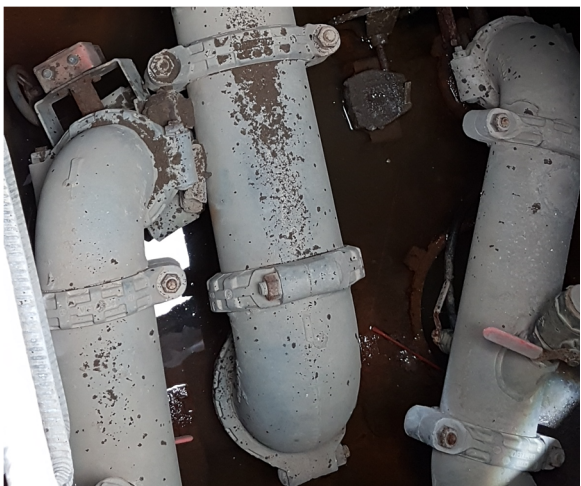
Yes – investigate water source
MH 40	<ul style="list-style-type: none"> • Requires pumping • Lower sewer piping not visible • Upper piping appears more recent (thaw laterolets) • Valve on lower piping between newer piping is supposed to be in closed position

Yes – investigate water source, confirm valve is closed

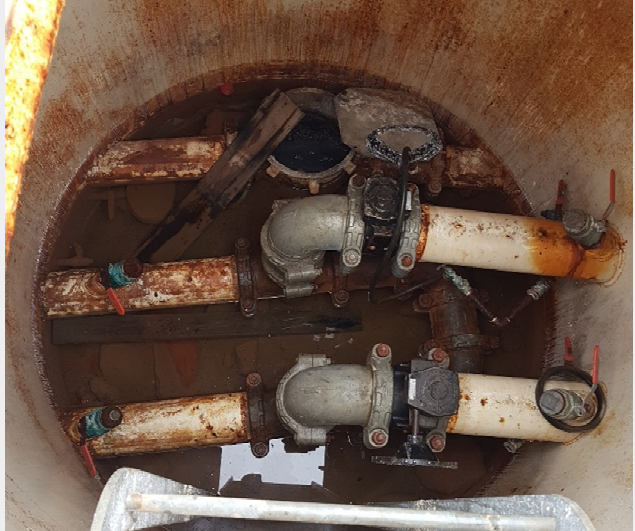
AV 40A	<ul style="list-style-type: none"> • Requires pumping • Cleanout not installed • Original configuration had water entering and returning within the structure, appears to have been extended. • Where (structure) the water returns, unknown • Piping for a bleed present, doesn't appear active • Corrosion around laterolet indicates minor leak

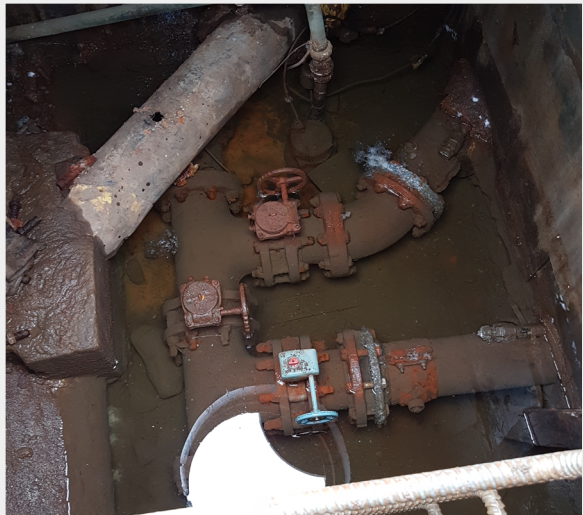
MH 24A – see image in Table 1.1 – Significant leak identified at the flanged connection of the 45° bend, repair the leak.

Yes – investigate water source, repair laterolet
MH 40	Previously reviewed, see above		
MH 24A	<ul style="list-style-type: none"> • Leak at 45° bends flanged connection • Requires pumping and cleaning, contamination risk is high with leak present • Electrical components are present but probably not functioning

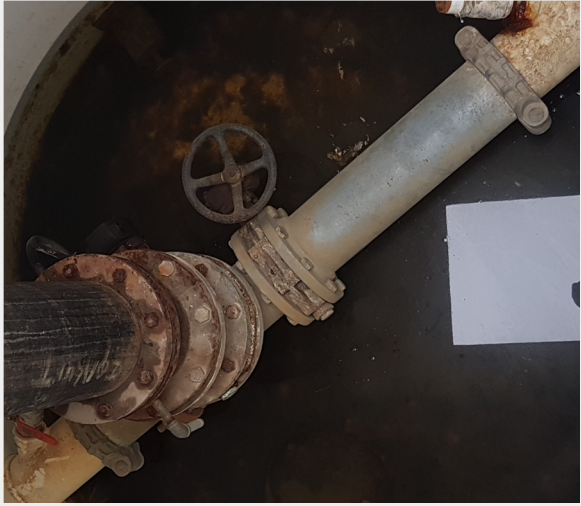
AV 25A	<ul style="list-style-type: none"> • Appears to have been provided to separate water from sewage (MH 25) • Requires pumping • Corrosion around laterolet indicates a minor leak

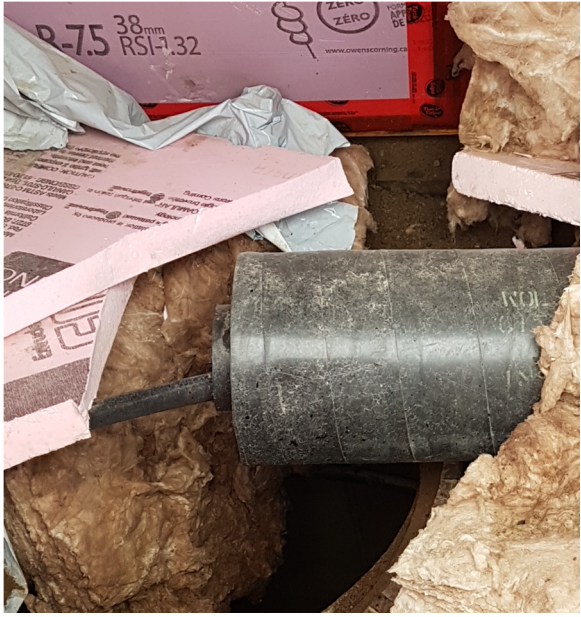
No
MH 26	<ul style="list-style-type: none"> • Wooden box has been constructed above the structure • Limited visibility • Appears to have ½ piping either acting as a service or as a bleed into the structure

Yes – Correct odd configuration and investigate internal componentns

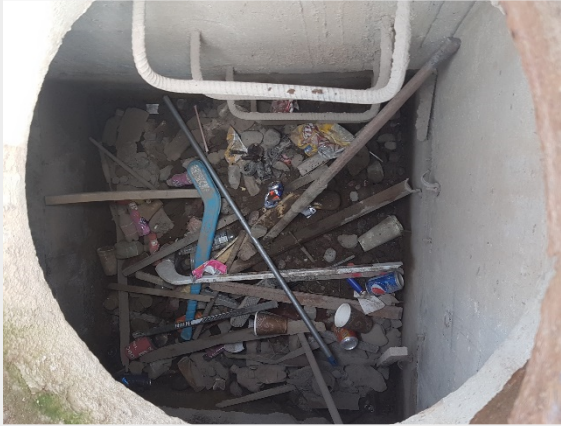
MH 27	<ul style="list-style-type: none"> Filled with debris, cleaning required
