Geotechnical Investigation

Lift Station #1, Septage Receiving
Station and Lower Iqaluit Sewer
Upgrades
Iqaluit, Nunavut

Prepared for:
City of Iqaluit

February 2023

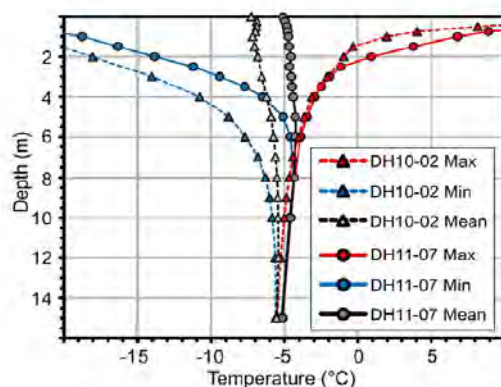
Figure 2.1: Thermistor data collected at the Iqaluit Airport as presented in the Journal of Applied Geophysics 2015 article.

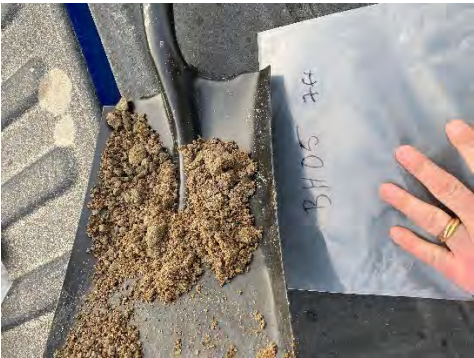
2.1 to 3.7	Coarse grained soil Sand with gravel Brown & light grey Frost between 2.4 – 3.6 m

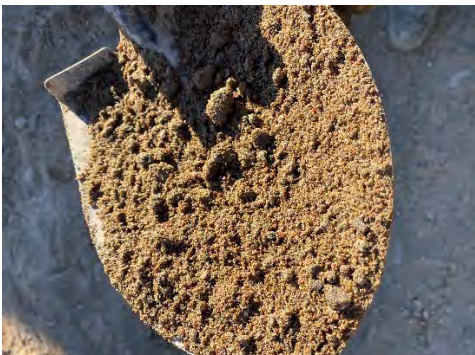
2.1 to 4.3	Coarse grained soil Sand with gravel Brown & light grey Moisture & cold Frost begins (air track likely melting)

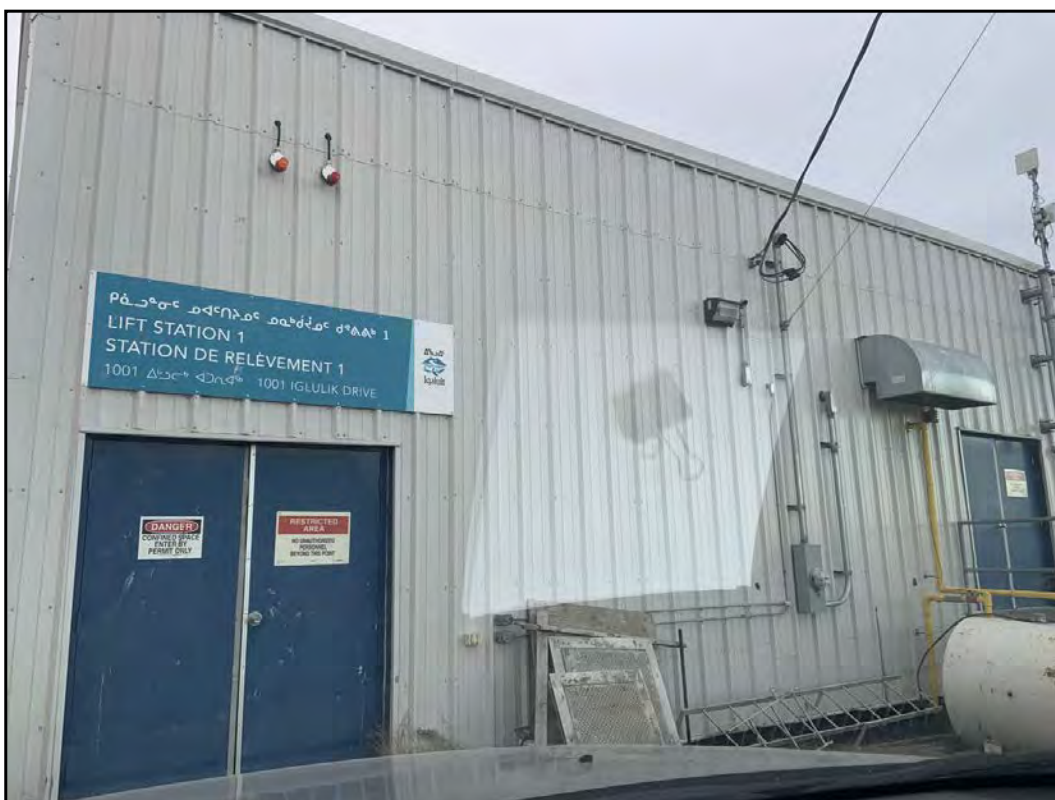
The north side of Lift Station No.1

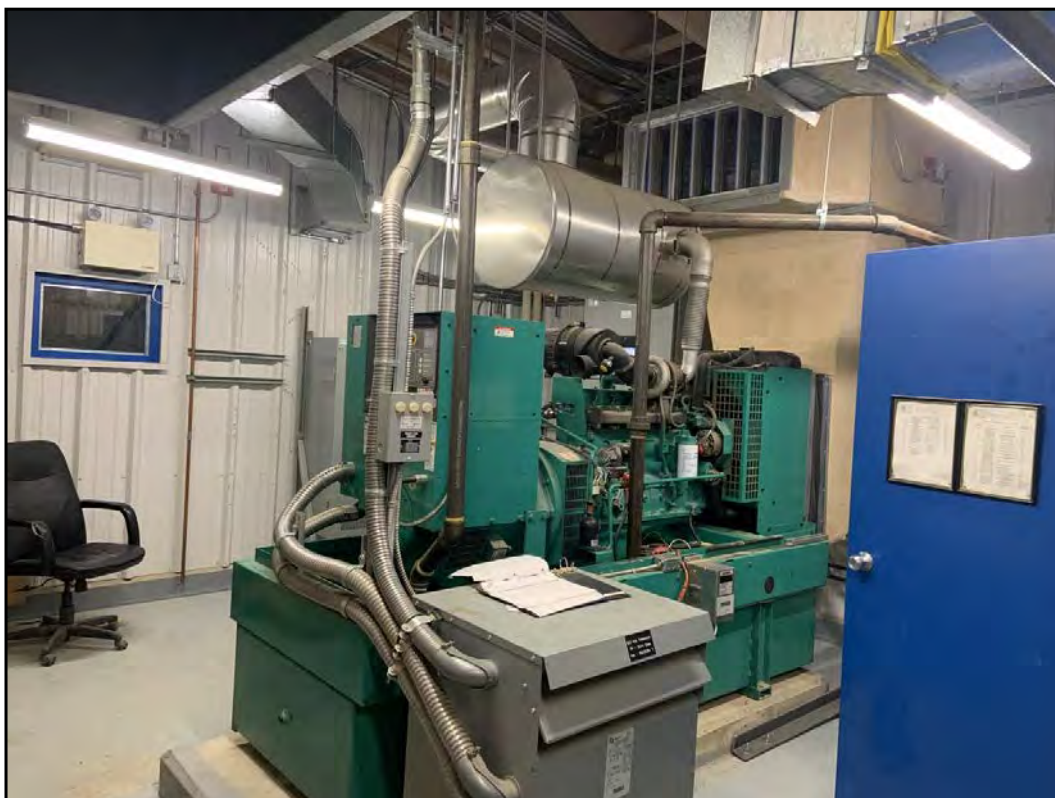
Inside Lift Station No.1

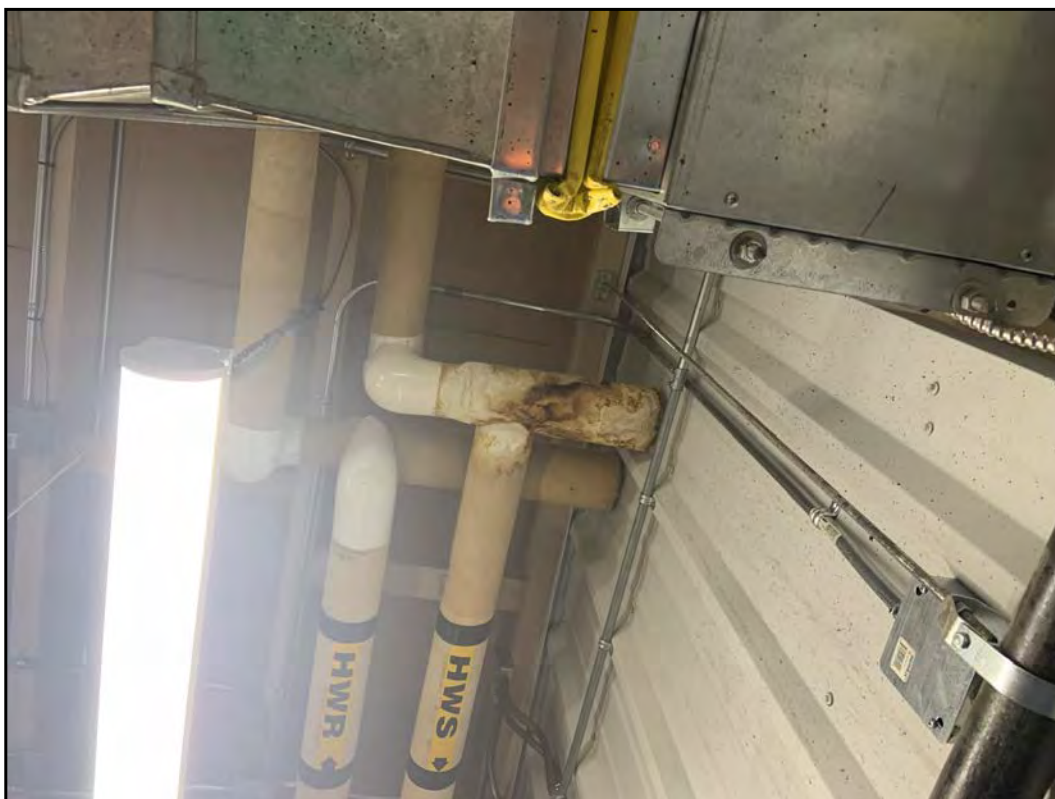
Water damage on pipe inside Lift Station No.1
