June 2018

Airport Creek Photos

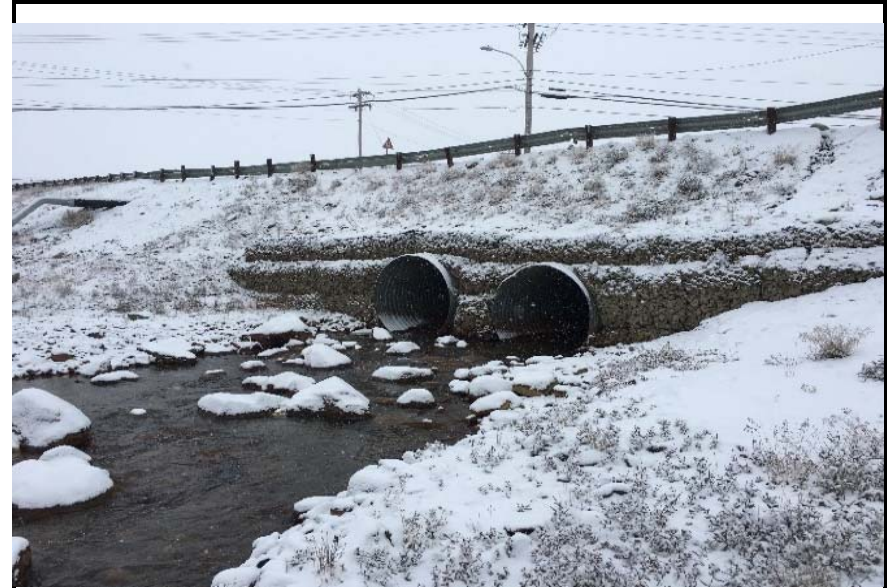
Crossing 1 (2 x 1800 mm dia.) - Early Fall

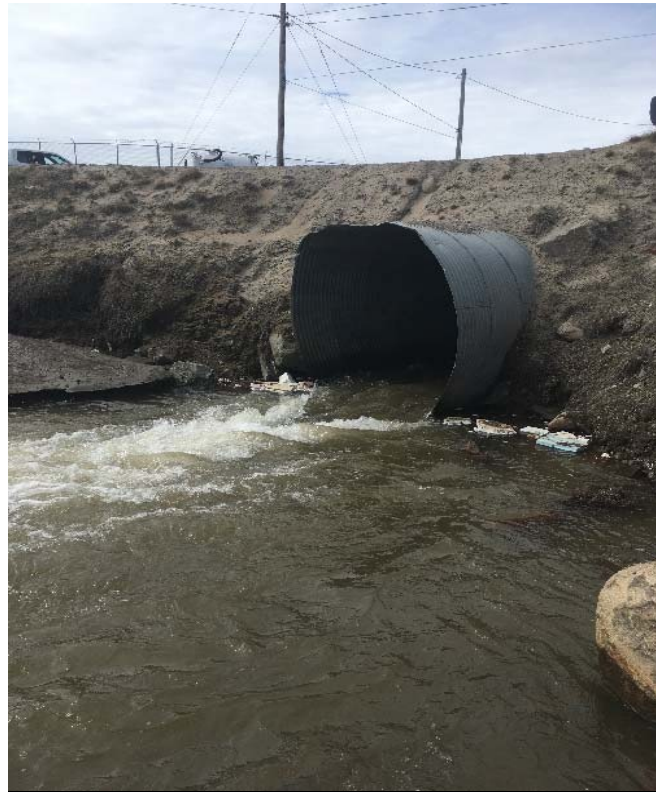
South of
Crossing 2
(2100 mm
dia.) -
Accumulated
Garbage

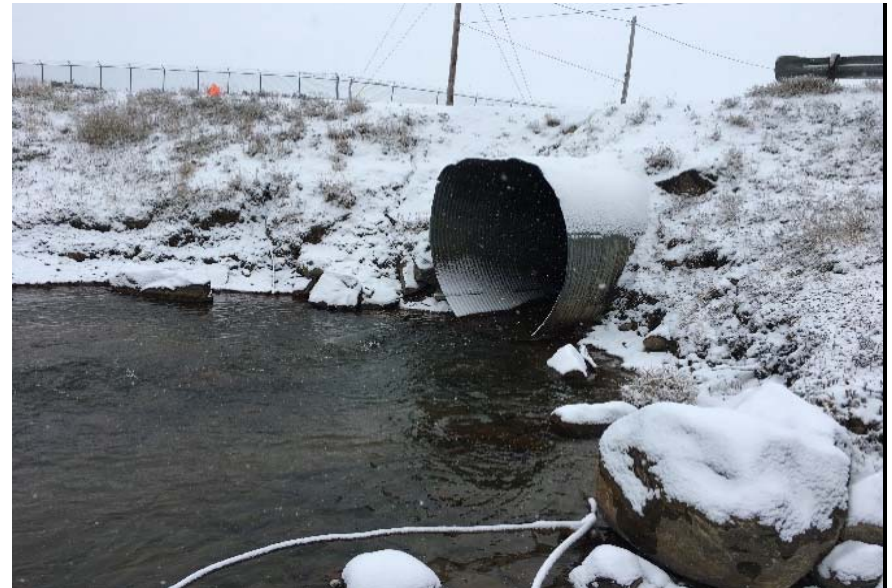
Crossing 2 (2100 mm dia.)

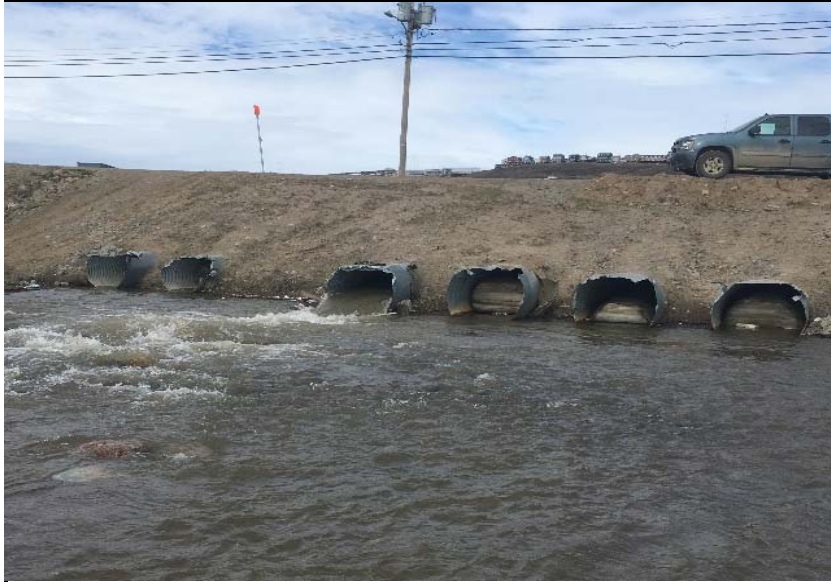
South of Crossing 3 (4 x 1200 mm dia. and 2 x 1000 mm dia.) - Damaged Ends

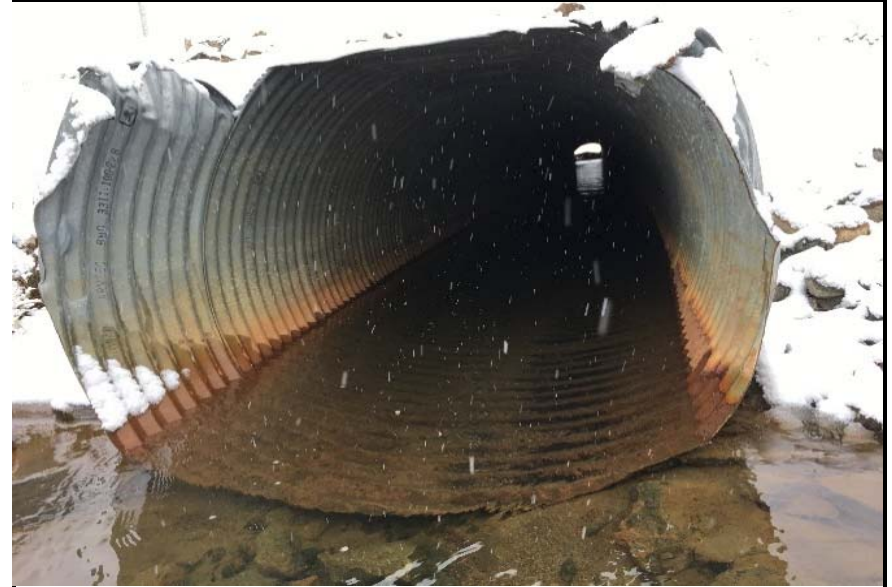
North of Crossing 3 - damaged ends

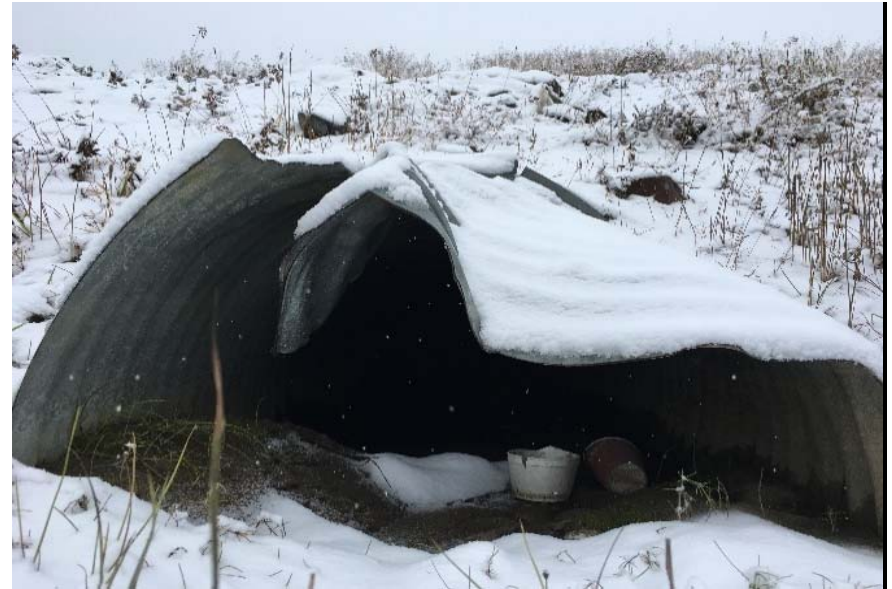
North of Crossing 3 - Deflected End

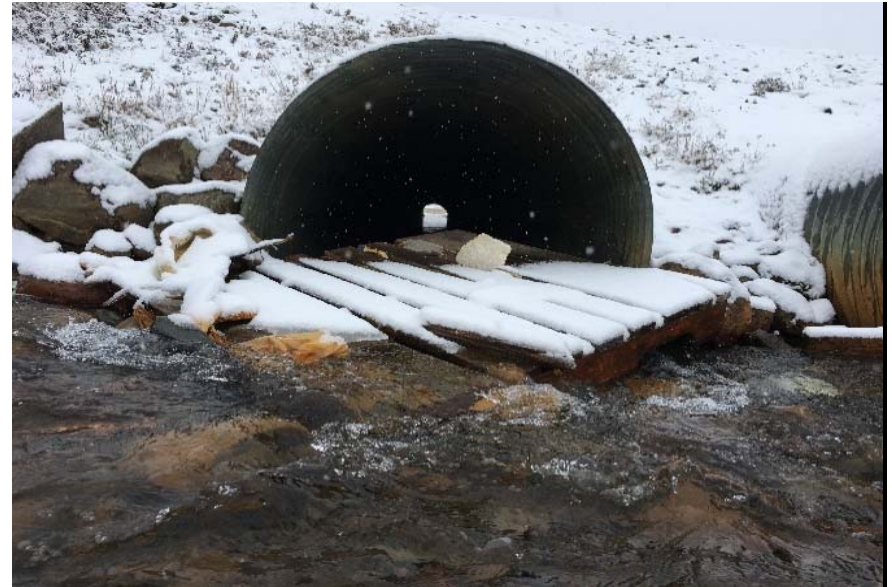
North of Crossing 3 - Wooden Pallet in Stream

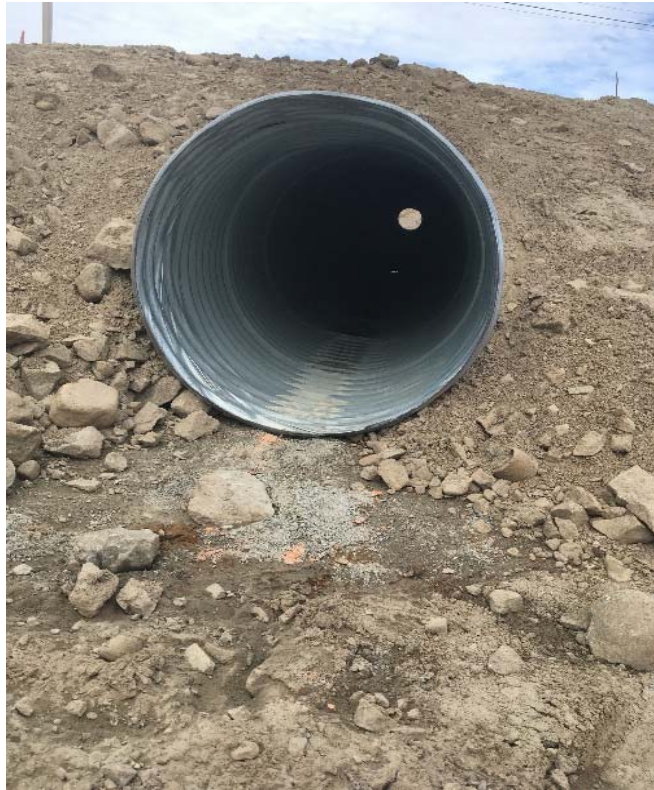
South of
Crossing 4
(800 mm dia.)
- not
receiving any
flow

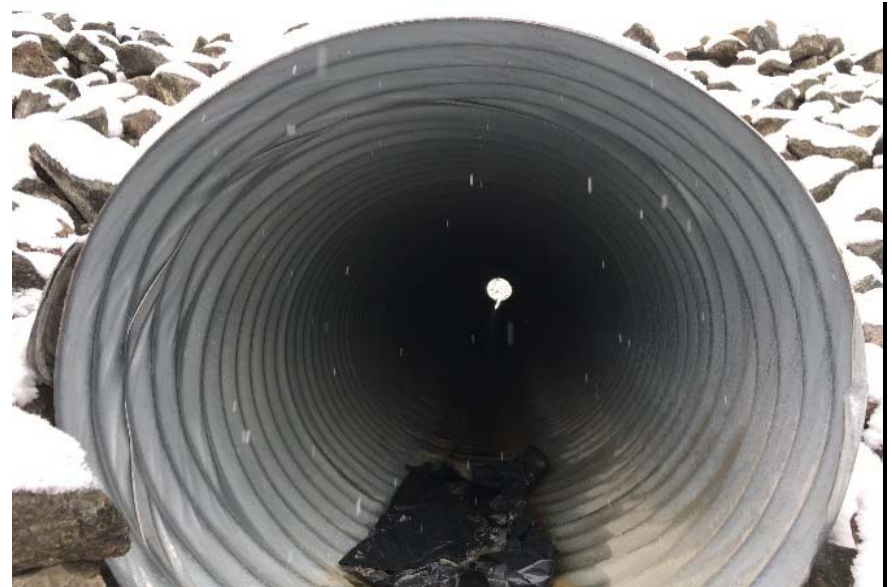
North of Crossing 4 (800 mm dia.) looking
Upstream - Garbage in the pipe

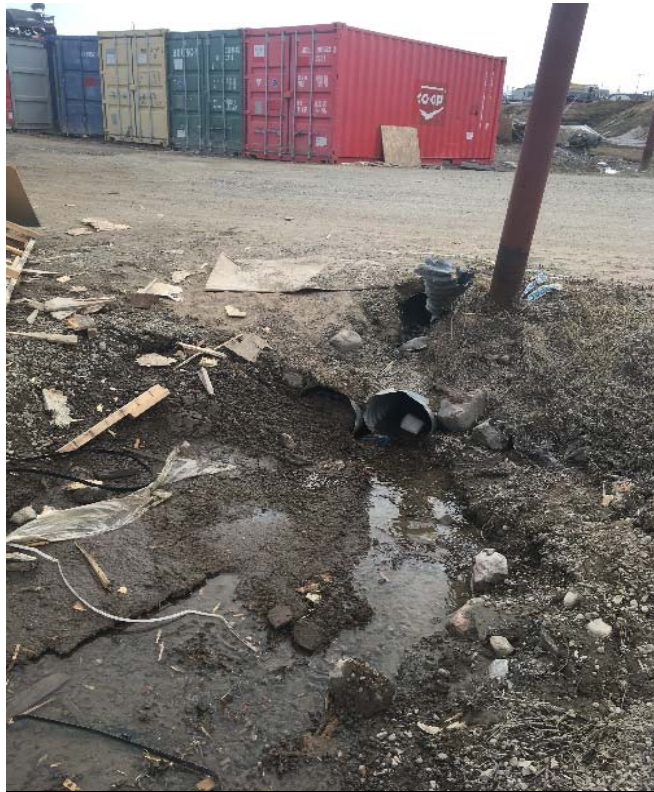
North of
Crossing 5 (3
x 300 mm
dia.) -
Garbage
accumulated

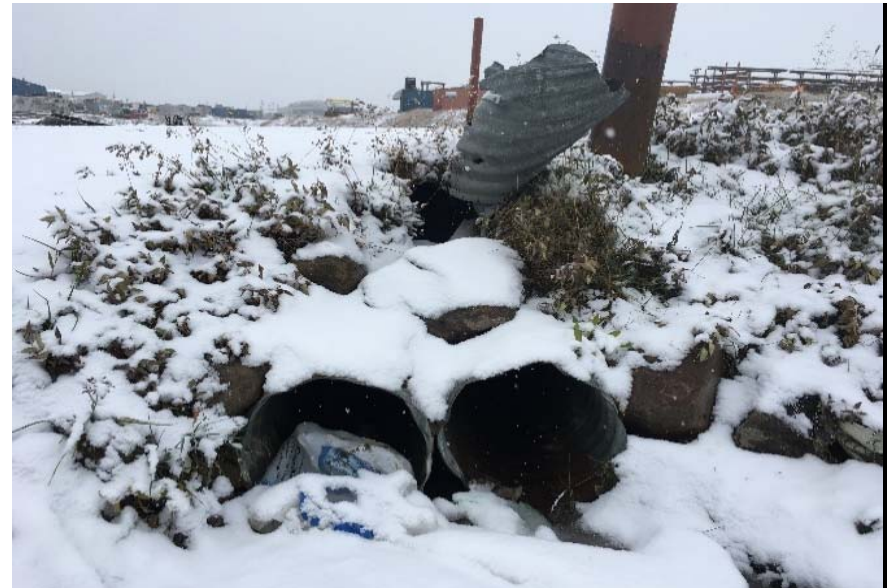
North of Crossing 5 (3 x 300 mm dia.) looking
Upstream - Garbage in the pipe

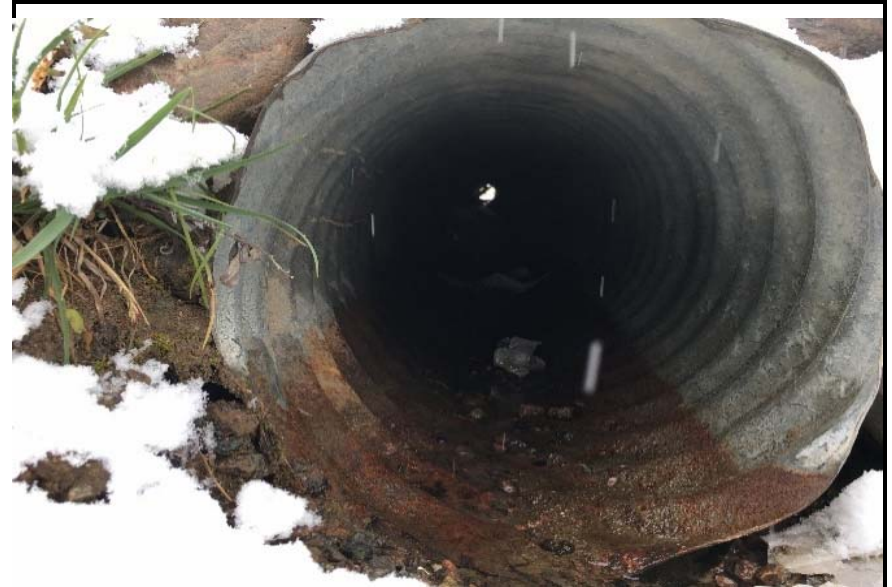
North of Crossing 5 (300 mm dia.) looking
Upstream - Corroded pipe exposed after the
removal of garbage

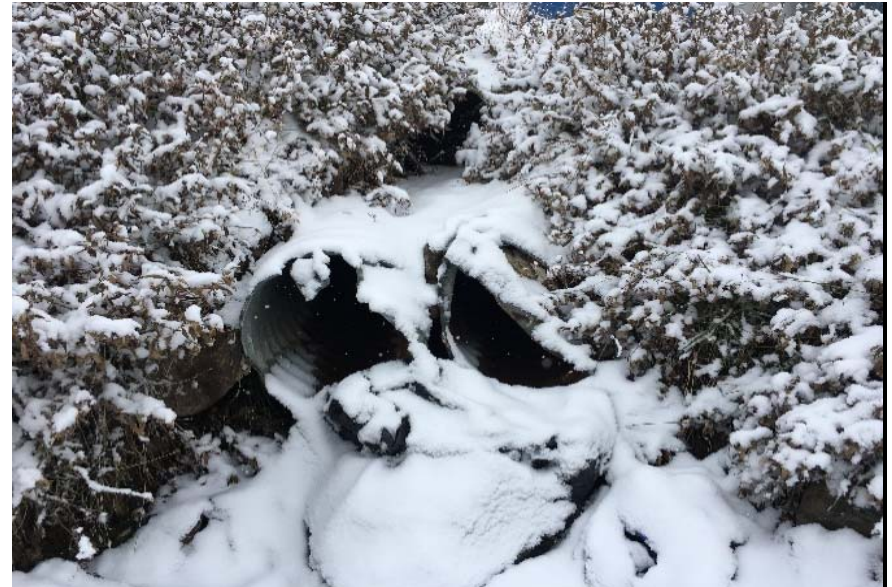
South of Crossing 5 (3 x 300 mm dia.) looking
Downstream - Garbage accumulated

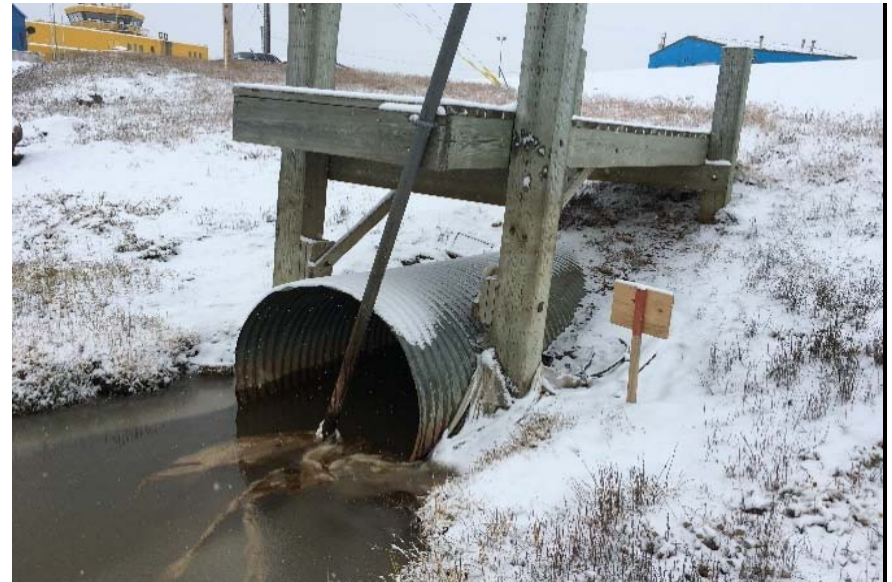
East of Crossing 6B (600 mm dia.) - Appears to be
garbage in the stream

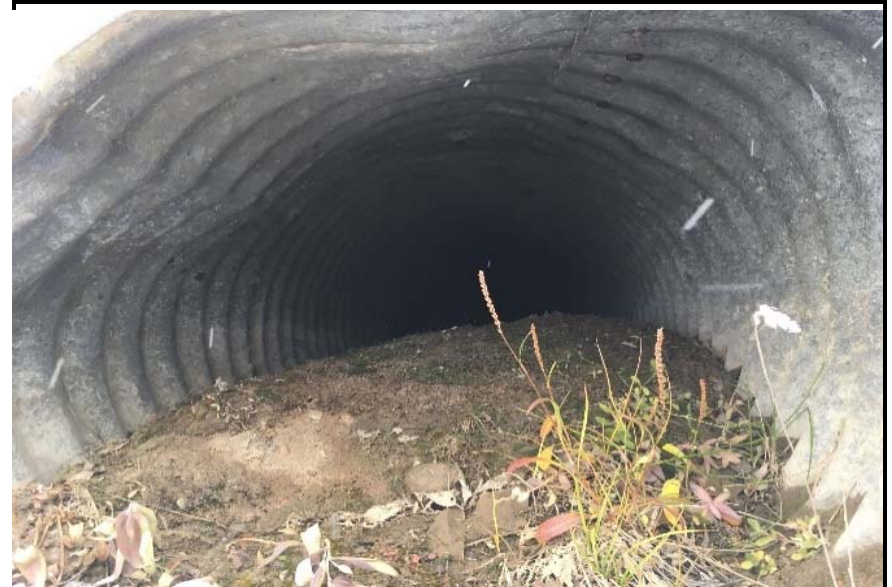
South of Crossing 7 (600 mm dia.) - Sediment
buildup in the pipe

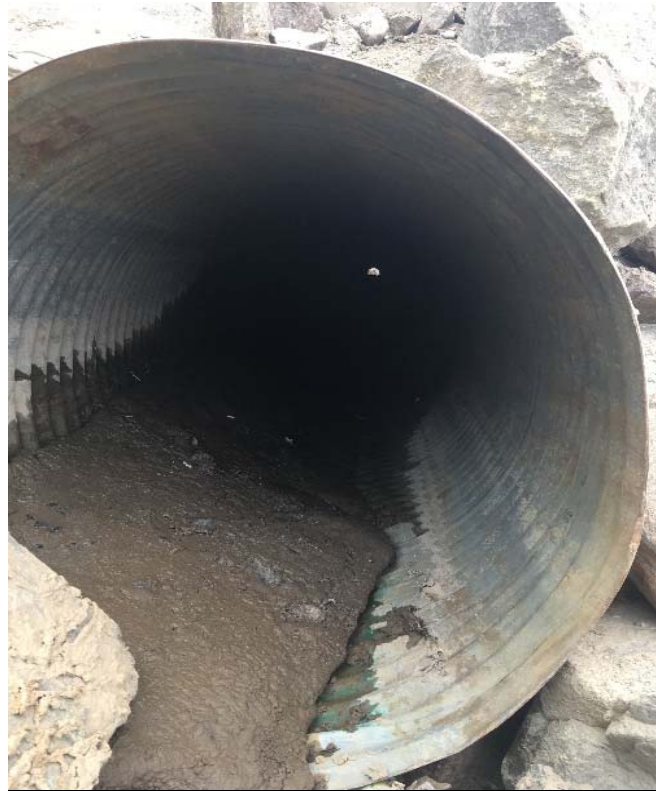
East of
Crossing 8
(1600 mm
dia.) closeup -
Sediment
buildup inside
the pipe

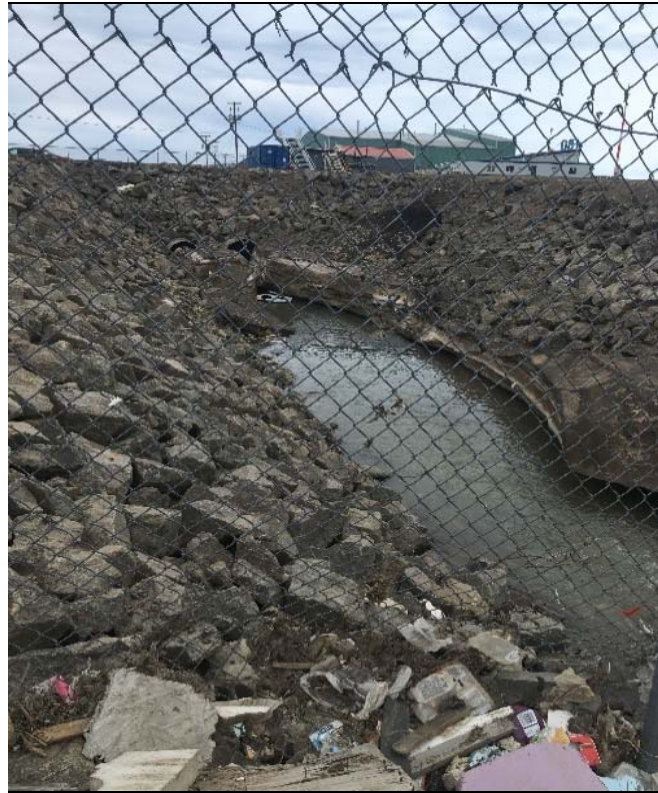
West of
Crossing 8
behind the
fence -
Garbage

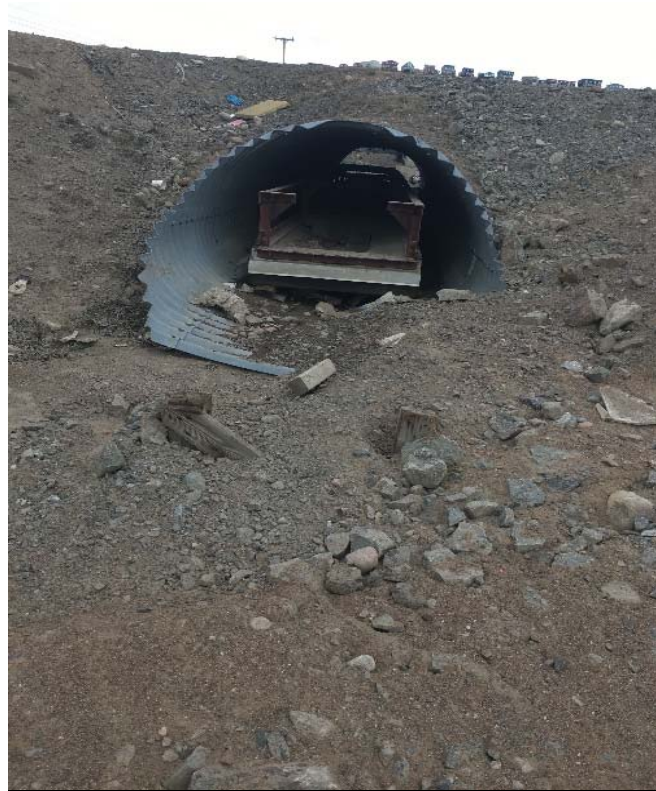
West of
Crossing 9
(2100 mm
dia.) -
Furniture
inside the
pipe

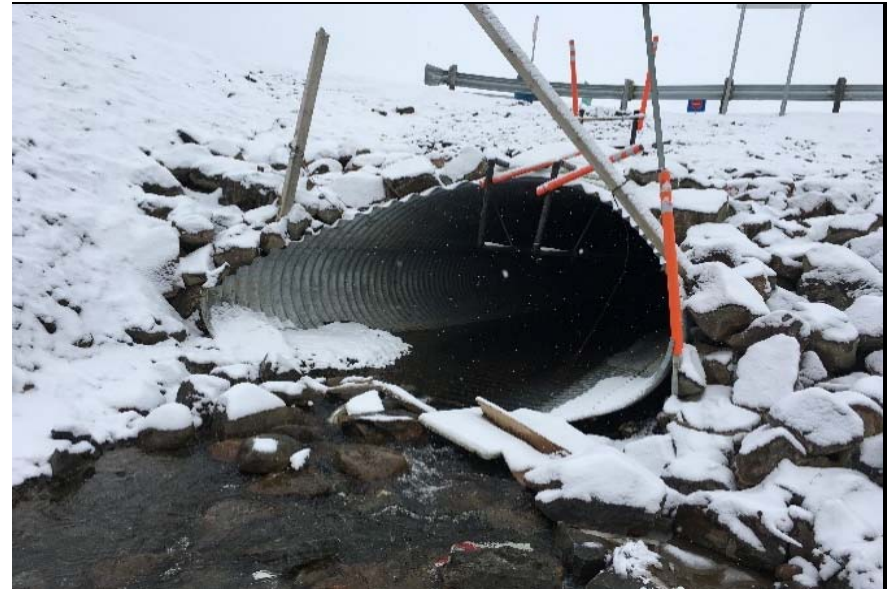
East of Crossing 10 (3100 mm dia.) - Deflected Pipe

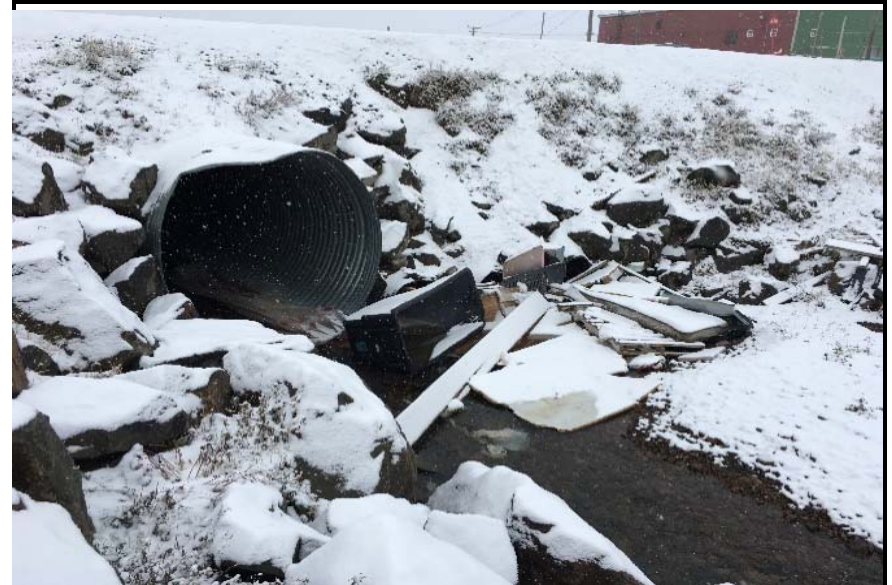
North of Crossing 12 (3 x 1000 mm dia. and 1 x
2100 mm dia.) looking Upstream - Garbage buildup
infront of pipe

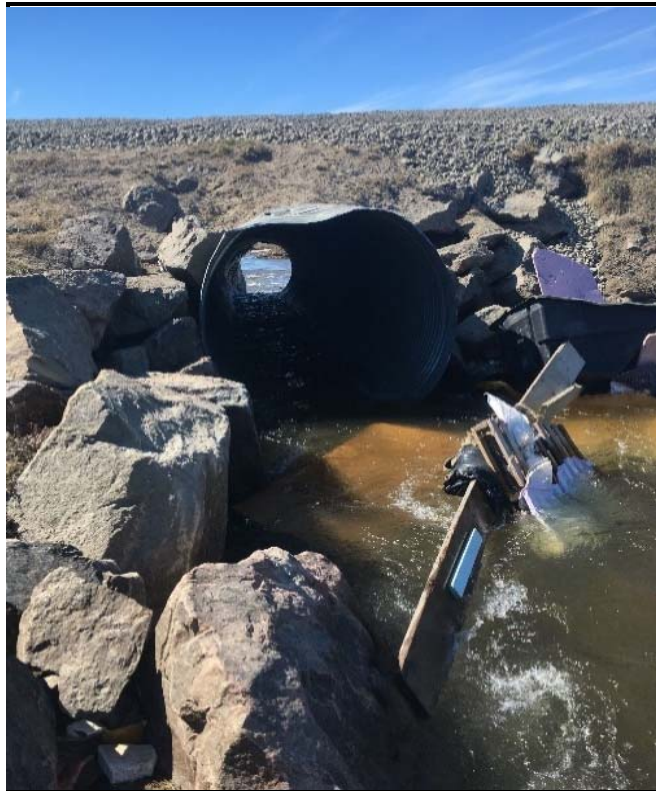
North of
Crossing 12 (3
x 1000 mm
dia. and 1 x
2100 mm
dia.) -
Garbage in
the stream

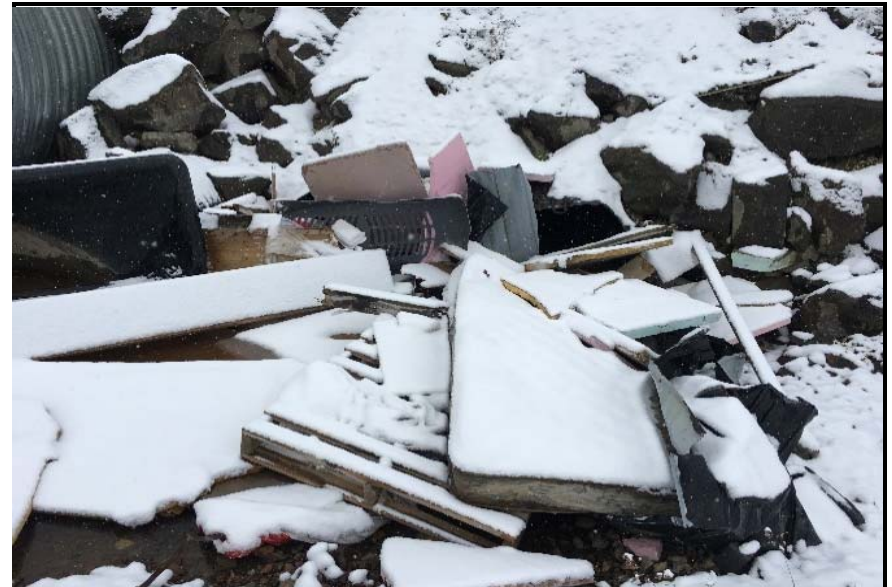
North of Crossing 12 (3 x 1000 mm dia. and 1 x
2100 mm dia.) looking Upstream - Wooden Pallets
and Garbage

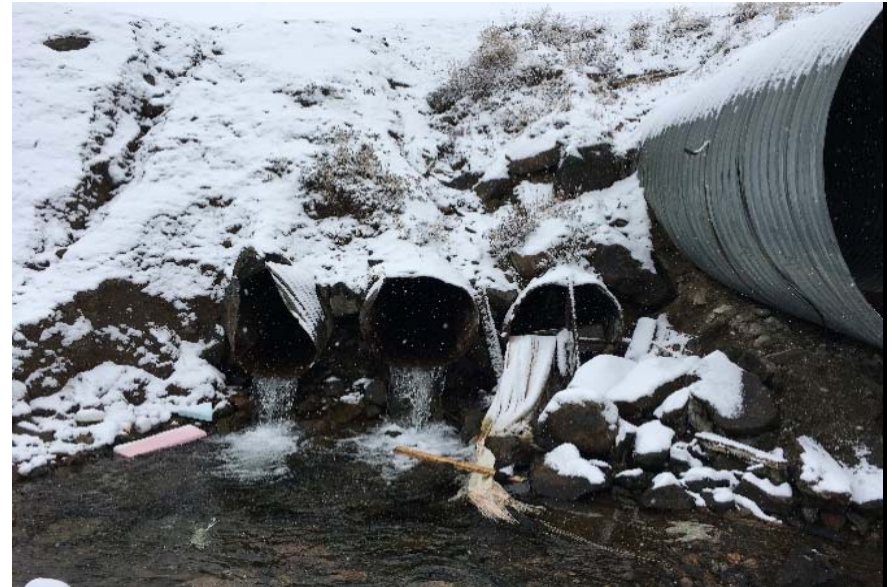
South of Crossing 12 (3 x 1000 mm dia. and 1 x
2100 mm dia.) looking Downstream - Garbage in
the flow

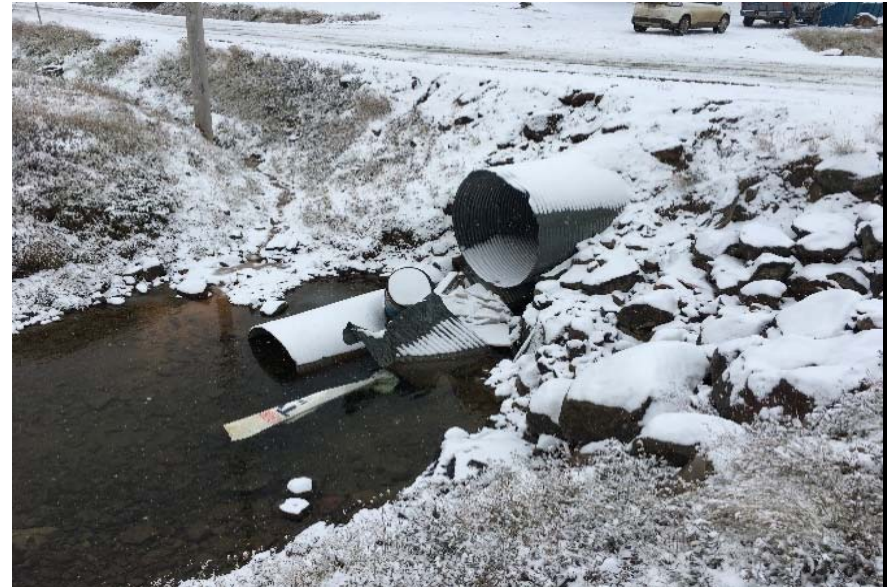
East of Crossing 13 (1600 mm dia.) looking
Downstream - Garage in the stream

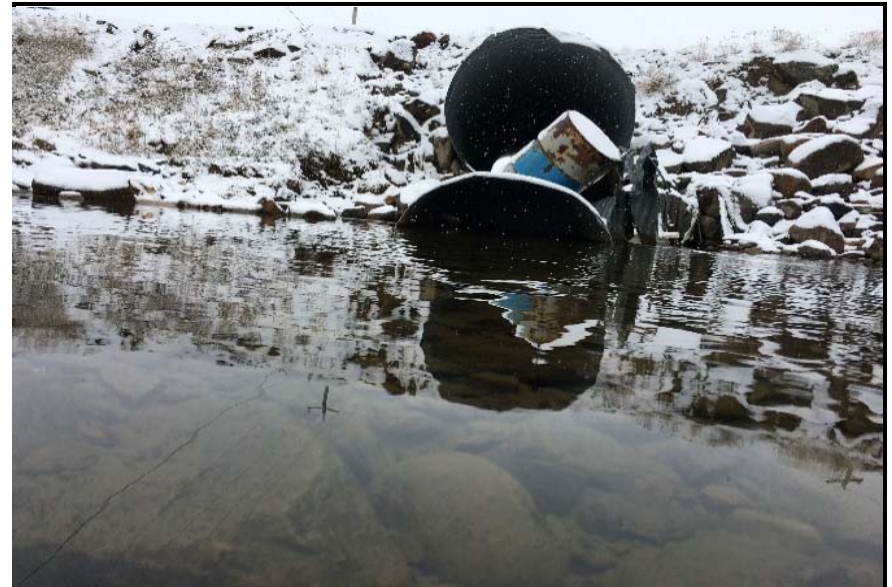
East of Crossing 13 (1600 mm dia.) looking
Downstream - Barrel inside the pipe, probably
received during the stream flow

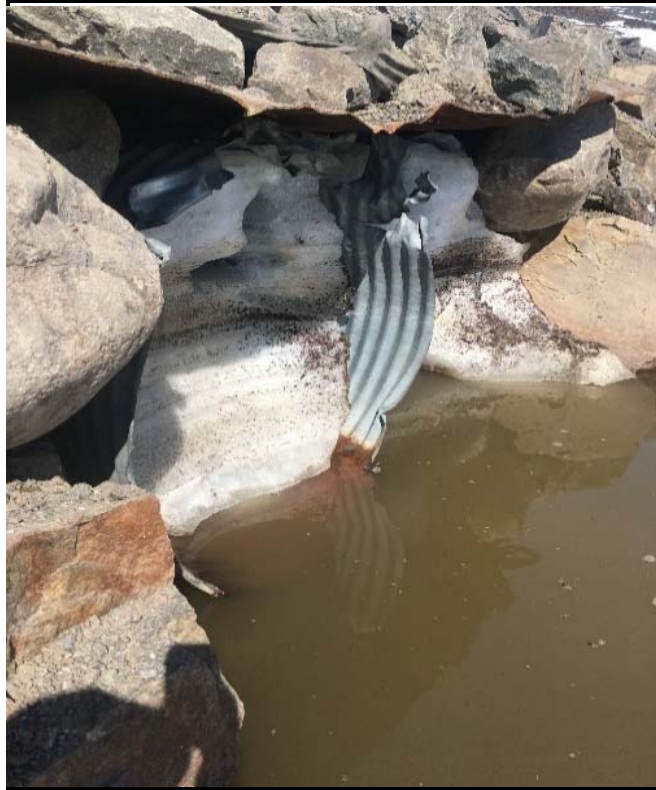
Eastern most
culvert on
south side of
road -
Blocked Pipe

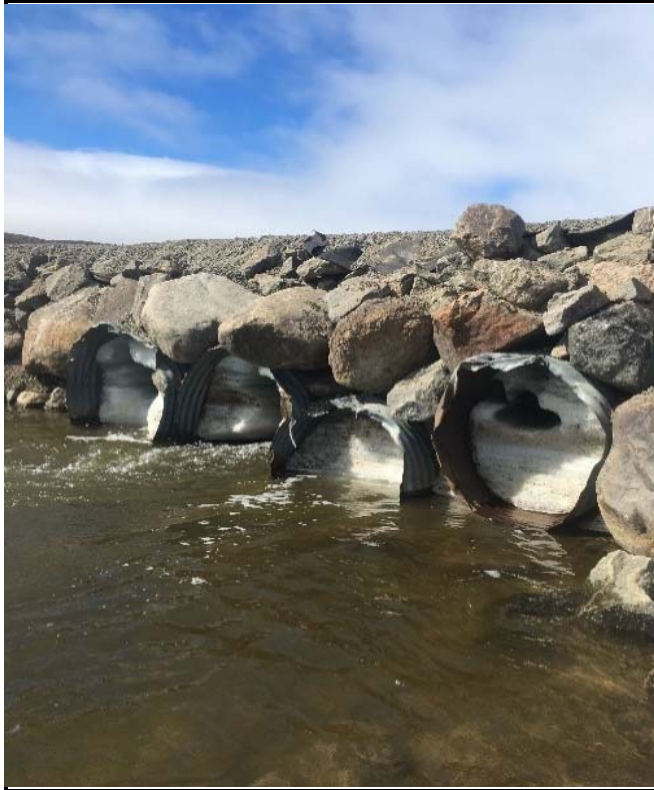
Cluster 1 of 4
Culverts (4 x
9400 mm
dia.) on south
side of road -
Blocked due
to snow

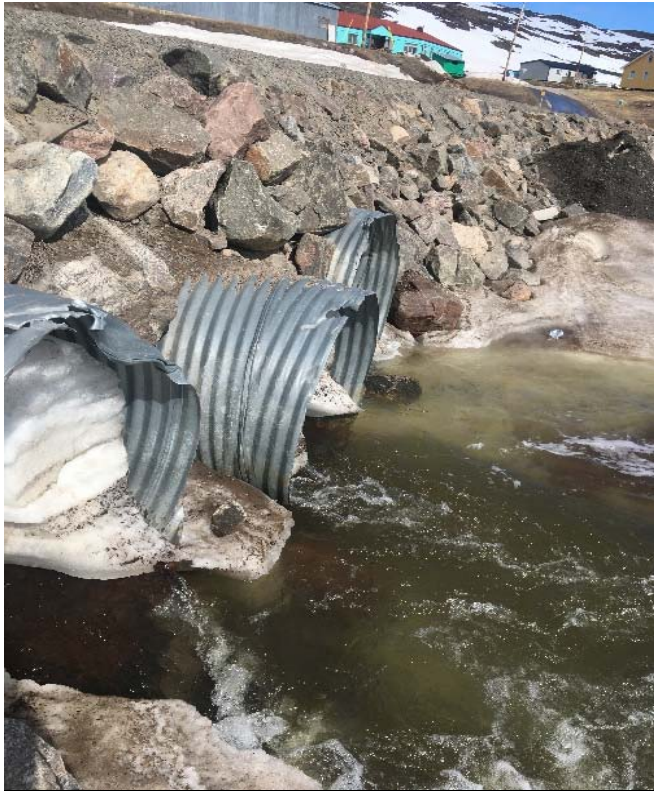
Cluster 2 of 3
Culverts (3 x
1100 mm
dia.) on south
side of road -
Blocked due
to snow

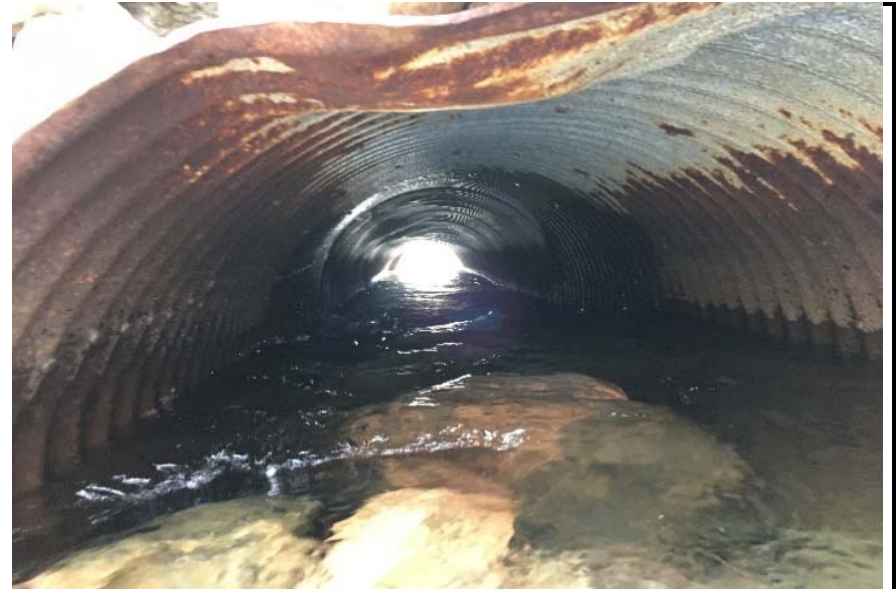
Cluster 2 of 3 Culverts (3 x 1100 mm dia.) on south
side of road - Deflected on the top end

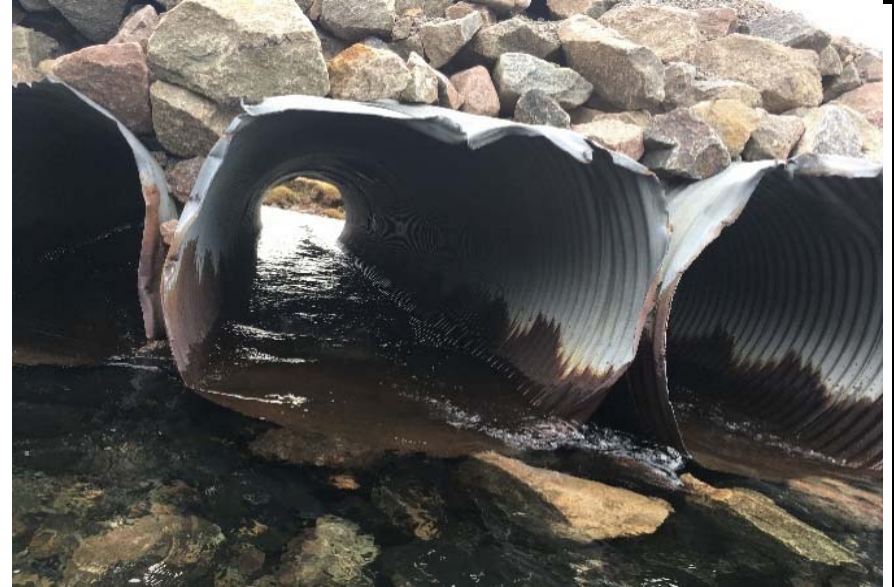
Cluster 2 (3 x 1100 mm dia.) taken from South side of road - Damaged Ends

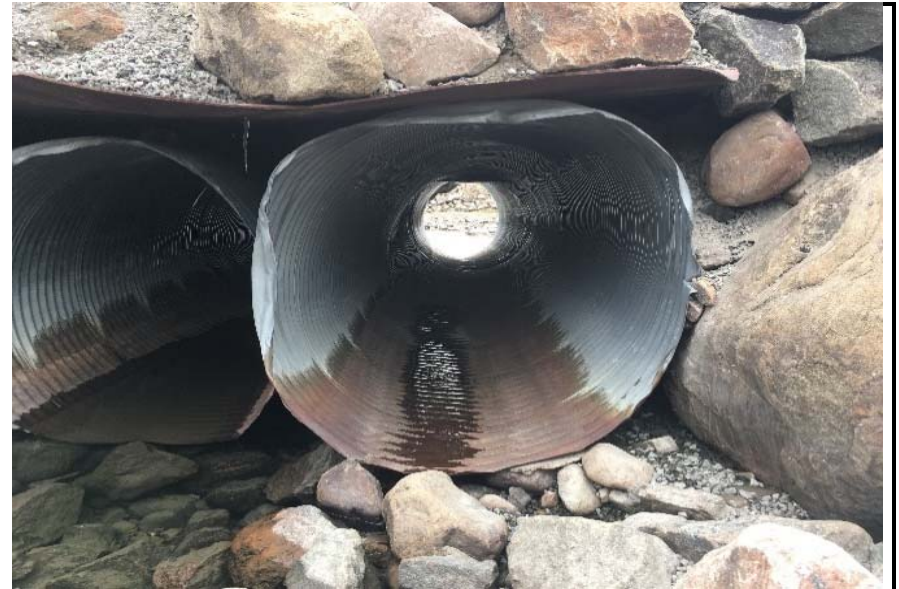
Northside of Cluster 3 - Deflected Pipe due to heavy loads

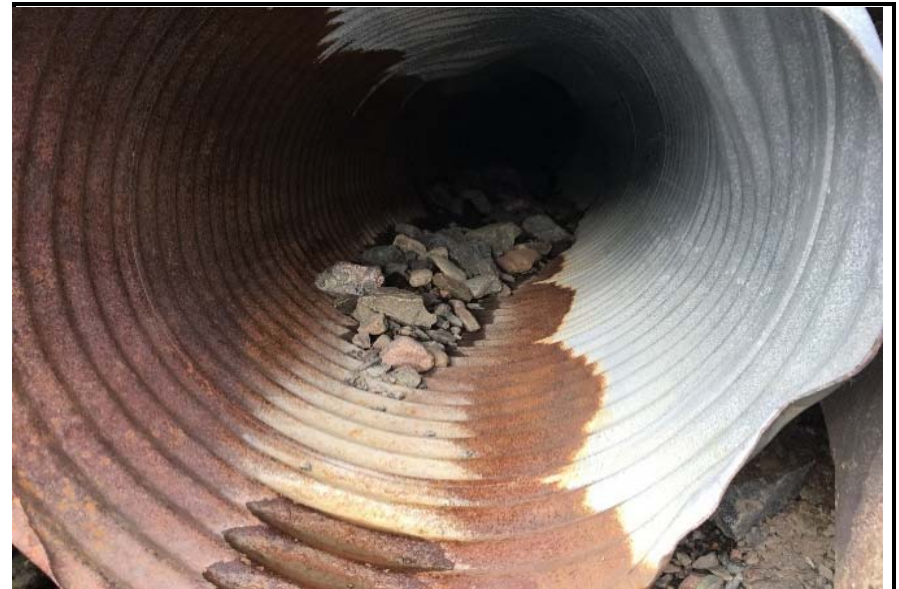
Southside of Cluster 3 - Debris due to
sedimentation in the culvert
