Project Name:	Road Improvement Projects
Addendum Number:	1
Project ID:	2026-RFT-008

Addendum 1 is hereby issued to amend the *2026-RFT-008 Road Improvement Projects*. The changes outlined in this addendum shall take precedence over the original document.

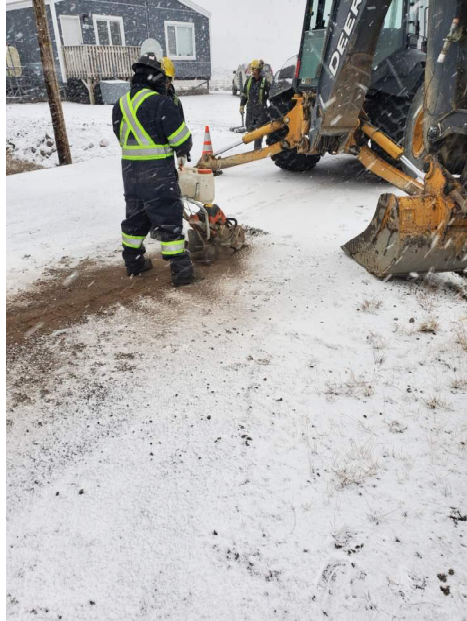
Photograph 1 – September 21, 2021
Cutting through asphalt for TP01.

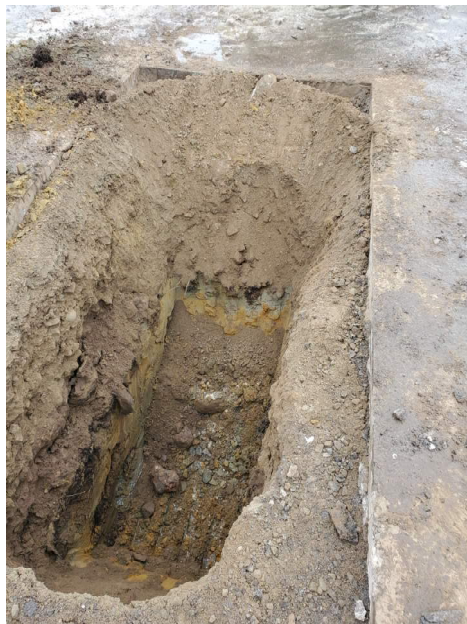
Photograph 2 – September 21, 2021
TP01 after excavation.

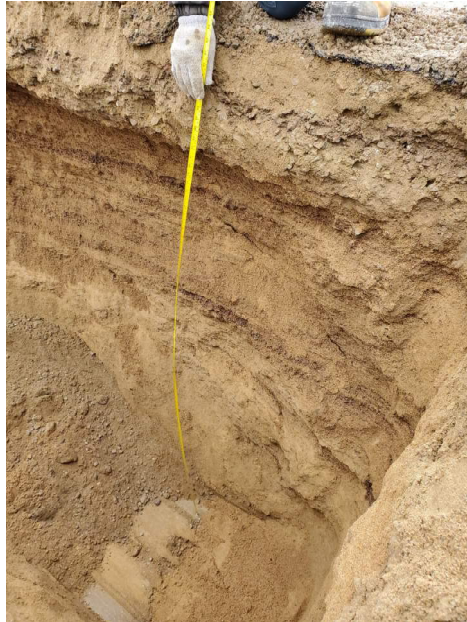
Photograph 3 – September 21, 2021
TP02.

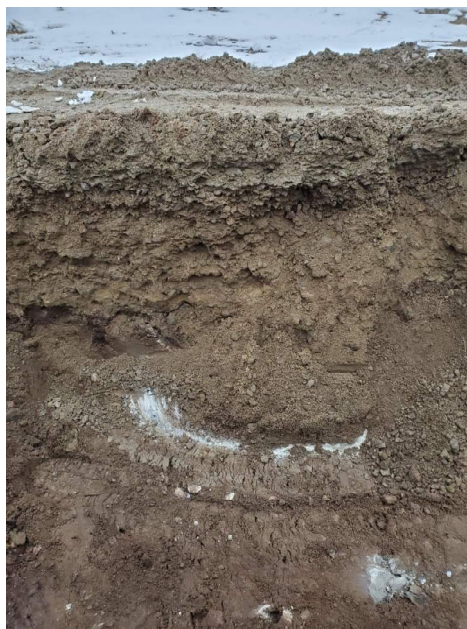
Test pits were excavated to depths of 0.60 to 2.38 mbg. Bedrock was encountered at 0.60 mbg in TP03 and all other test pits were terminated after reaching refusal on permafrost. The principal strata encountered at the sites are outlined in the following table and subsections. Further details are provided within the attached test pit logs.

Photograph 4 – September 21, 2021
TP03 after reaching bedrock.

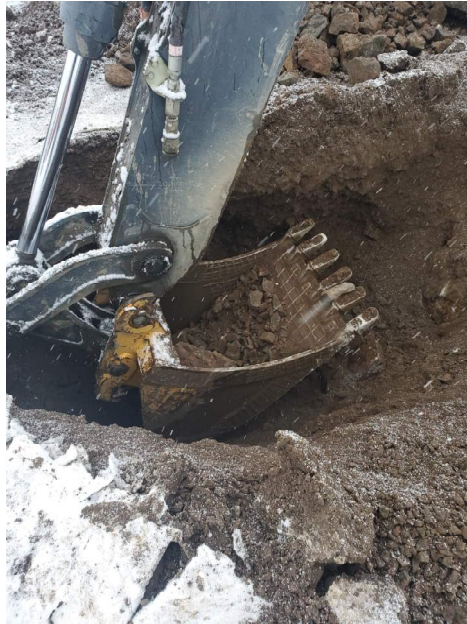
Photograph 5 – September 22, 2021
Excavating TP04.

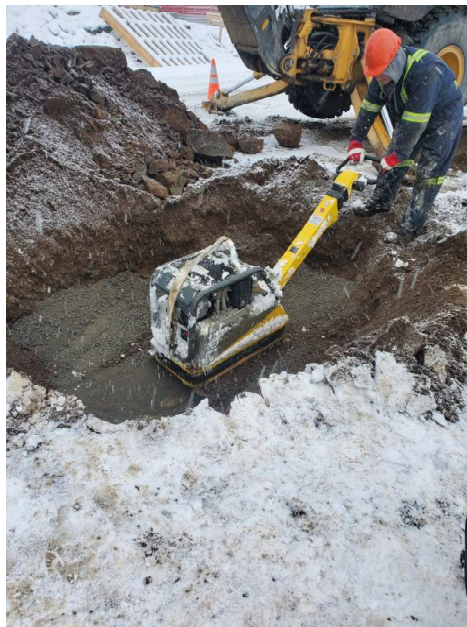
Photograph 6 – September 22, 2021
Backfilling and compacting TP04.

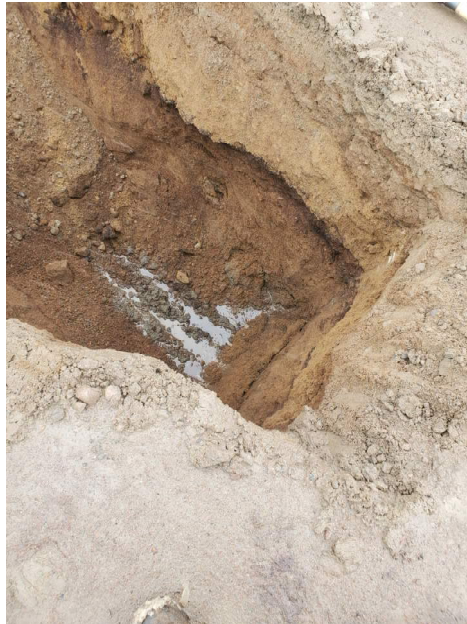
Light to moderate groundwater seepage was observed in four of the seven test pits. Groundwater flow through the sites is anticipated to be moderate to significant during the spring freshet and travel along the bottom of the active layer or top of sound bedrock during thaw. It is anticipated that groundwater levels will fluctuate with seasonal weather trends, during precipitation events, and with significant site disturbance and construction activities.

Photograph 7 – September 22, 2021
Groundwater seepage in TP05.

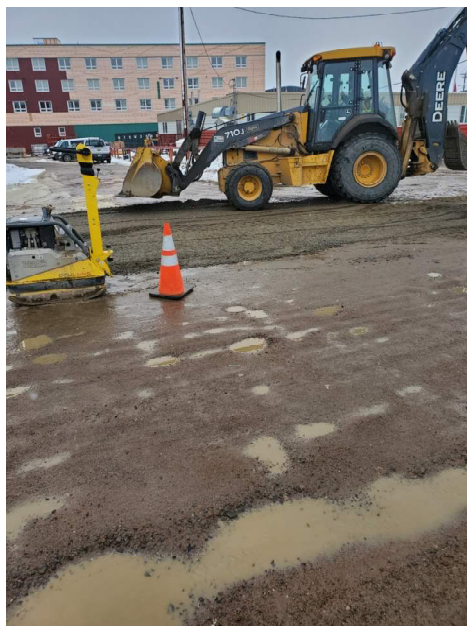
Photograph 8 – September 22, 2021
Grading backfill surface of TP05.

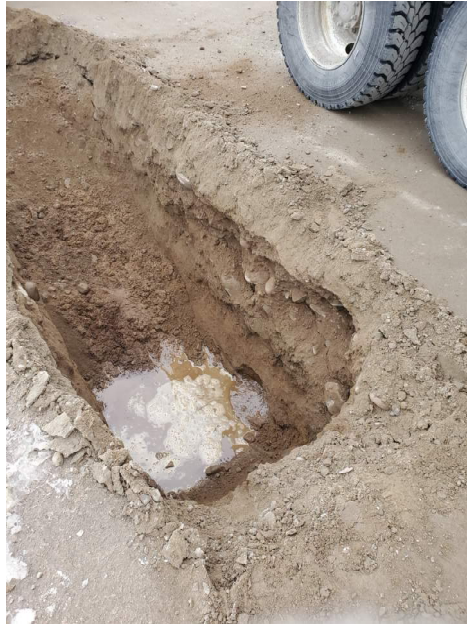
Photograph 9 – September 22, 2021
Groundwater seepage in TP06.

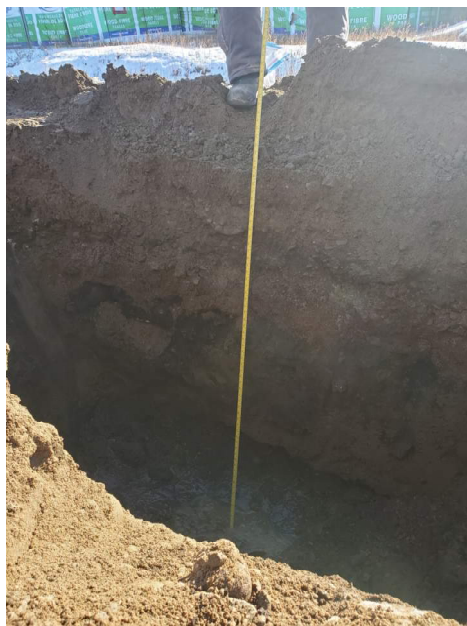
Photograph 10 – September 23, 2021
TP07.

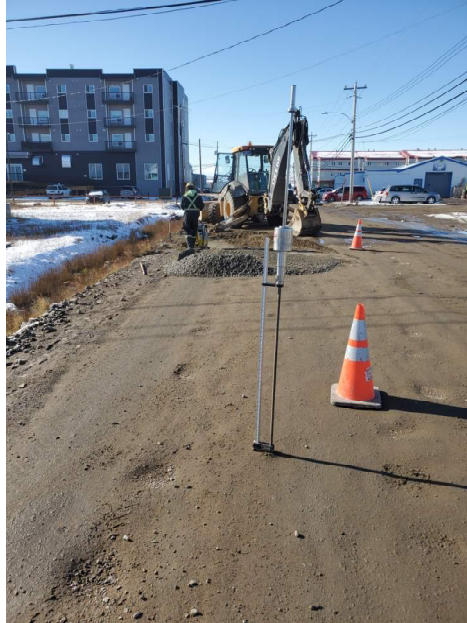
Photograph 11 – September 23, 2021
Dynamic cone penetration testing adjacent to TP07.

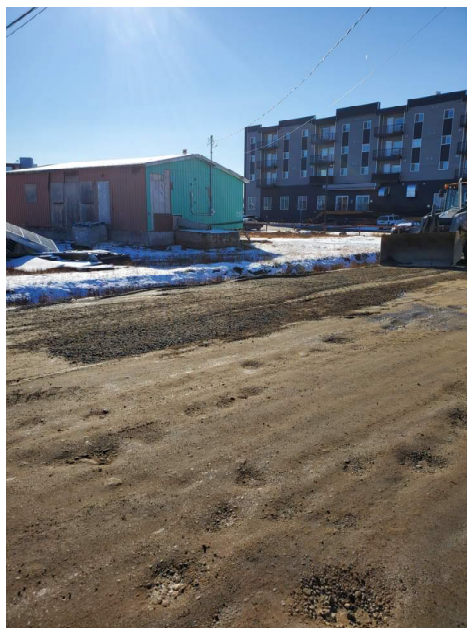
Photograph 12 – September 23, 2021
Location of TP07 after completion of work.
