Nunatta Project 26-38

## EXECUTIVE SUMMARY

Nunatta Environmental Services Inc. was retained by the City of Iqaluit to conduct a Phase I Environmental Site Assessment of a site adjacent to Toonik Pond on Niaqungusiariaq in the Tundra Ridge neighbourhood of Iqaluit, Nunavut. The site is on un-surveyed Commissioner's land within the boundary of the City. The site is divided into eastern and western portions by a rock outcrop in the centre of the site. It is currently undeveloped, with construction of a storage garage planned for the eastern portion of the site. The planned building has not been assigned a number in the Iqaluit building number system.

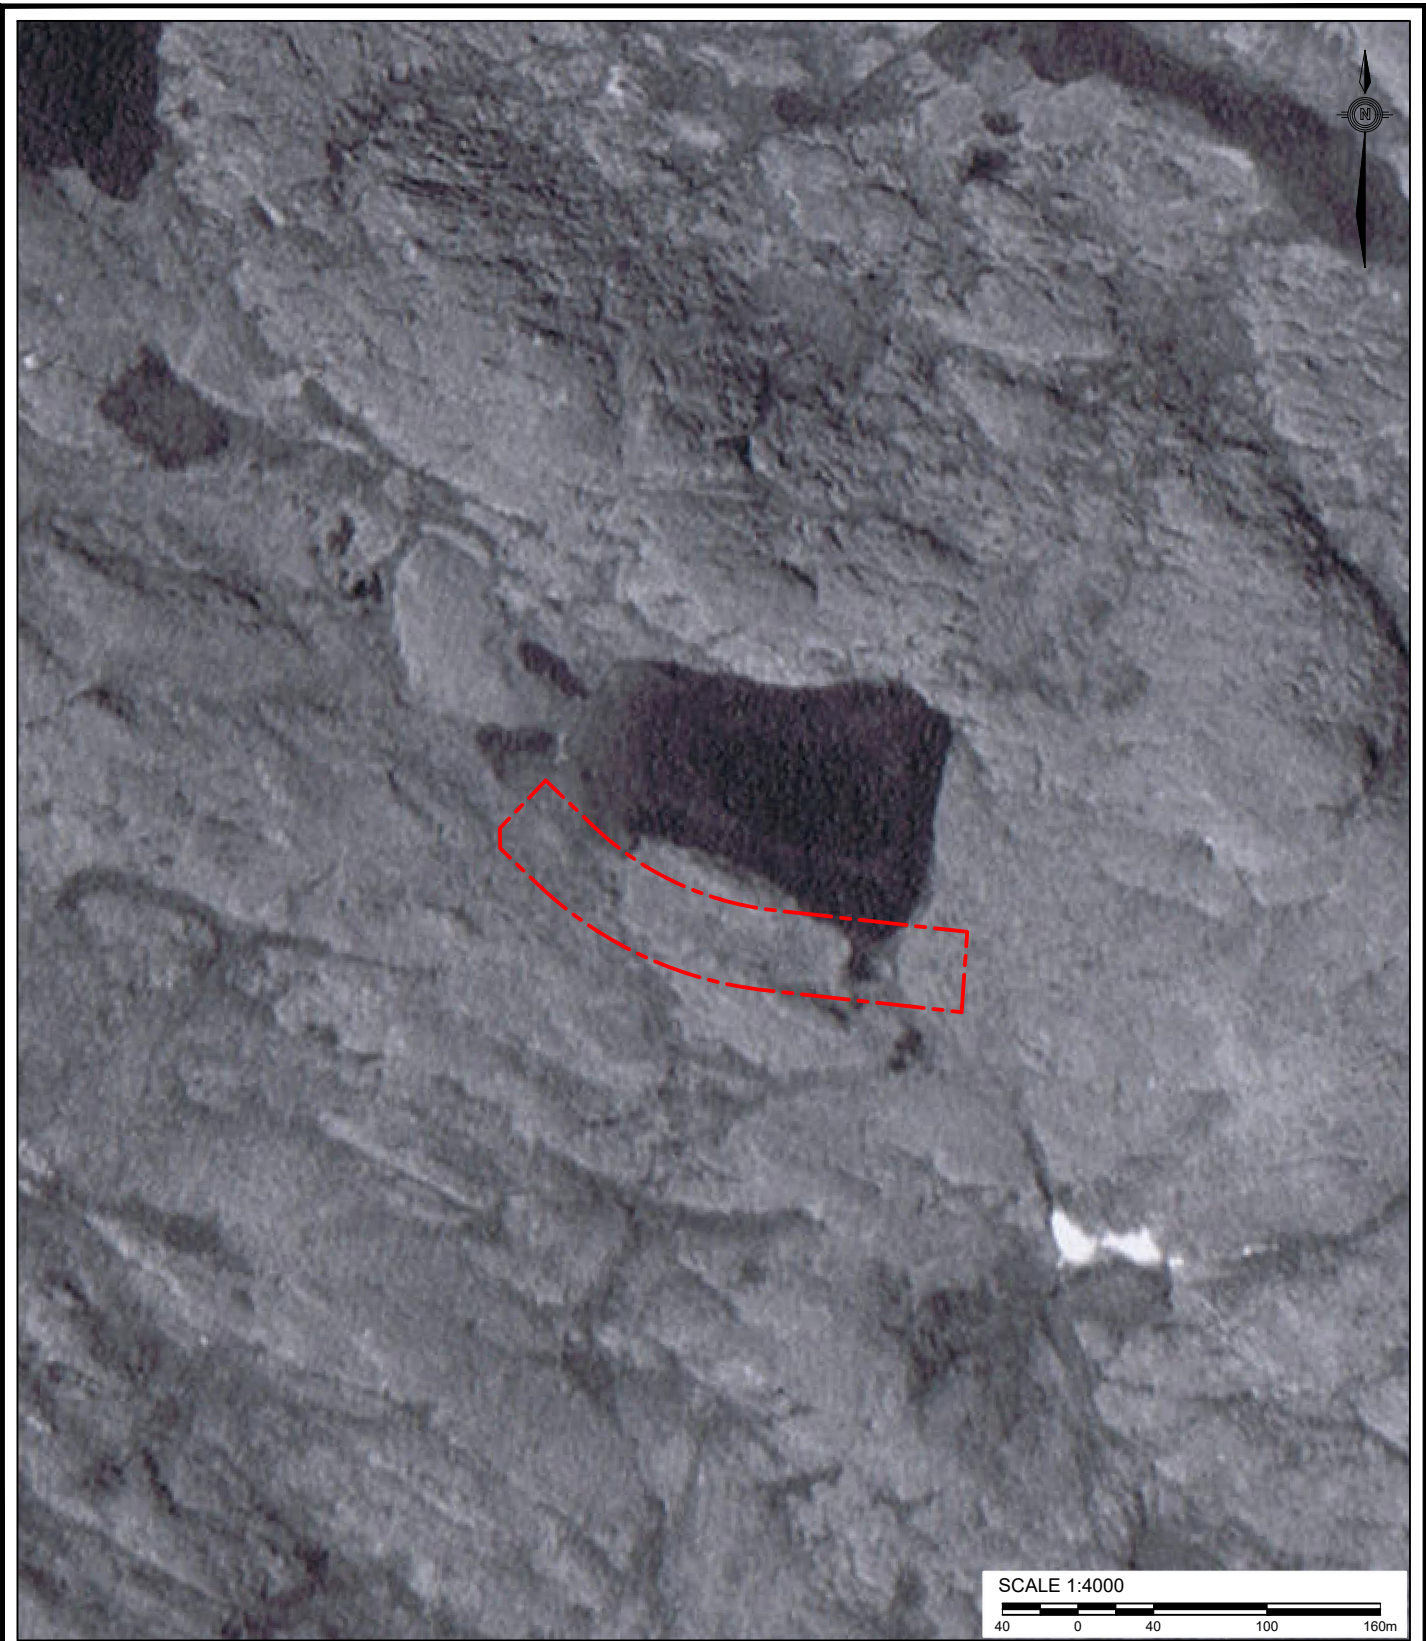
| <div>LEGEND</div> <div><div><div></div><div></div><div></div></div><div>Subject Property (Approximate)</div></div> <div>Roll Number: A11535</div> <div>Photo Number: 0031</div> <div>Photo Scale: 1:20,000</div> <div>Date: 1948-07-22</div> <div>NOTE:</div> <div>Scale and property location are approximate</div> | <div>CLIENT</div> <div>City of Iqaluit</div> | <div>PROJECT</div> <div>Phase I Environmental Site Assessment<br/>Proposed Garage, Iqaluit, NU</div> | | | | |

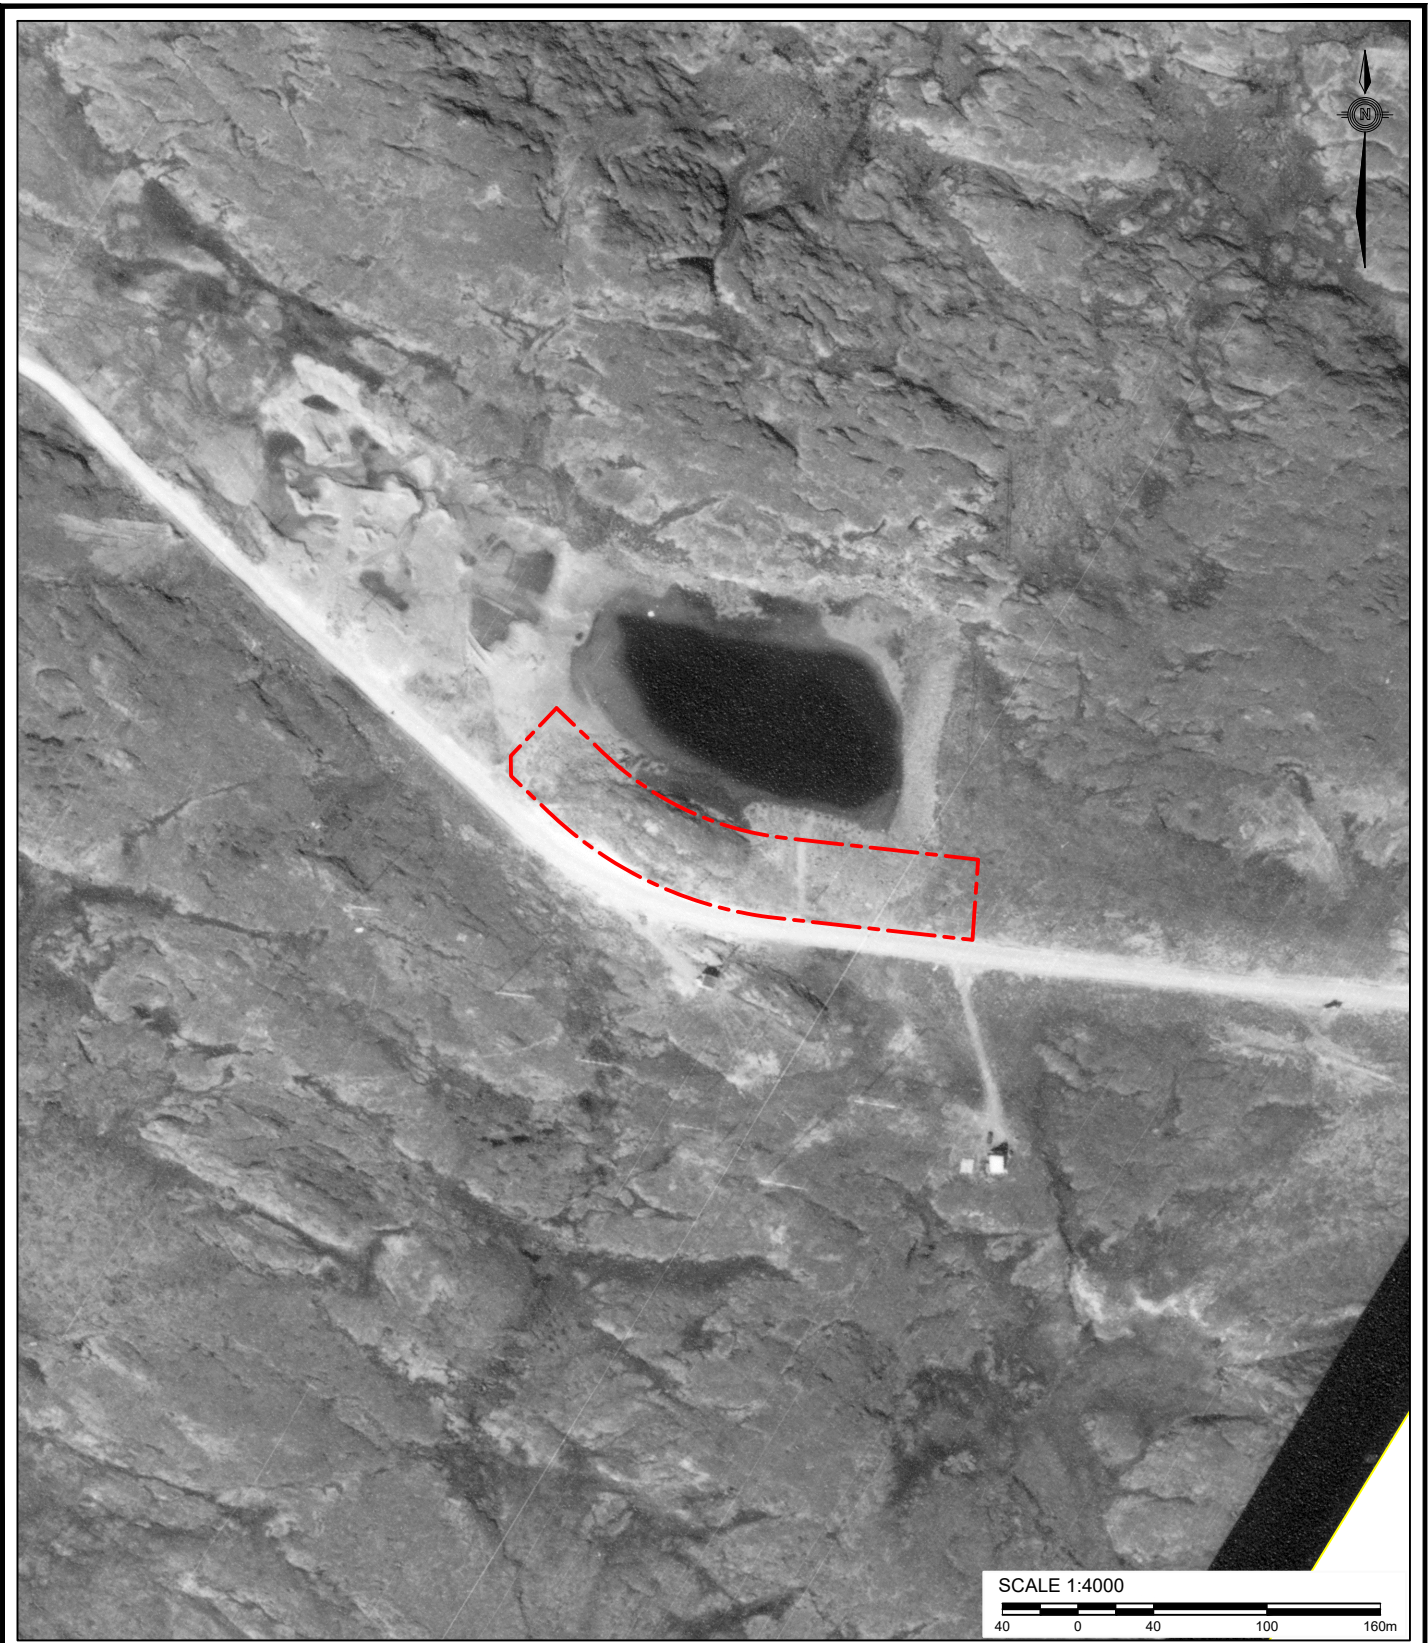
| <div>LEGEND</div> <div><div><div></div></div> Subject Property (Approximate)</div> <div>Roll Number: A21180</div> <div>Photo Number: 0016</div> <div>Photo Scale: 1:12,000</div> <div>Date: 1969-08-13</div> <div>NOTE:</div> <div>Scale and property location are approximate</div> | <div>CLIENT</div> <div>City of Iqaluit</div> | <div>PROJECT</div> <div>Phase I Environmental Site Assessment<br/>Proposed Garage, Iqaluit, NU</div> | | | | |

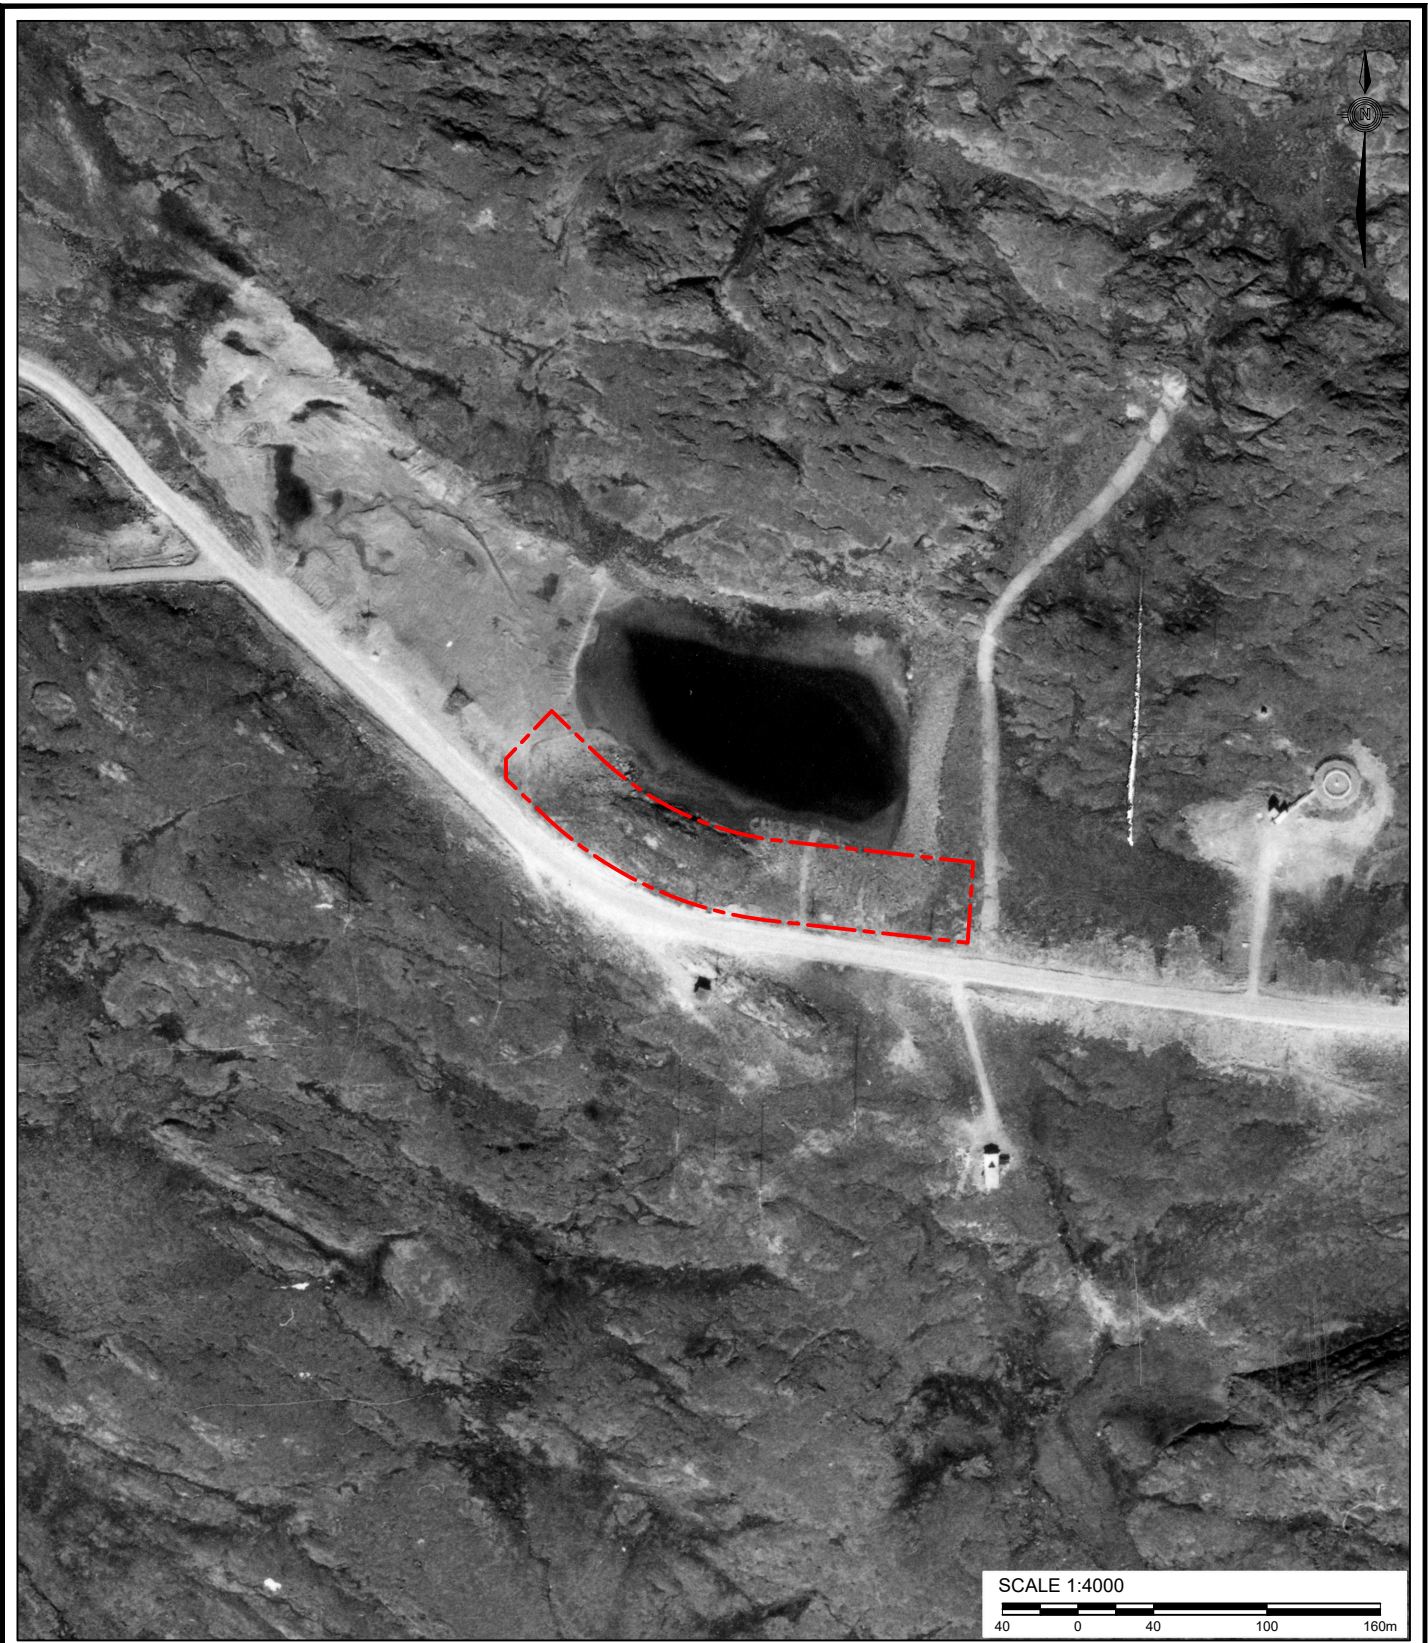
| <div>LEGEND</div> <div><div><div></div></div> Subject Property (Approximate)</div> <div>Roll Number: A24492</div> <div>Photo Number: 0136</div> <div>Photo Scale: 1:20,000</div> <div>Date: 1976-08-18</div> <div>NOTE:</div> <div>Scale and property location are approximate</div> | <div>CLIENT</div> <div>City of Iqaluit</div> | <div>PROJECT</div> <div>Phase I Environmental Site Assessment<br/>Proposed Garage, Iqaluit, NU</div> | | | | |

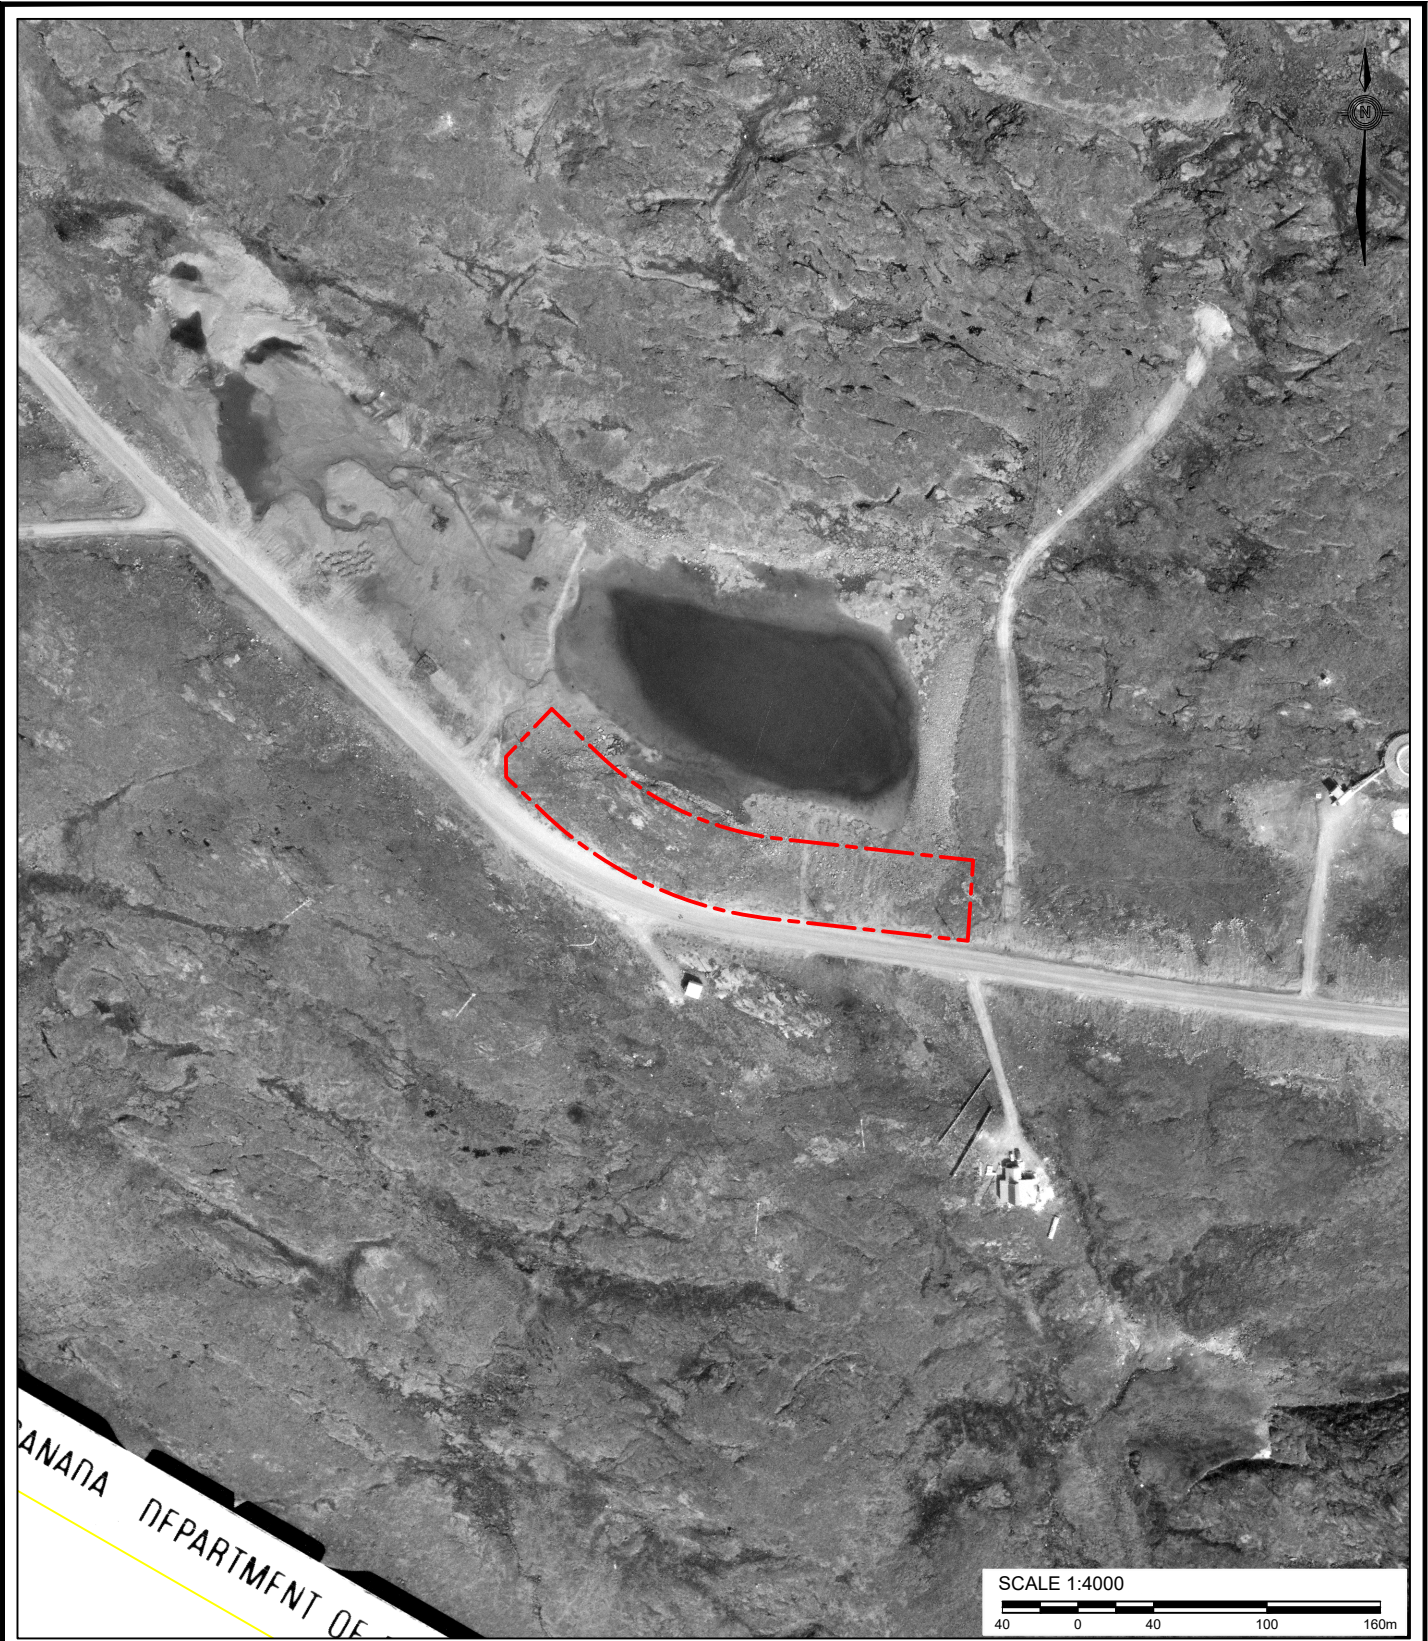
| <div>LEGEND</div> <div><div><div></div></div> Subject Property (Approximate)</div> <div>Roll Number: A26392</div> <div>Photo Number: 0137</div> <div>Photo Scale: 1:5,000</div> <div>Date: 1983-07-17</div> <div>NOTE:</div> <div>Scale and property location are approximate</div> | <div>CLIENT</div> <div>City of Iqaluit</div> | <div>PROJECT</div> <div>Phase I Environmental Site Assessment<br/>Proposed Garage, Iqaluit, NU</div> | | | | |

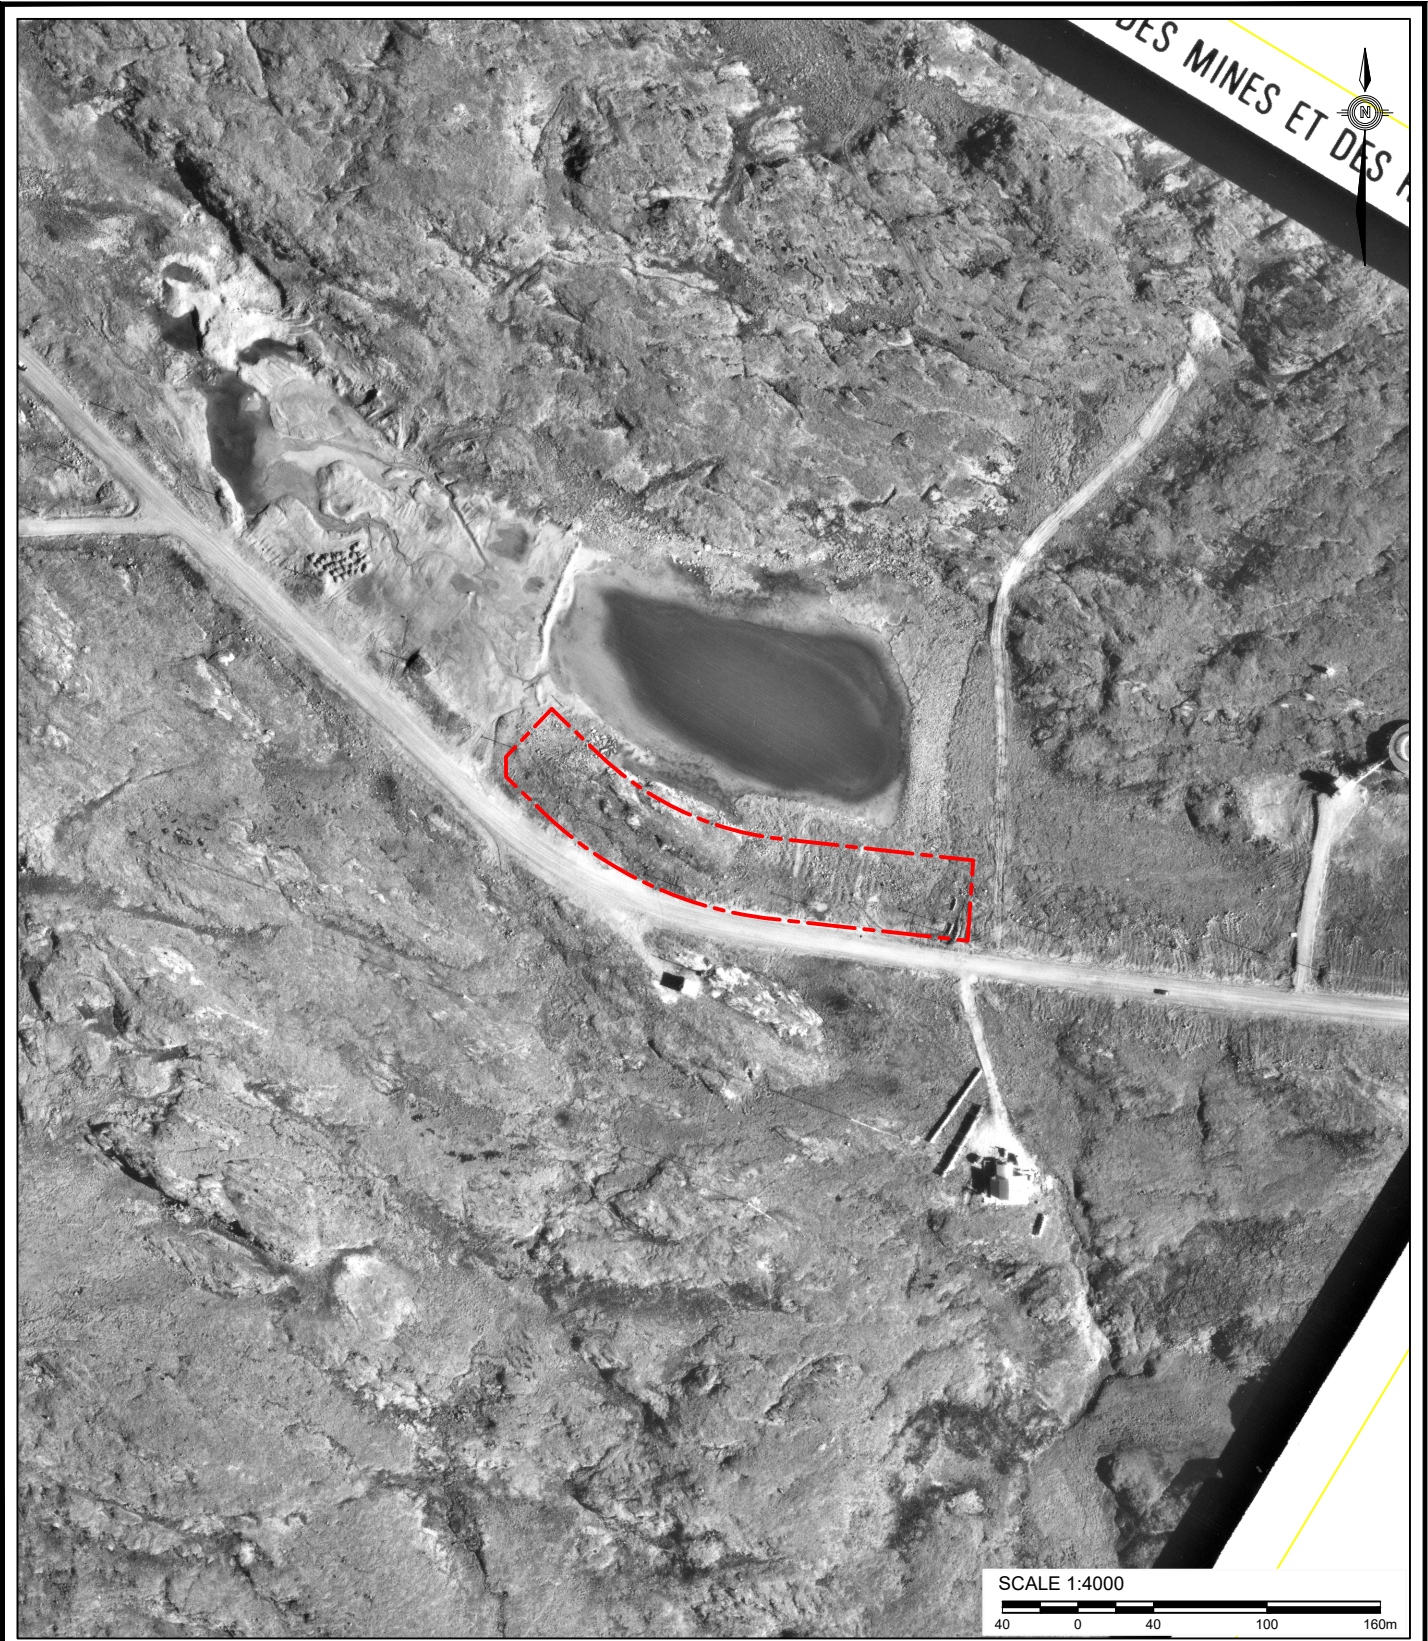
| <div>LEGEND</div> <div><div><div></div></div> Subject Property (Approximate)</div> <div>Roll Number: A27161</div> <div>Photo Number: 0129</div> <div>Photo Scale: 1:6,000</div> <div>Date: 1987-08-20</div> <div>NOTE:</div> <div>Scale and property location are approximate</div> | CLIENT | PROJECT | | | | | Phase I Environmental Site Assessment<br>Proposed Garage, Iqaluit, NU | |

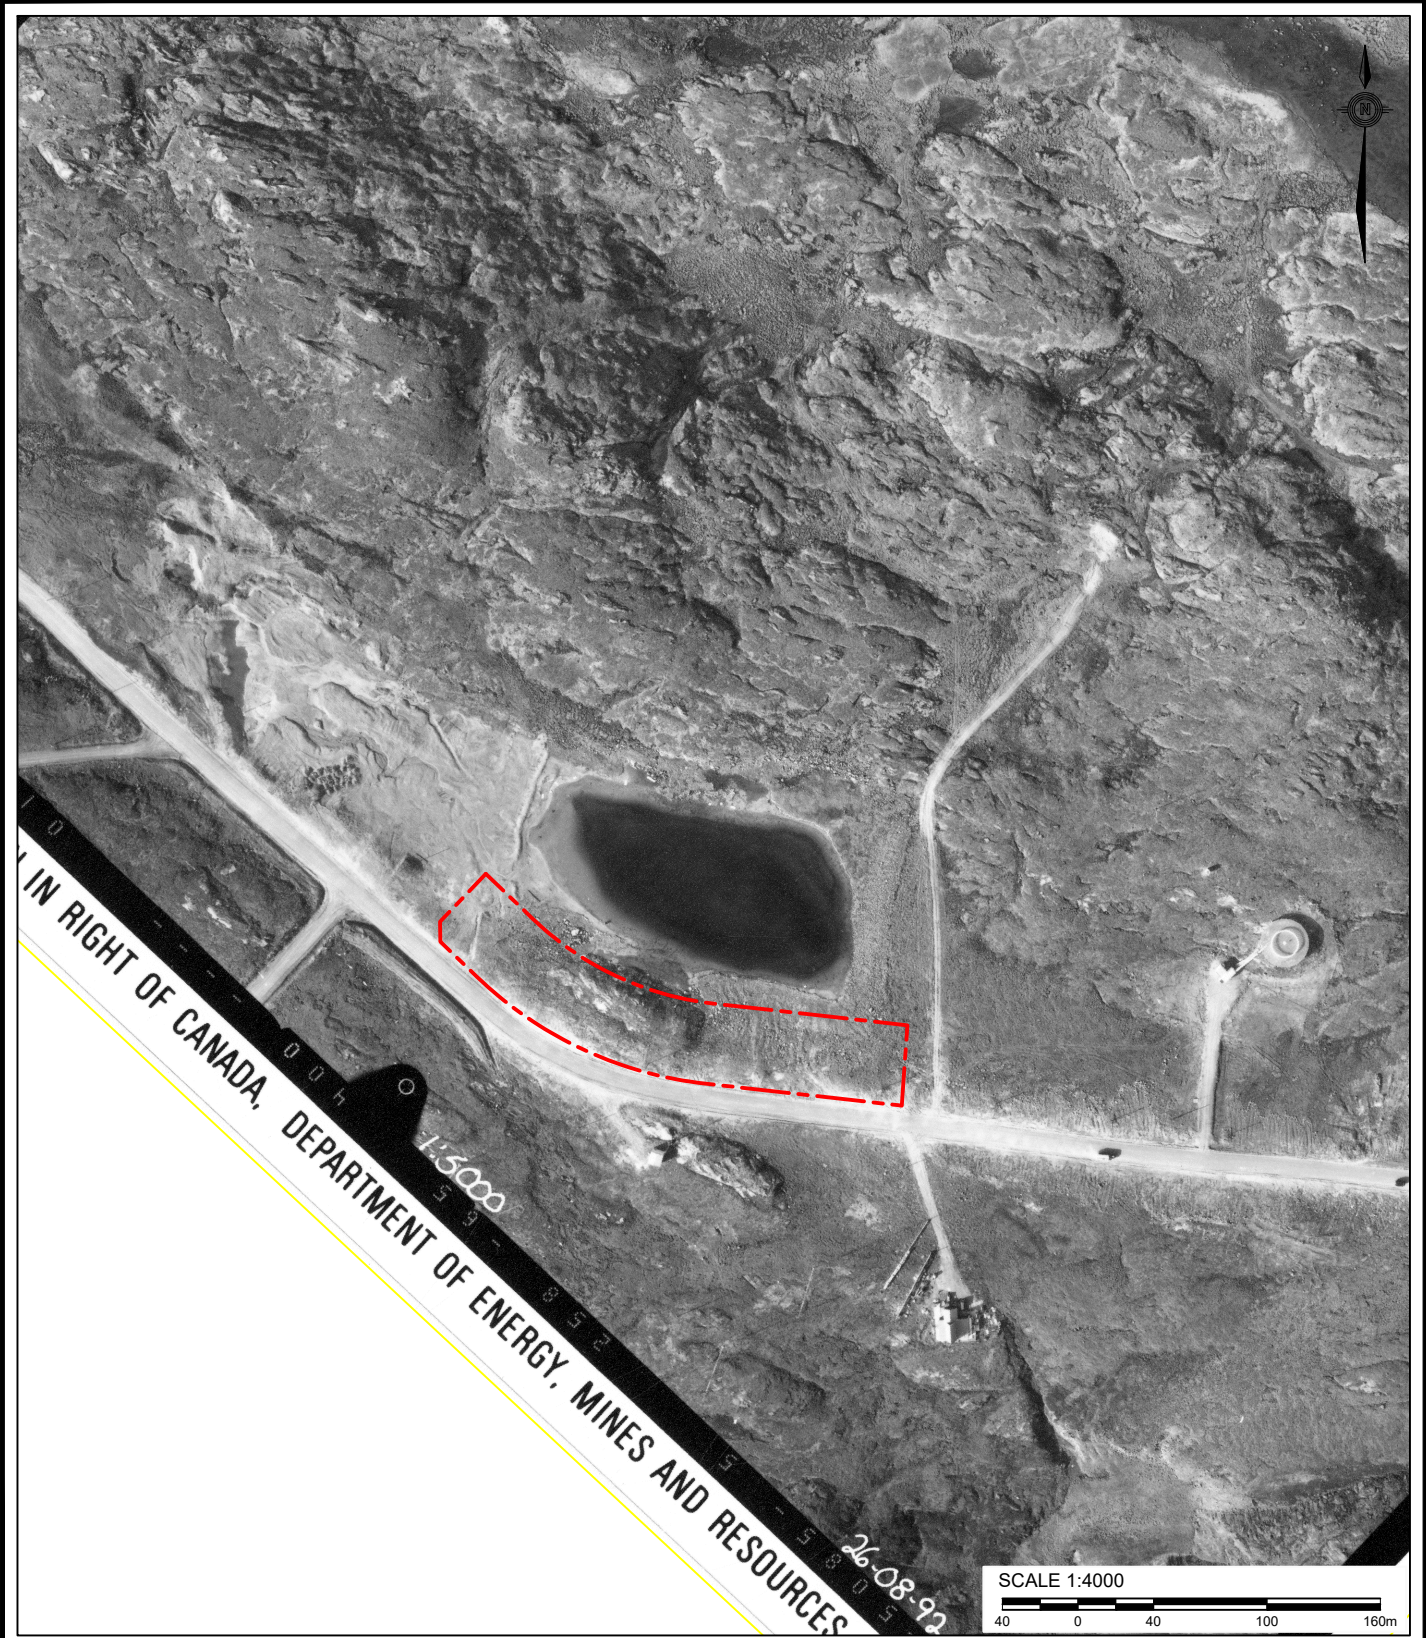
| <div>LEGEND</div> <div><div><div></div></div> Subject Property (Approximate)</div> <div>Roll Number: A27862</div> <div>Photo Number: 0055</div> <div>Photo Scale: 1:6,000</div> <div>Date: 1992-08-26</div> <div>NOTE:</div> <div>Scale and property location are approximate</div> | <div>CLIENT</div> <div>City of Iqaluit</div> | <div>PROJECT</div> <div>Phase I Environmental Site Assessment<br/>Proposed Garage, Iqaluit, NU</div> | | | | |

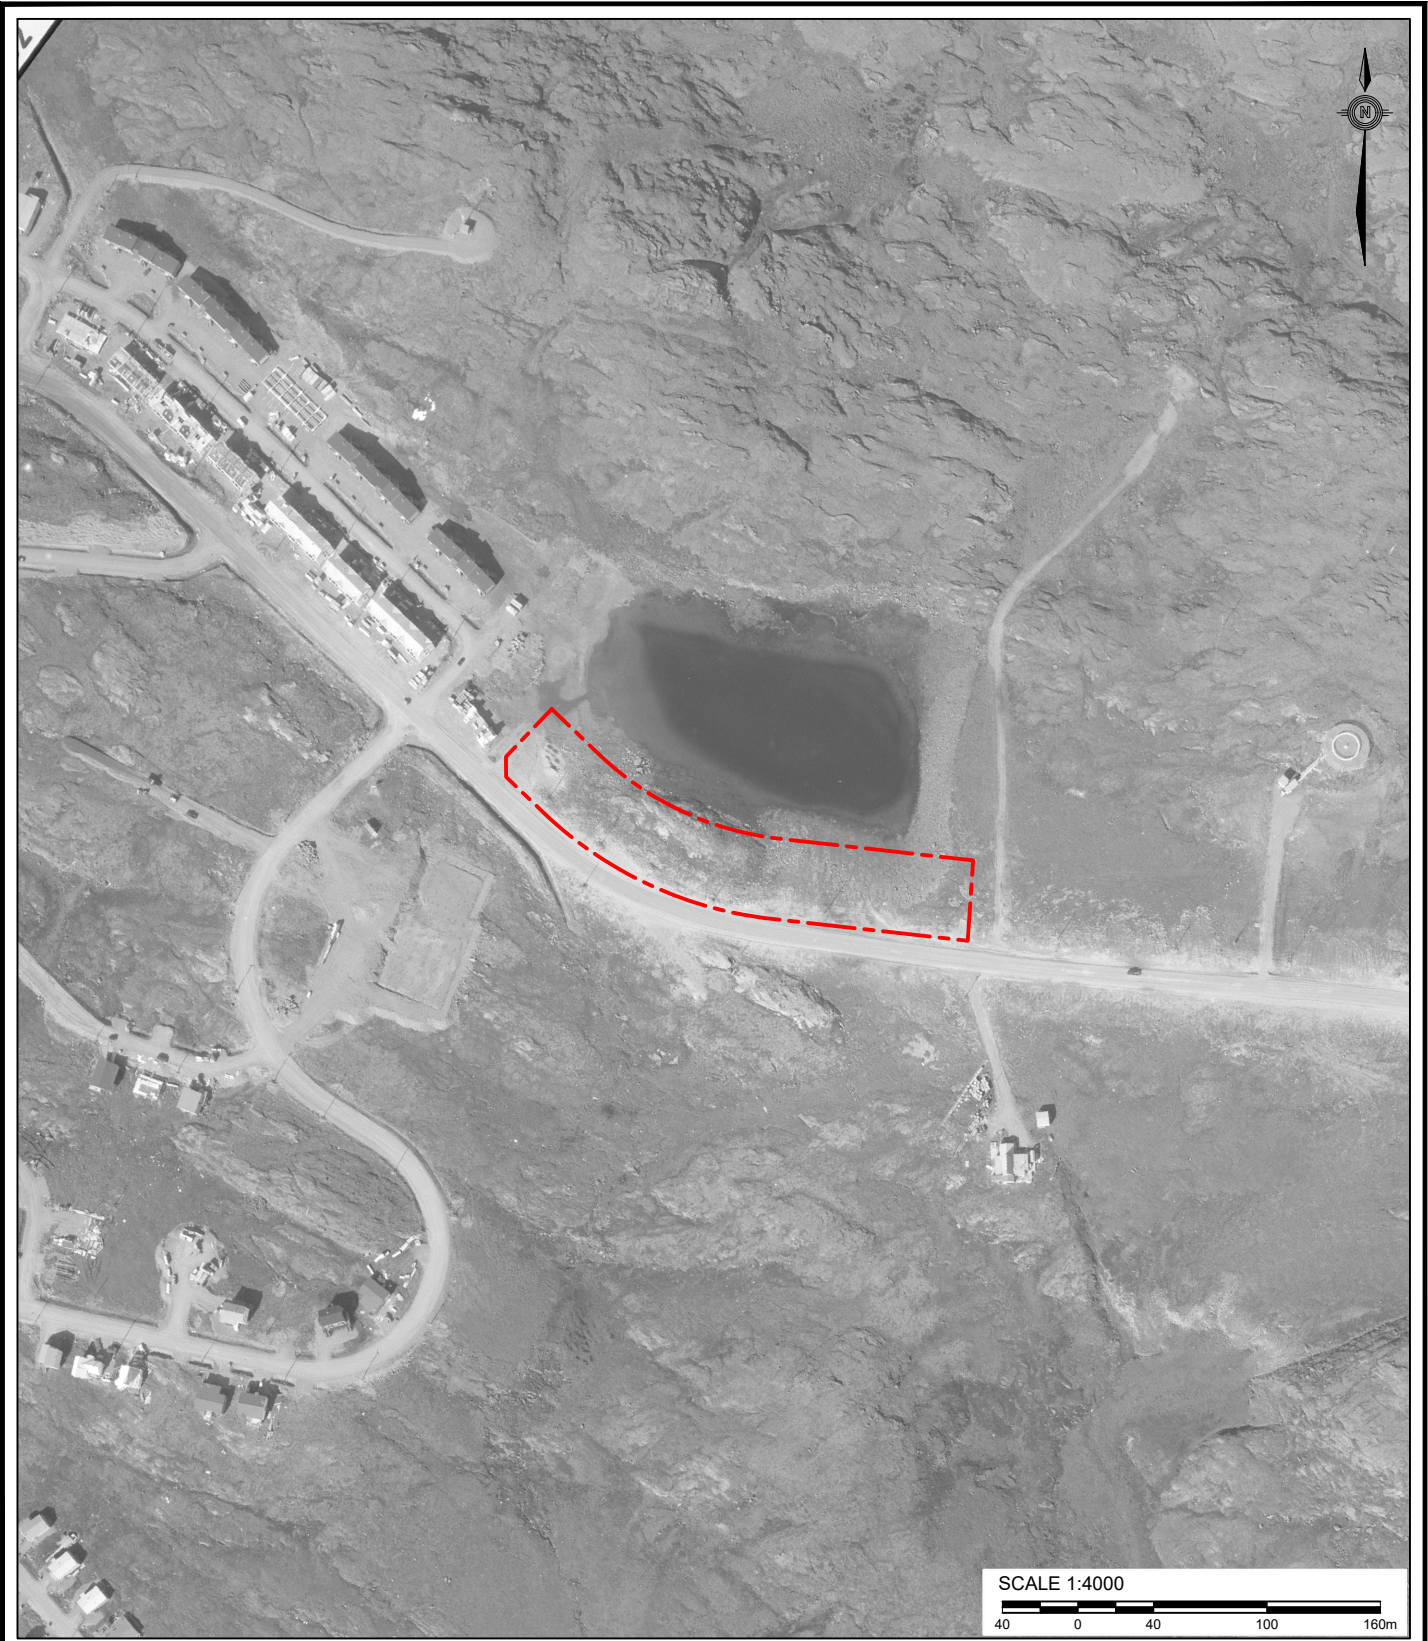
| <div>LEGEND</div> <div><div><div></div></div> Subject Property (Approximate)</div> <div>Roll Number: A28353</div> <div>Photo Number: 0109</div> <div>Photo Scale: 1:10,000</div> <div>Date: 1998-08-27</div> <div>NOTE:</div> <div>Scale and property location are approximate</div> | CLIENT | PROJECT | | | | | Phase I Environmental Site Assessment<br>Proposed Garage, Iqaluit, NU | |

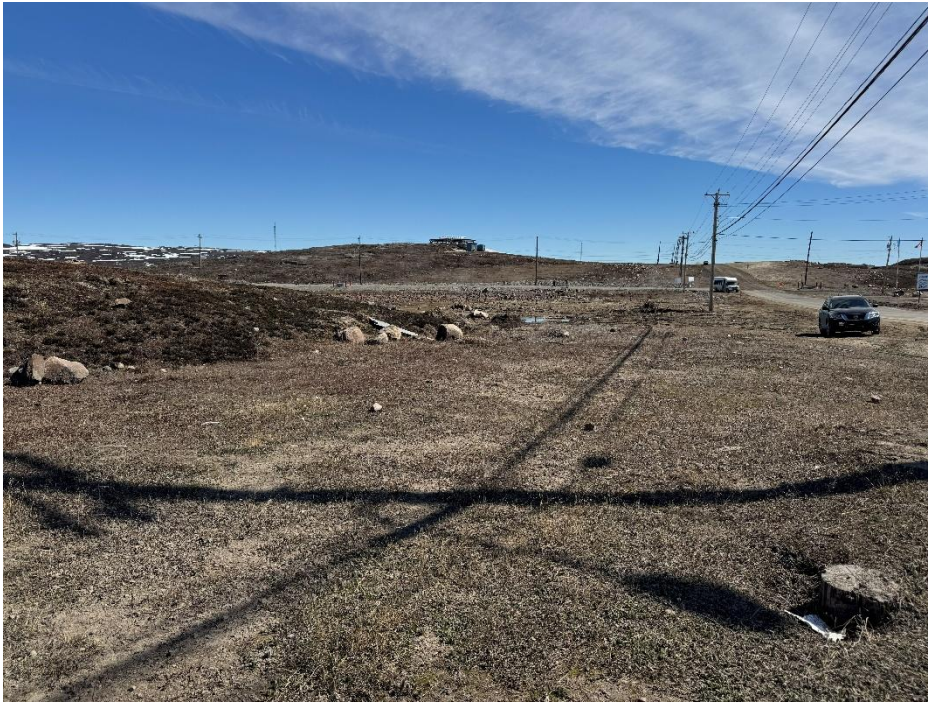
Photo ID: 1  
Date: June 10, 2026  
Description: Site, looking east from centre

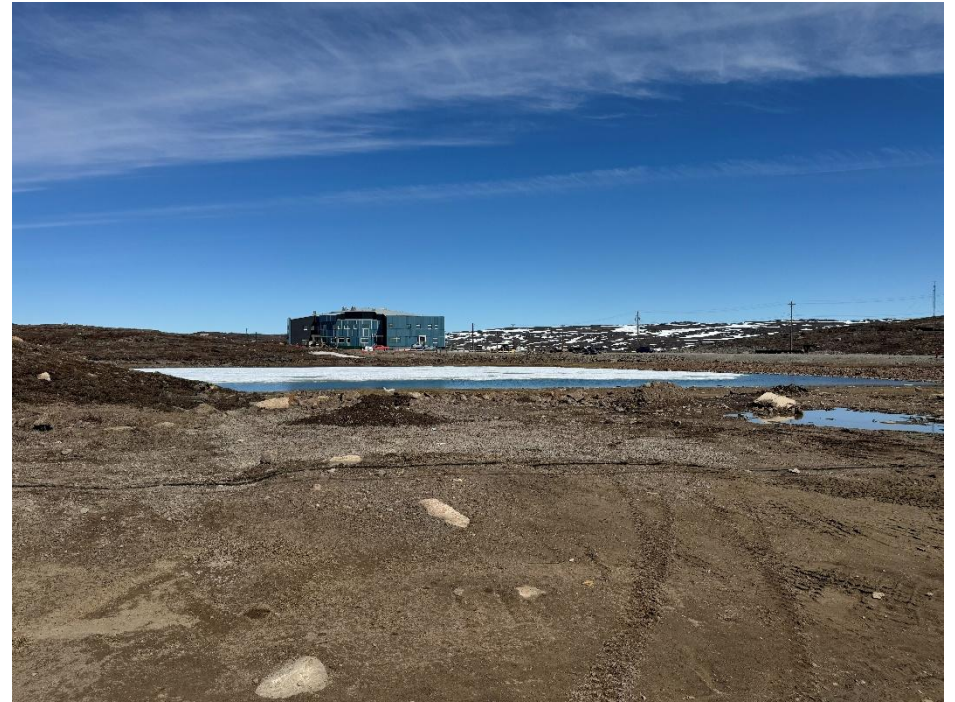
Photo ID: 2  
Date: June 10, 2026  
Description: Site, looking north from the centre

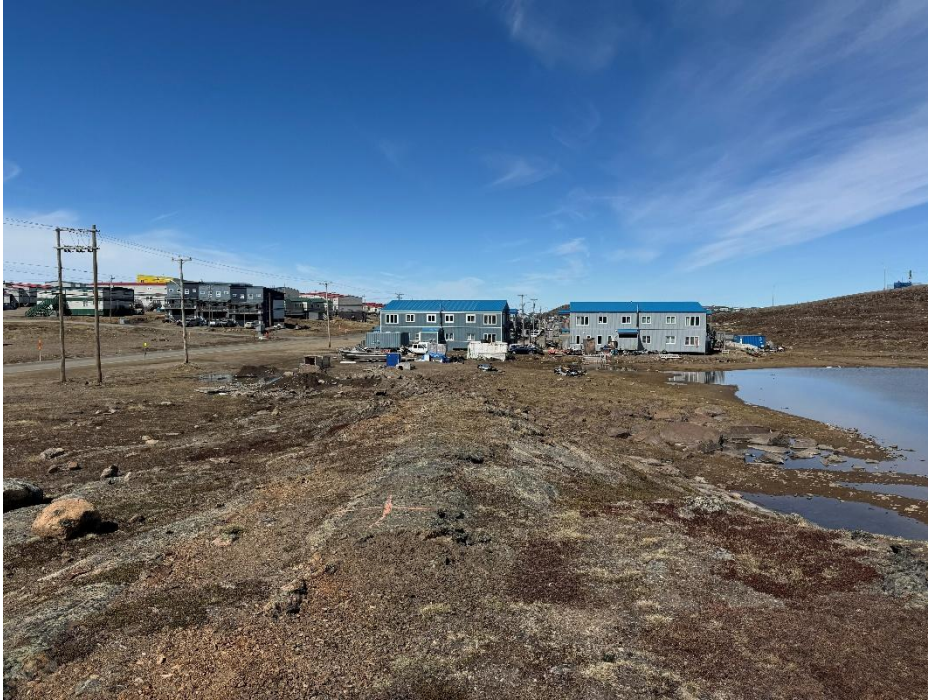
Photo ID: 3  
Date: June 10, 2026  
Description: Site, looking west from the centre

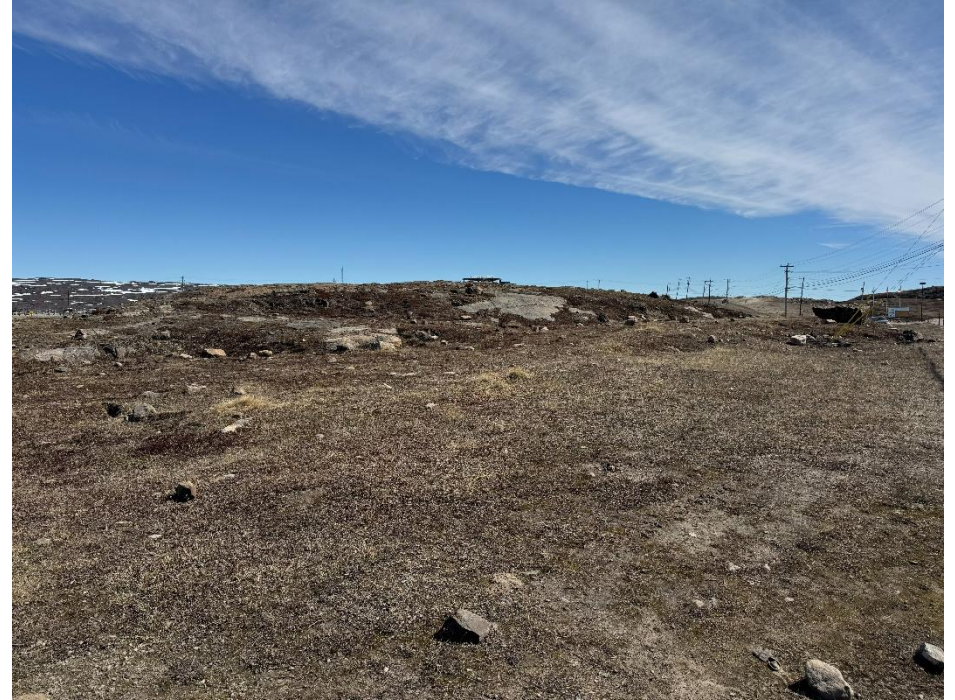
Photo ID: 4  
Date: June 10, 2026  
Description: Outcrop in the centre of site

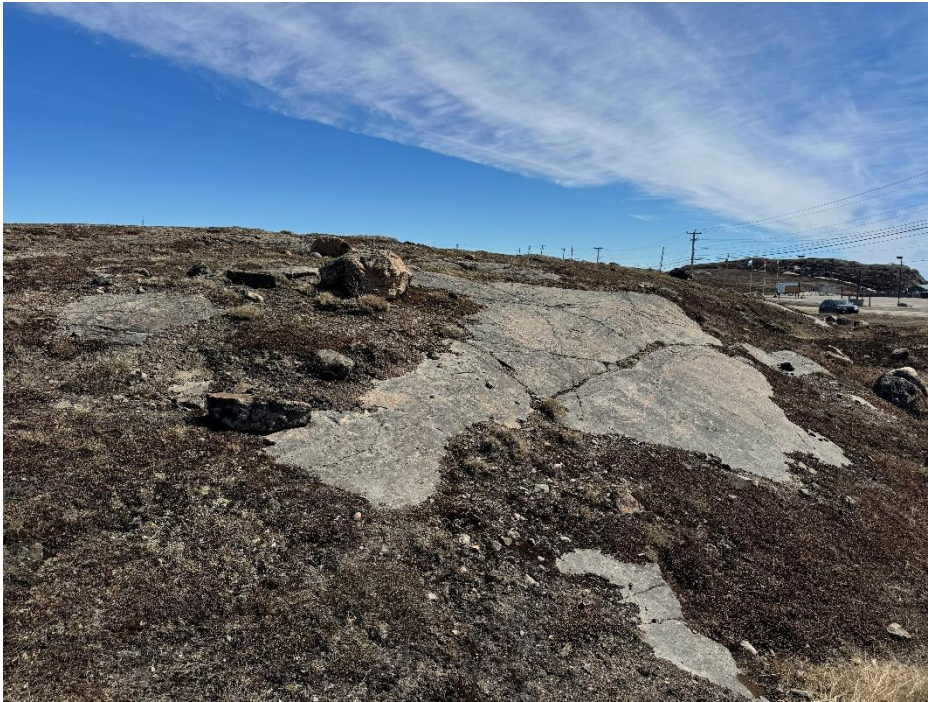
Photo ID: 5  
Date: June 10, 2026  
Description: Outcrop

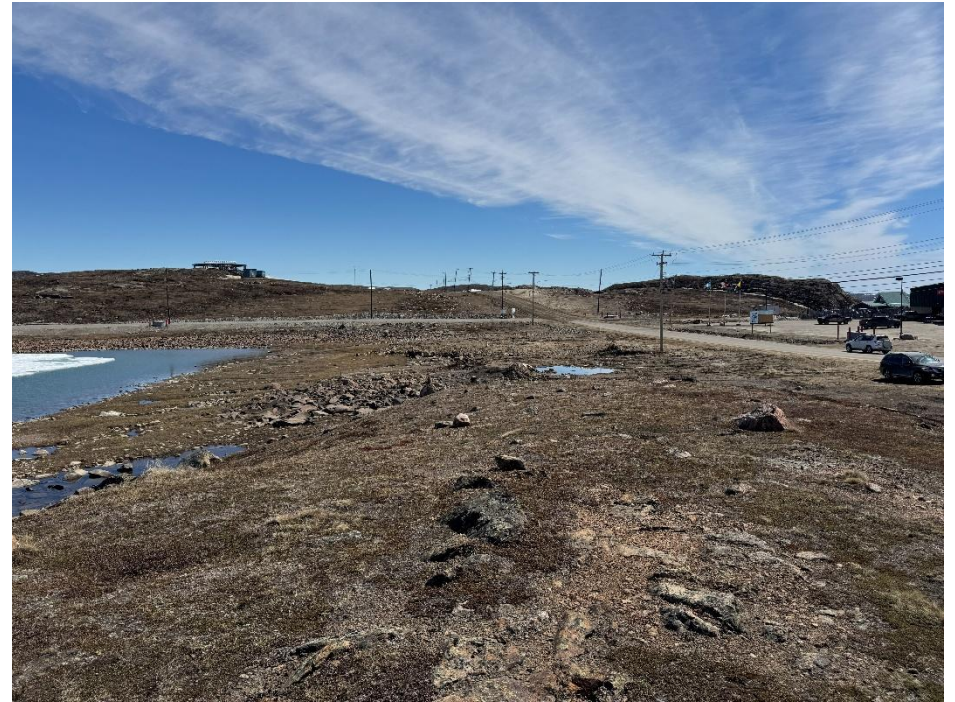
Photo ID: 6  
Date: June 10, 2026  
Description: View east from centre of site

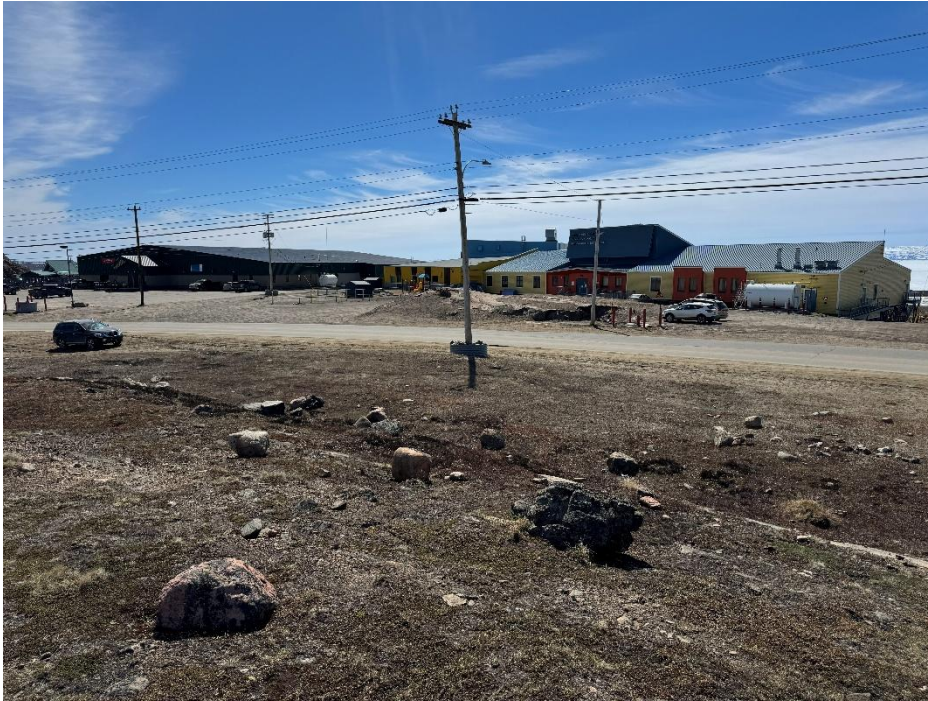
Photo ID: 7  
 Date: June 10, 2026  
 Description: View south from centre of site

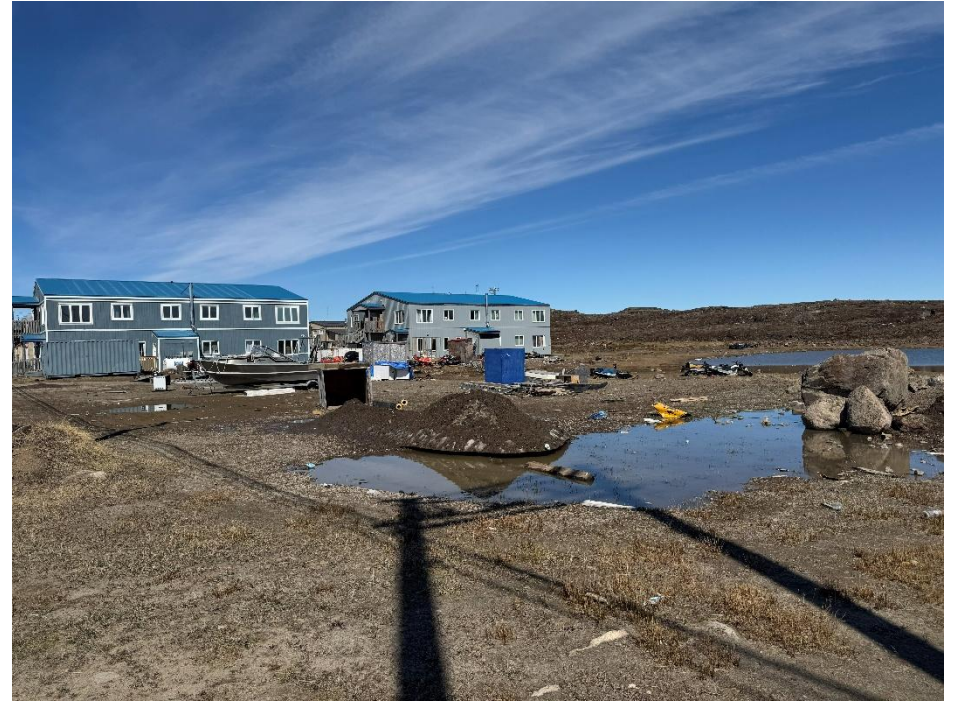
Nunatta observed equipment storage in the western portion of the site, and an area of snow and debris.

Photo ID: 8  
 Date: June 10, 2026  
 Description: Residual snow, debris (foreground) and equipment storage (background)

Nunatta collected two soil samples to address potential impacts from the equipment storage and snow dumping/debris. Neither sample exhibited exceedances of guidelines, so Nunatta does not consider that these areas are environmental concerns.
