Geotechnical Investigation

Geotechnical Investigation Proposed Expansion to City of Iqaluit Public Works Garage Facility Building 1549, Federal Road, Iqaluit, Nunavut

Project Number OTT-00245997-A0

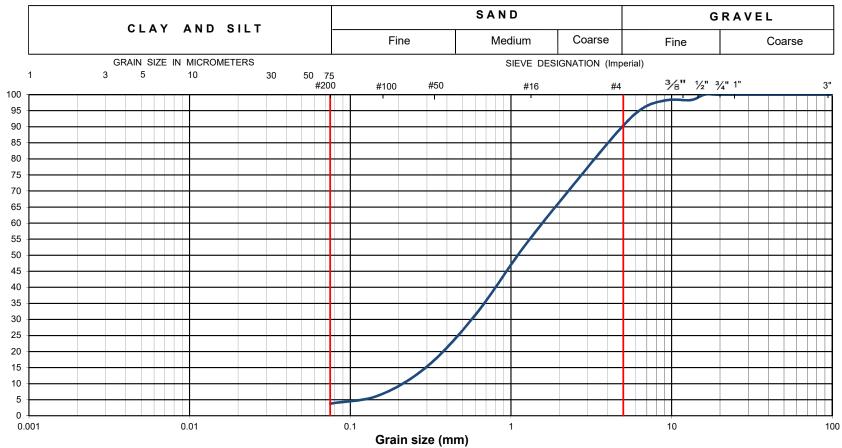
The surficial soil at the site is fill, which extends to 5 m depth in Borehole No. 1 (Elev. 23.7 m) and to a depth of 2.5 m to 3.0 m (Elev. 23.0 m to 26.1 m) in other boreholes. The fill mainly consists of poorly graded to well-graded gravel except in Borehole No. 1 where poorly graded sand fill (SP) was encountered to 3 m depth. The fill is non-frost susceptible (NF) except in Borehole No. 1 below 3 m depth, where it contains ice crystals (V_x). The natural moisture content of the fill varies from 2 to 58 percent. Two grain-size analyses performed on soil samples from this stratum indicate that it contains 1 to 4 percent fines, 34 to 86 percent sand and 10 to 65 percent gravel (Figures 11 and 12).

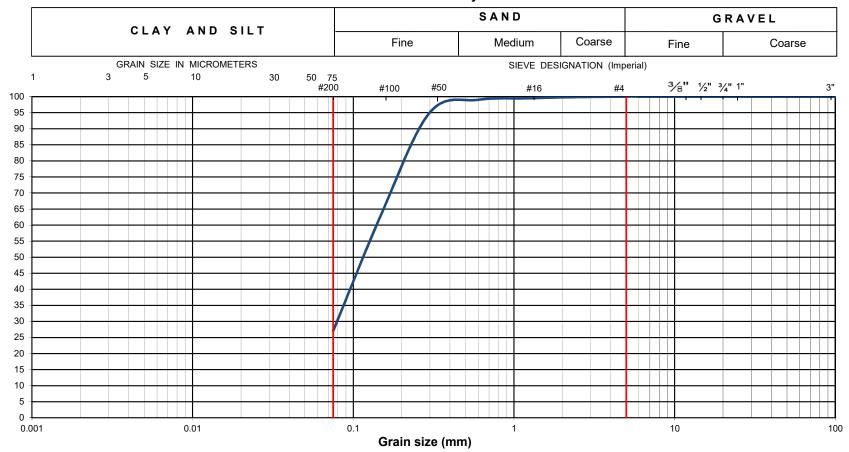
Grain-Size Distribution Curve Method of Test For Particle Size Analysis of Soil ASTM C-136/ASTM D422

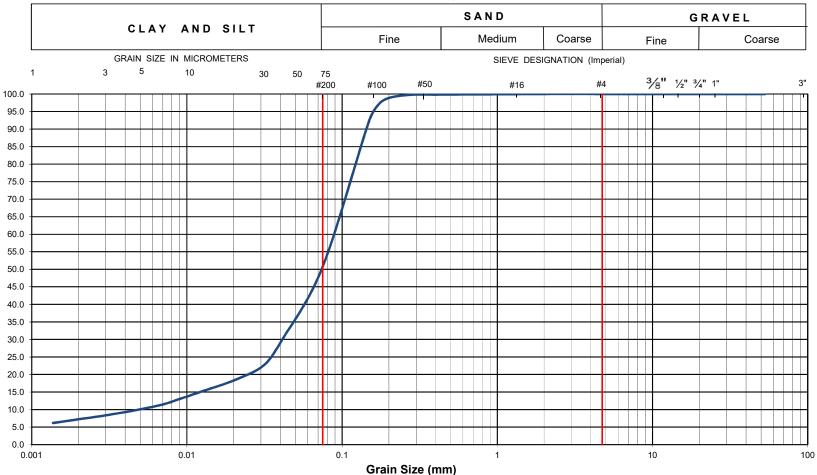
Grain-Size Distribution Curve Method of Test For Particle Size Analysis of Soil ASTM C-136/ASTM D422

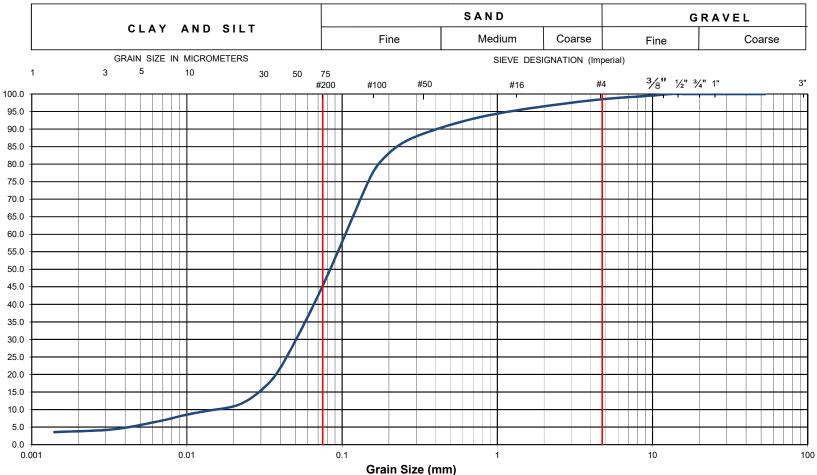
Grain-Size Distribution Curve Method of Test For Particle Size Analysis of Soil ASTM C-136/ASTM D422

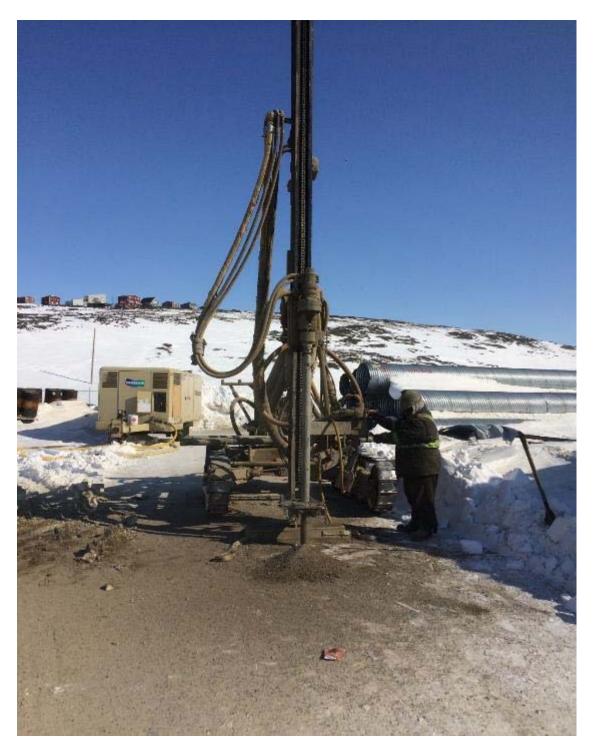
Photo A2: Drilling BH 8, looking North, Apr 12, 2018

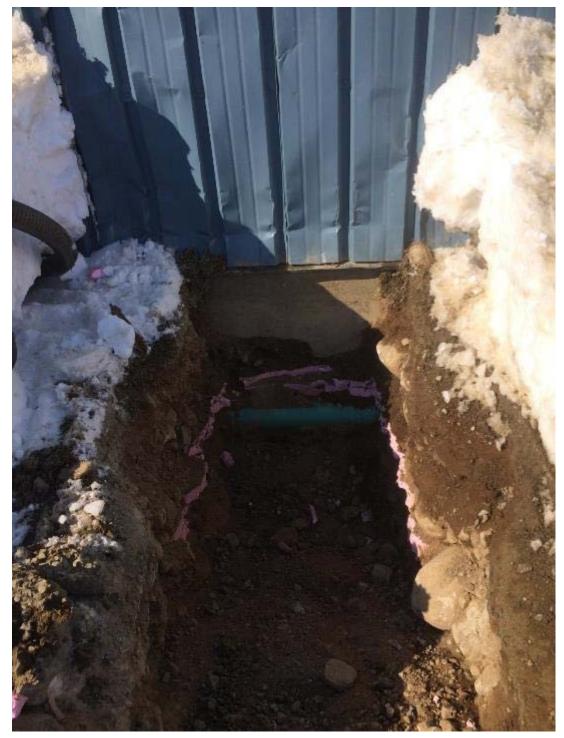
Photo A3: Test Pit adjacent to Existing Building, i.e. TP-2 (Note Green PVC Pipe and Insulation)

Test Pit No. 2 (Figure B2) was excavated adjacent to the south wall of the existing building to determine the type of foundation of the structure since design or as-built drawings are not available. This test pit encountered a concrete slab of 600 mm thickness beneath which 190 mm of pink extruded polystyrene insulation (EPS) was encountered. The insulation was underlain by a 150 mm diameter green PVC pipe. The function of the pipe could not be established. It is unlikely to be an air duct since air ducts normally consist of metal pipes. The pipe was underlain by sand and gravel fill (Photo A3). A summary of the findings in this test pit is presented below:

Based on the investigation, it is not known whether the thickness of concrete observed is that of the slab or that of a thickened slab footing of the existing building.

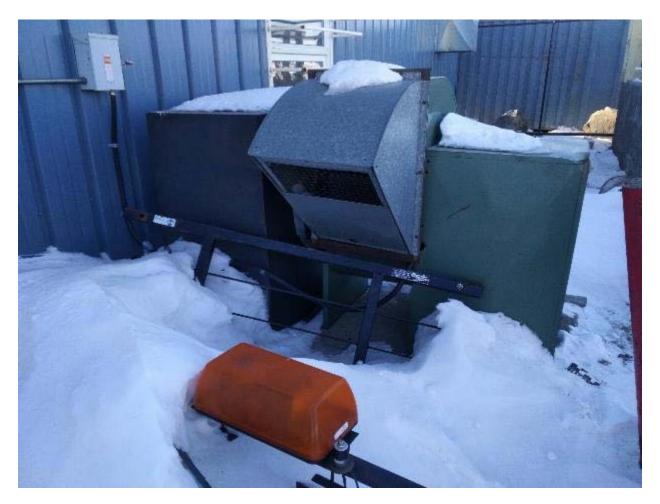
Photo A4: Showing Utility Blower

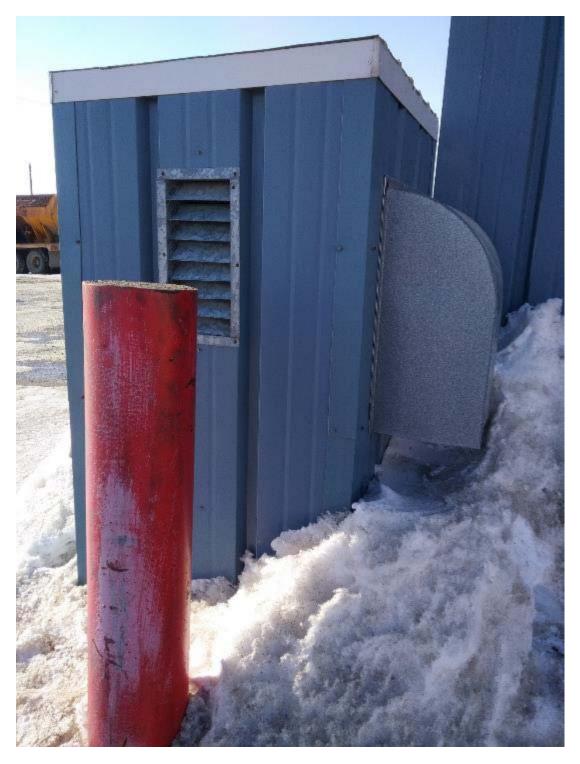
Photo A5: Showing Exhaut Vent
