**Fish and Fish Habitat Assessment  
of the Niaqunguk (Apex) River,  
Lake Geraldine, and the Lake  
Geraldine Drainage Channel**

*FINAL REPORT*

*Prepared for:*  
**City of Iqaluit**  
Iqaluit, Nunavut

*Prepared by:*  
**Nunami Stantec Limited**  
Rankin Inlet, Nunavut

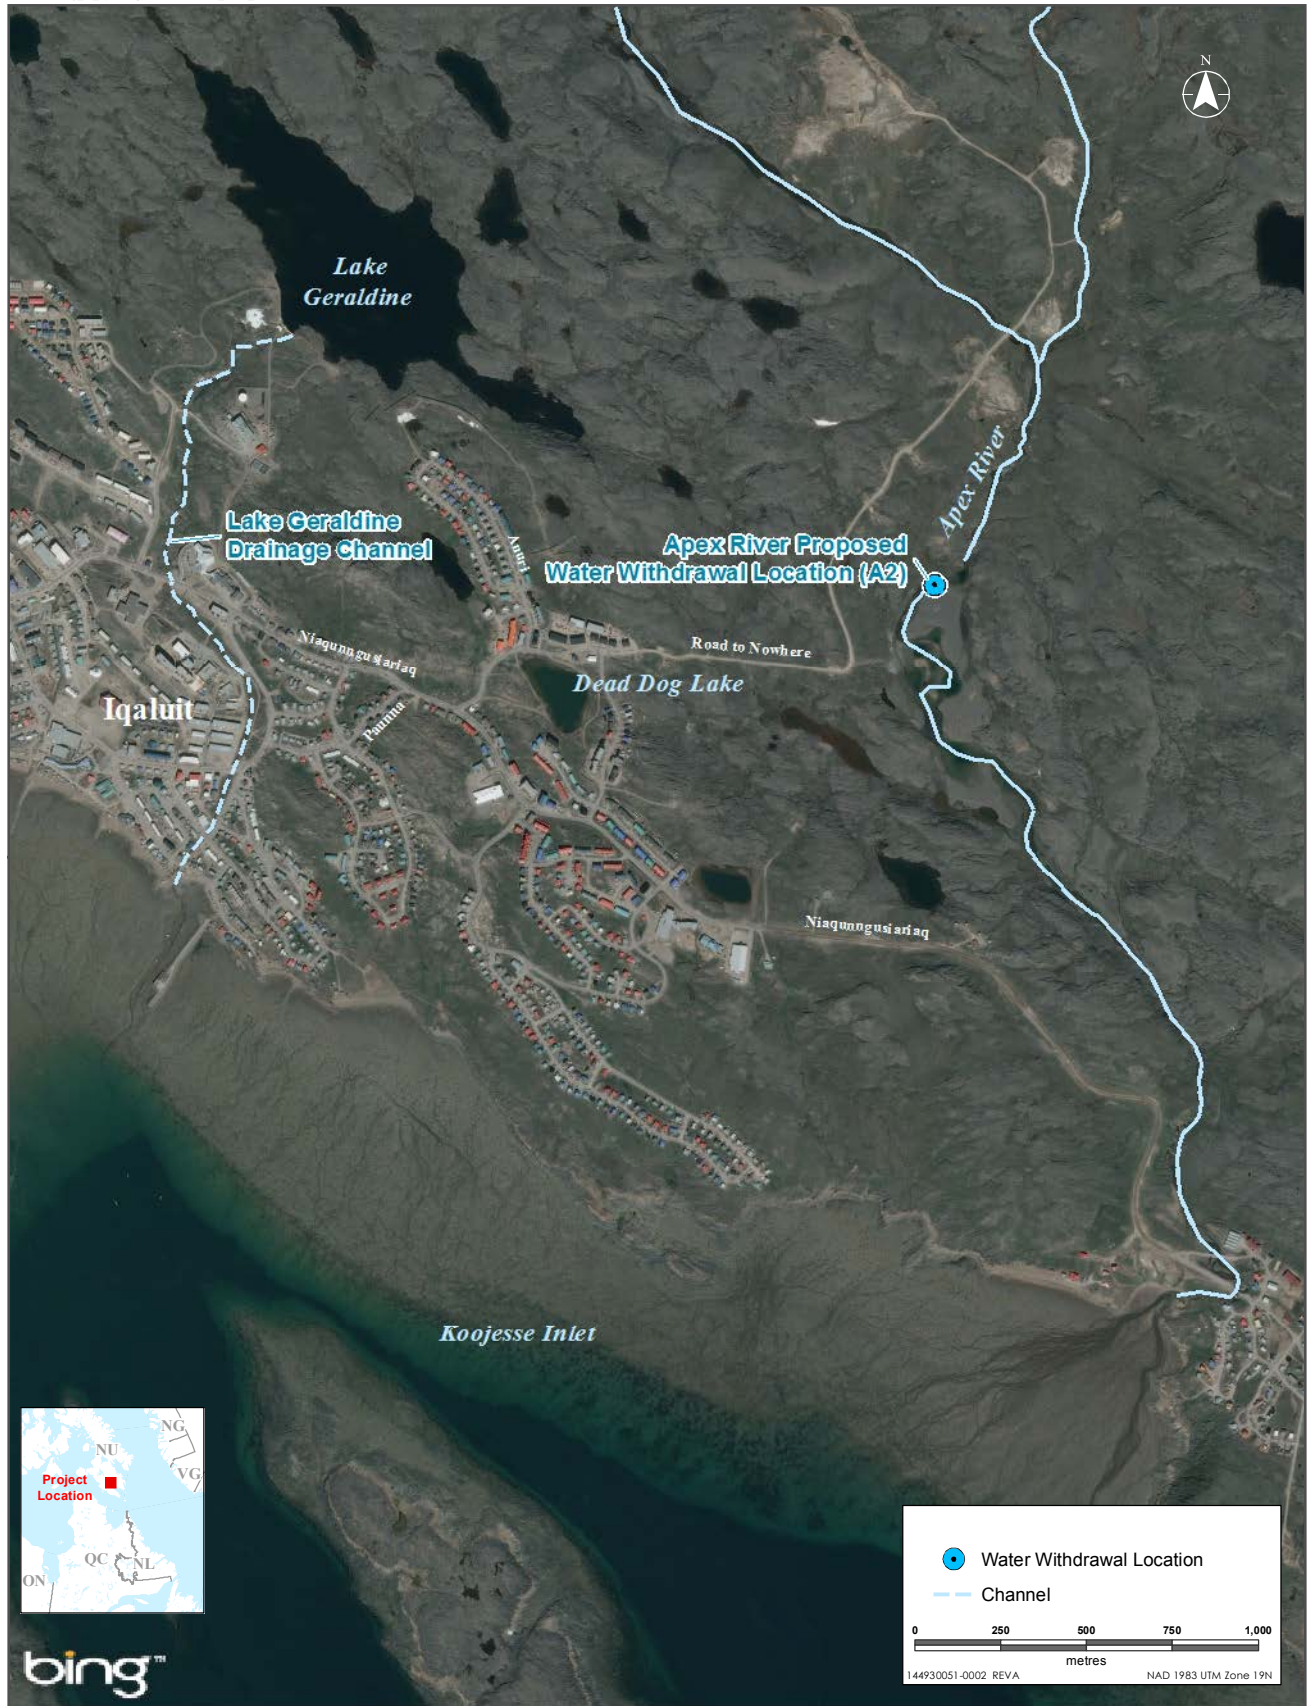
The three waterbodies included in the study are shown in Figure 1-1. The Apex River lies on the east side of Iqaluit. It is approximately 8 km in length with headwater elevations up to 365 m asl, and has a catchment area of approximately 60 km<sup>2</sup> (Obradovic 1986). The proposed A2 water withdrawal location on the Apex River is shown on Figure 1-1.

Lake Geraldine lies on the northeast side of Iqaluit and is 1 km west of the Apex River. In 2006, the spillway elevation of the Lake Geraldine dam was raised by approximately 2 m to increase storage capacity of the reservoir (City of Iqaluit, 2007). From a 2008 bathymetric study, Lake Geraldine has an estimated shoreline perimeter of 3.5 km, a surface area of 0.29 km<sup>2</sup>, a maximum depth of 12 m, and a volume of 1.3 million cubic metres (Mm<sup>3</sup>) (Budkewitsch 2011). Golder (2013) augmented the 2008 bathymetry data to account for the increased storage capacity and water level elevation to the spillway elevation (111.3 m asl), and volume estimates for Lake Geraldine are now 1.89 Mm<sup>3</sup>. The lake's drainage channel is approximately 2 km in length and originates from the reservoir dam, on the lake's southwest shore; the drainage channel flows through Iqaluit to Koojesse Inlet.

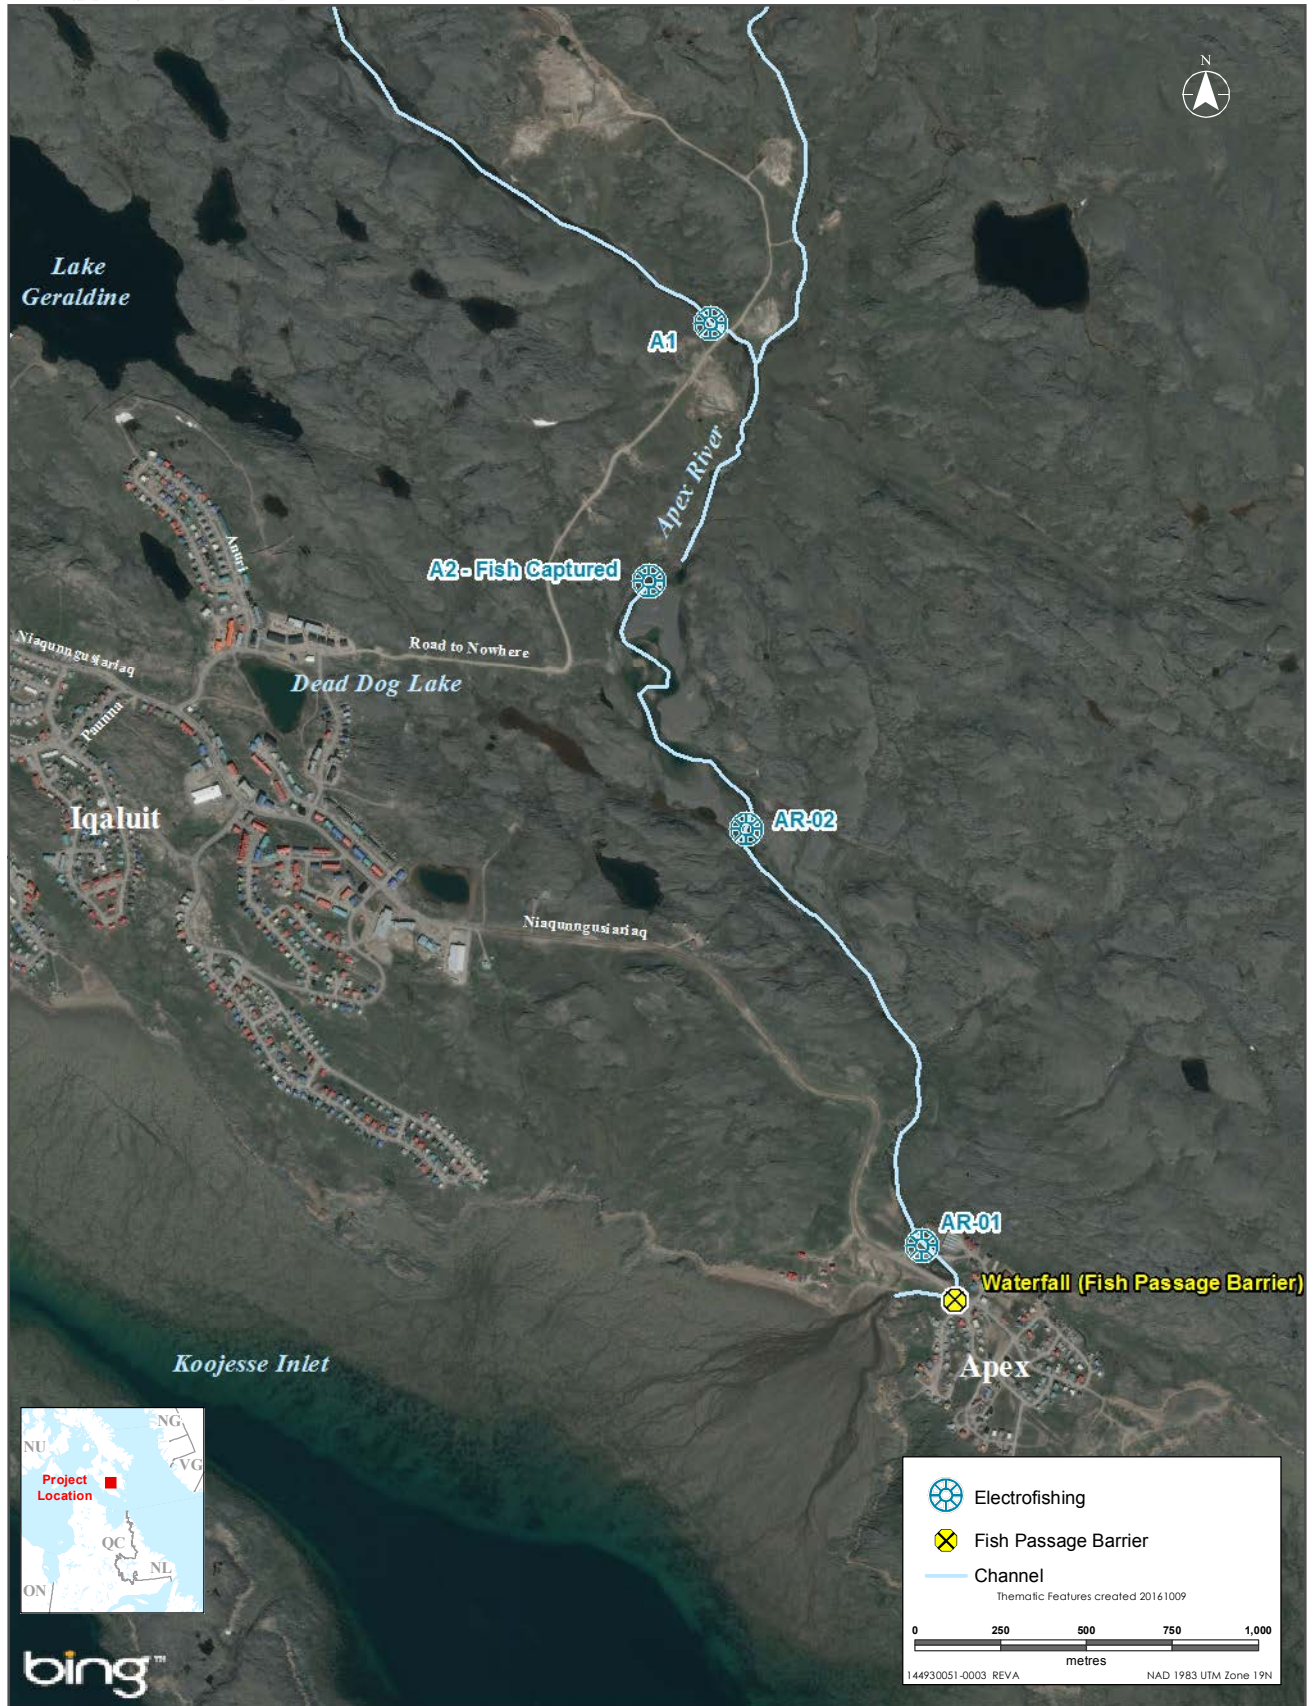
Figure 3-1 identifies the sampling locations on the Apex River, as well as features of interest.

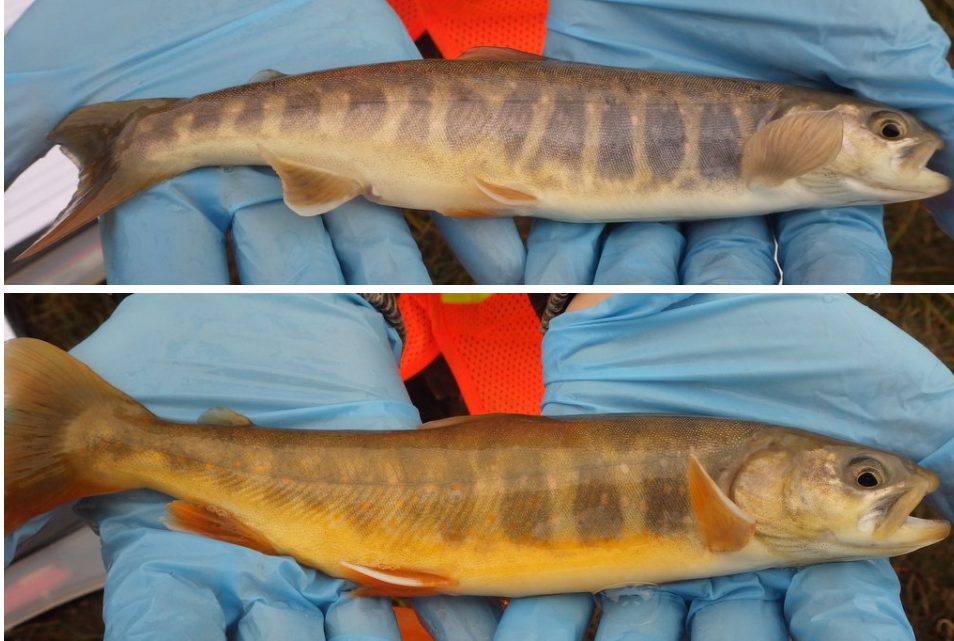
**Photo 3-1 Two of the Largest Arctic Char (223 mm [top] and 218 mm [bottom]) Captured in the Apex River on September 1, 2016; Both Showing Signs of Spawning Colours**

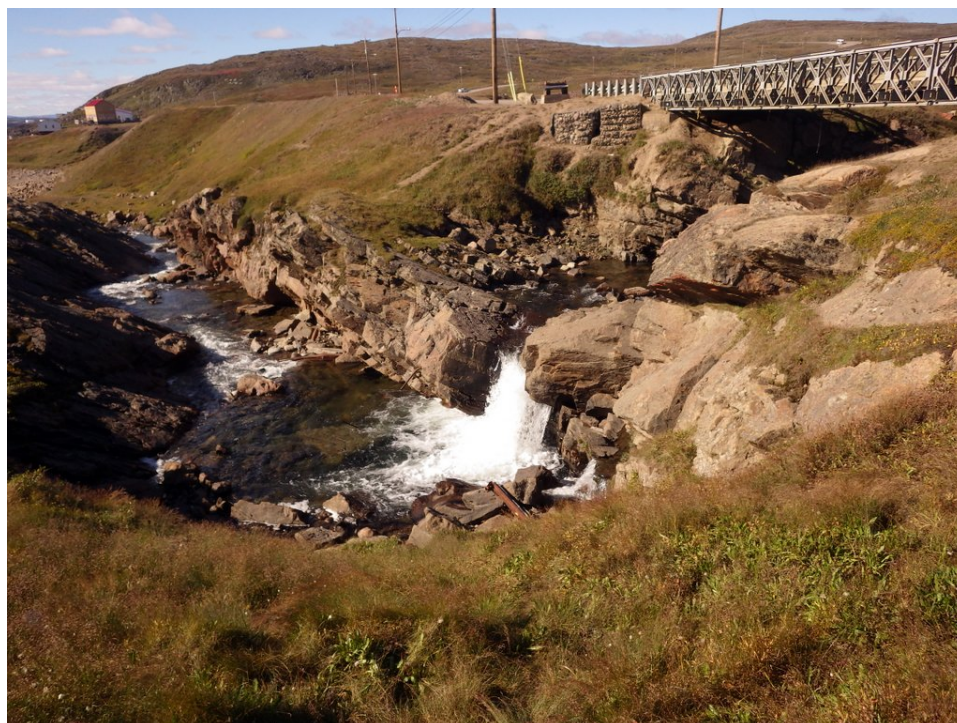
At the mouth of the Apex River, exposed bedrock shelves create a series of waterfalls, the largest being over 2 m in height (Photo 3-2). This waterfall creates a barrier to upstream fish movement at the community of Apex, approximately 350 m upstream from the Koojesse Inlet. The lowest reach assessed, AR-01 (Figure 3-1), is just upstream this waterfall, near the Bypass Road in the community of Apex.

**Photo 3-2 Fish Passage Barrier (Waterfall) at the Community of Apex; Northwest Aspect**

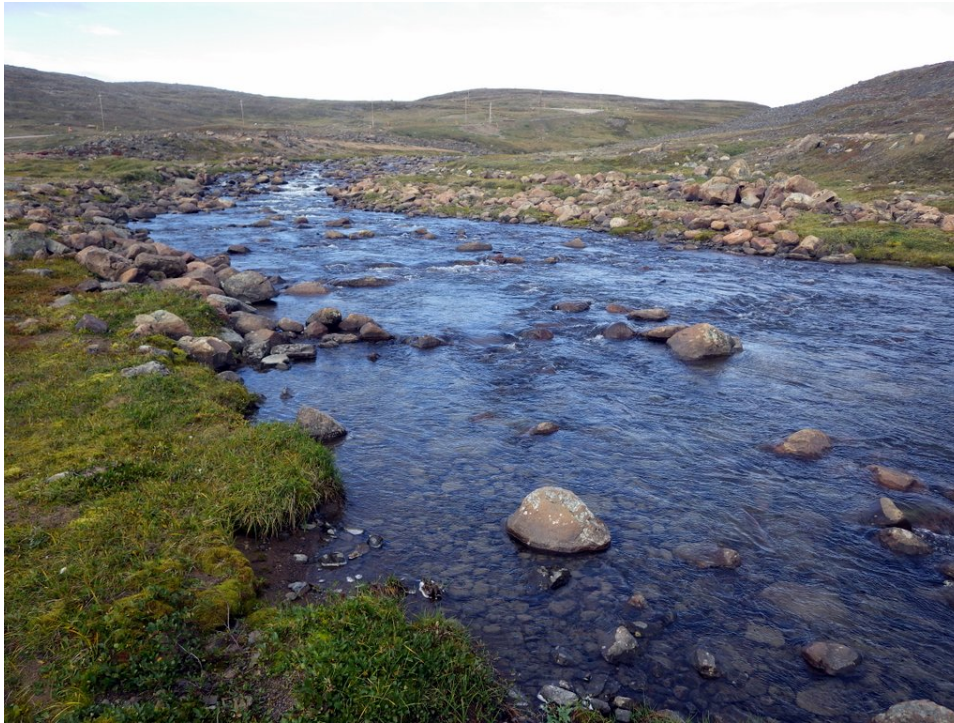
**Photo 3-3      Looking Upstream at Reach AR-01; North Aspect**

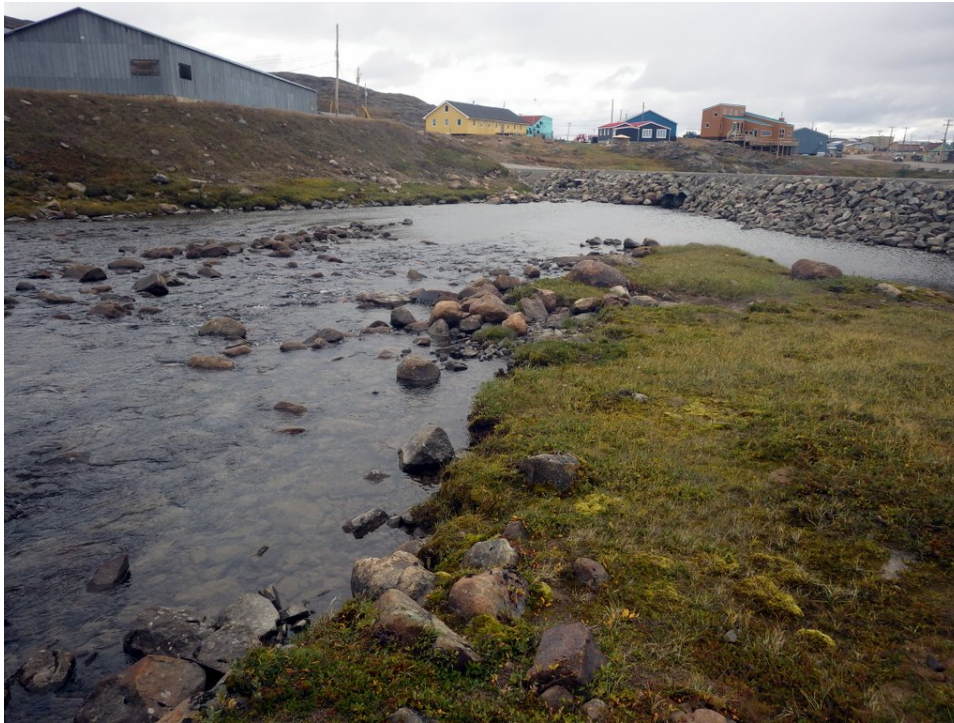
In the lower part of the AR-01 reach, Bypass Road (Photo 3-4) creates a “choke point” impounding the river during higher flows, resulting in the deposition of smaller substrate sizes, including fine materials.

**Photo 3-4 Looking Downstream in Reach AR-01 at the Impoundment Created by Bypass Road in Apex; South Aspect**

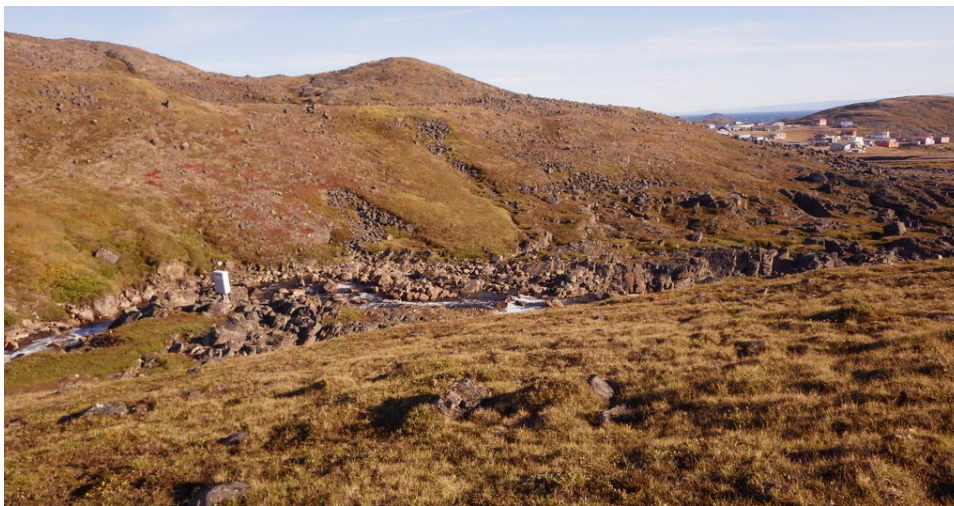
Between reach AR-01 and reach AR-02, the Apex River flows through a steep canyon, where the Water Survey of Canada flow gauging station is located (Photo 3-5). Through the canyon, the river has a steeper, cascade and rapids habitat type, but there do not appear to be any barriers to fish passage.

**Photo 3-5 Water Survey of Canada Gauge in the Apex River Lower Canyon; West Aspect**

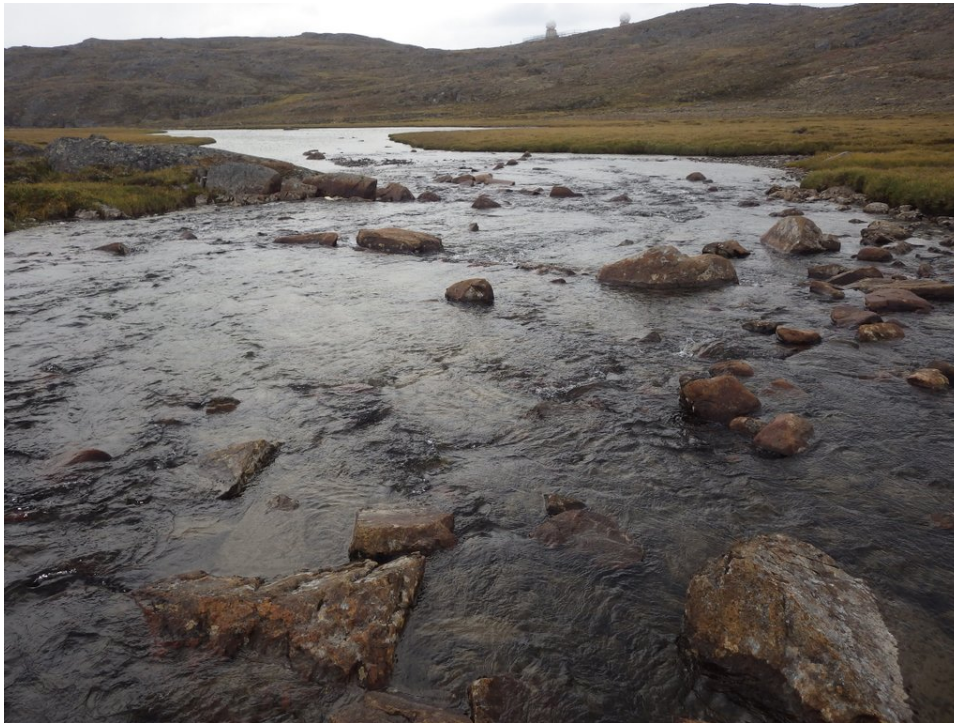
**Photo 3-6      Reach AR-02 Looking Downstream at the Bedrock Outcrop; South Aspect**

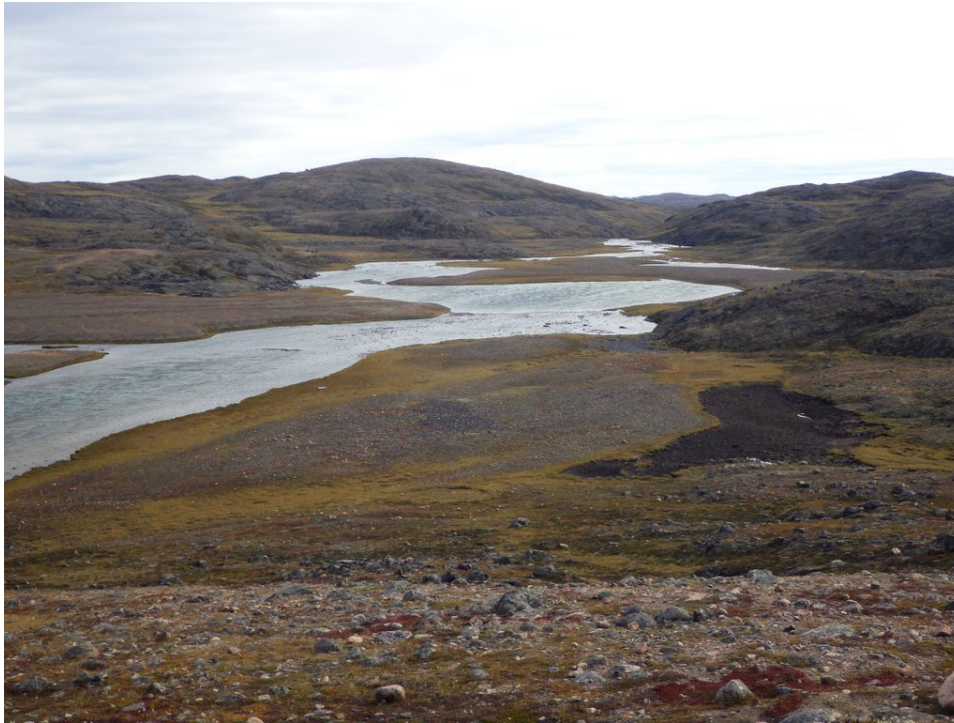
Approximately 2 km from Koojesse Inlet, the Apex River flows through a wide flat valley, upstream of the lower canyon. As the river flows through the lower gradient valley bottom, the river widens and forms a series of small lakes (Photo 3-7). The lakes are approximately 500 m long and at places, as wide as 100 m.

**Photo 3-7      Looking Downstream at the Low Gradient Valley Lakes on the Apex River; Southeast Aspect**

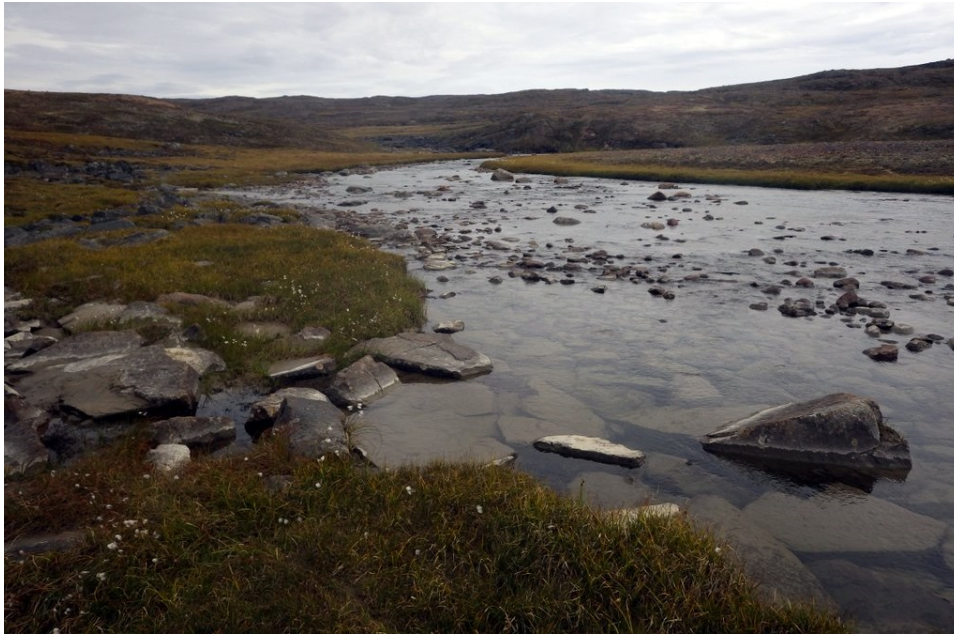
**Photo 3-8 Reach A2 Looking Upstream Towards the "Swimming Lake"; Northeast Aspect**

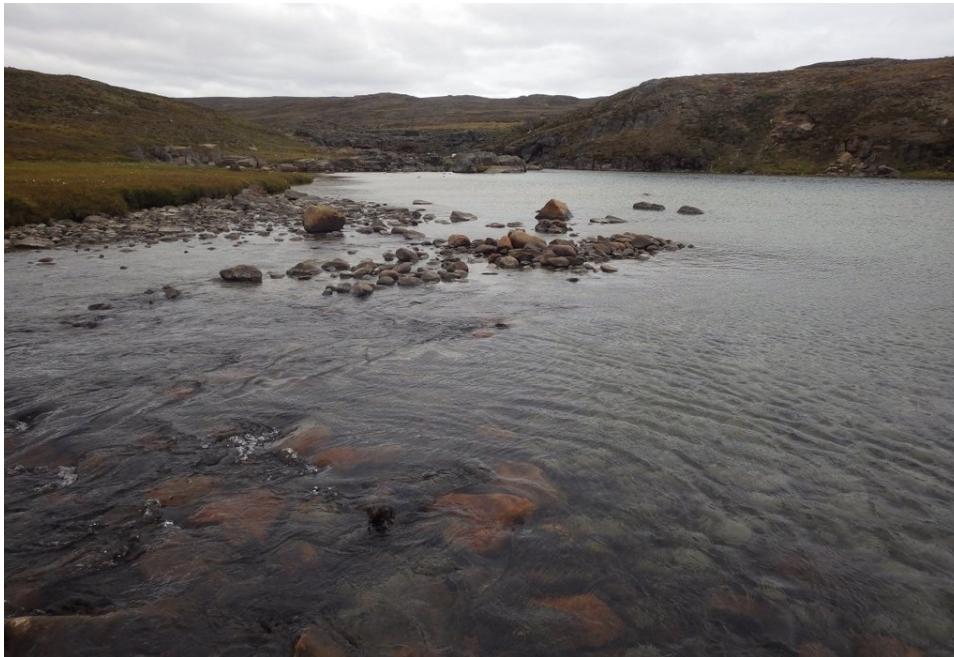
**Photo 3-9 Looking Upstream from Reach A2 into the "Swimming Lake"; Northeast Aspect**

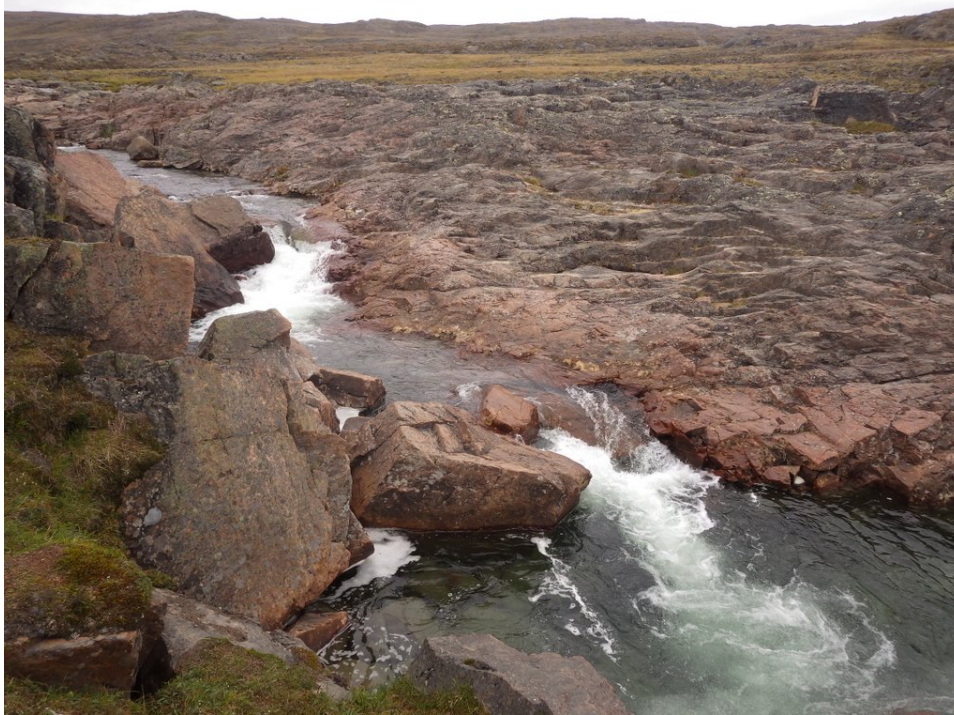
Upstream of the "Swimming Lake", the river is confined in a tighter steep valley with bedrock outcrops creating a series of cascade and rapid sections (Photo 3-10 to Photo 3-12). Substrates are large coarse materials and exposed bedrock. There are a series of cascades forming drops that may limit upstream fish movement, although they do not appear to be high enough to be complete barriers. The presence of scour pools for resting and jumping, small bypass channels, and stepped drops along the edge of the cascade, likely provide passage through the canyons.

NOTE: Fish observed in the pool below the falls

**Photo 3-10 Cascade Upstream of the "Swimming Lake" (19V 526407 m E, 7069344 m N)**

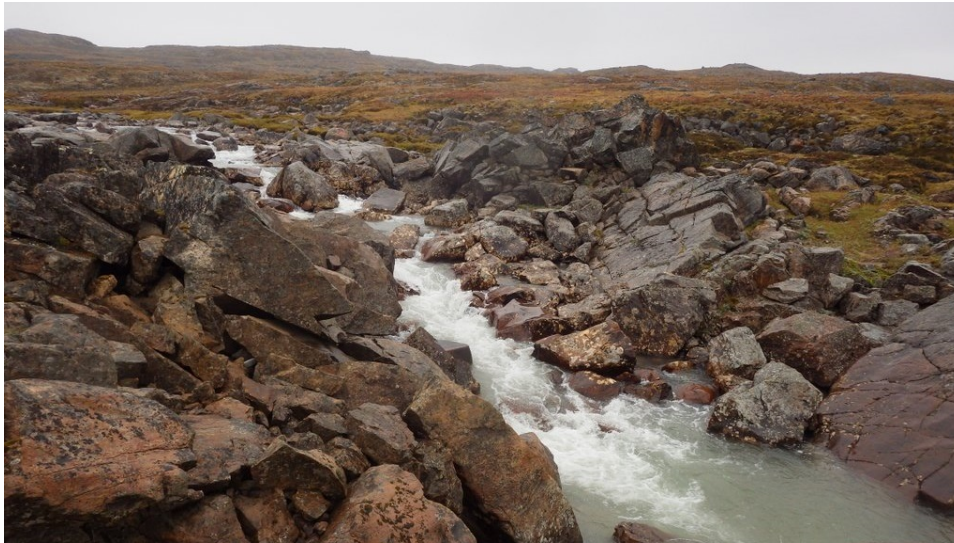
**Photo 3-11** Looking Upstream in the Cascade on Apex River (19U 526526 m E, 7069570 m N)

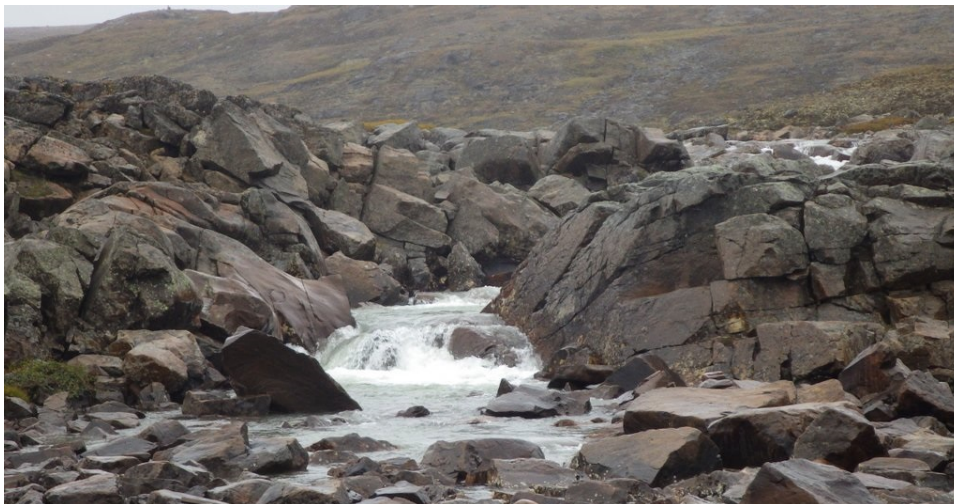
**Photo 3-12** Looking Upstream at Cascade on Apex River (19U 526526 m E, 7069570 m N)

With rain events, it appears that the river quickly becomes turbid, as observed during rain on 05 September 2016 (Photo 3-12). A likely contributor to the increase in suspended sediments is the exposed fine soils found at the apparent sand pit near the Road to Nowhere, west of Reach A1 (Photo 3-13). This indicates that the construction in the area should have sediment and erosion control measures to reduce the potential movement of sediment overland into the Apex River.

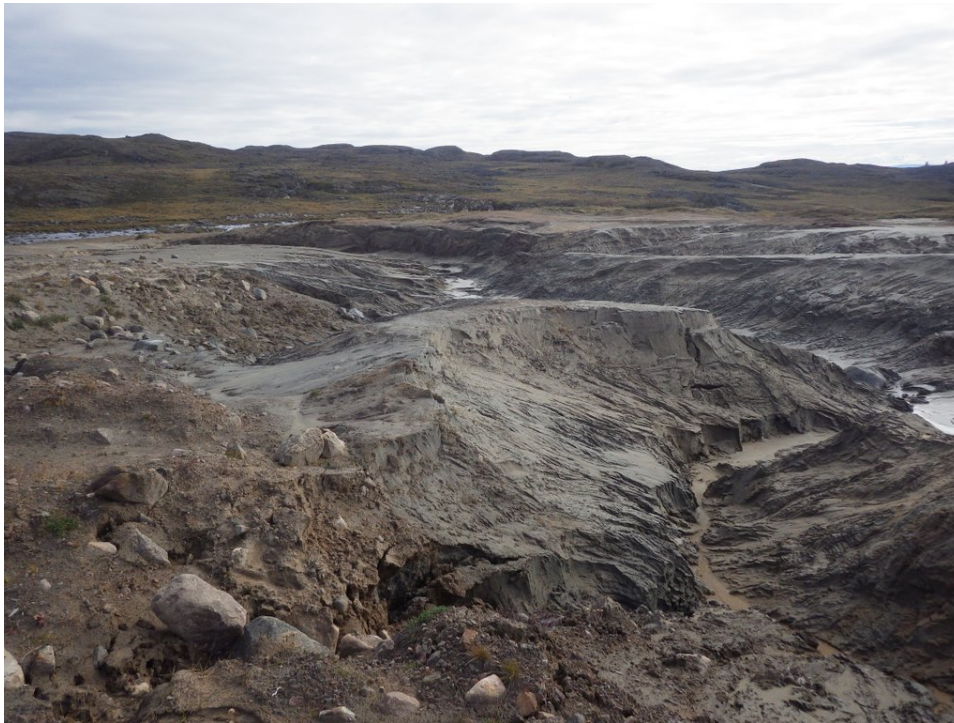
impoundment caused by the road has resulted in a smaller substrate size at the lower end of the A1 reach, with fine materials dominating. Boulders present along the east side of the river provide cover. Under the bridge on the Road to Nowhere, the constriction increases the water velocity and a coarse substrate was observed, consisting of boulders and cobble. Between the “Road to Nowhere” and the canyon downstream, there is a sand pit adjacent to the river that is a source of sediment input (Photo 3-13)

**Photo 3-13 Sand Pit Adjacent to the Apex River, downstream of Reach A1  
(19V 526467.94 m E, 7069819.72 m N)**

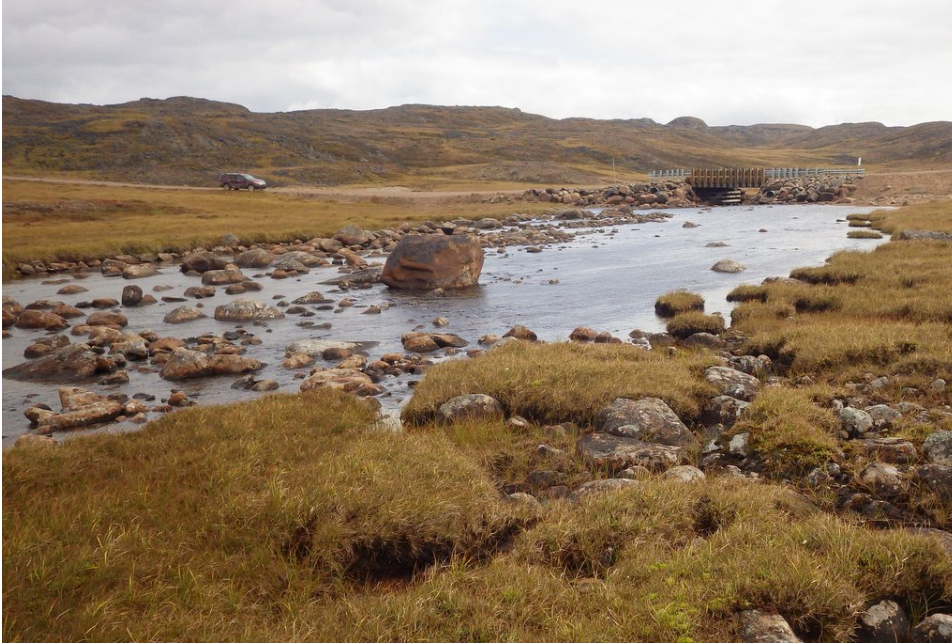
The reach at A1 consists of boulder garden/run habitat along much of the channel length and width, with a narrow riffle zone along the east bank (Photo 3-14). The channel width varies from 25 to 32 m wide, with a wetted width from 22 to 32 m. The channel has depths ranging up to 1.38 m recorded in between large boulders that have a diameter of 1.5 m (Photo 3-15). The dominant substrate is large boulders, followed by cobbles. The banks are stable and vegetated by grasses. Although fish were not captured in this reach it appears that it could provide good fish habitat for fish, with high amounts of cover between the boulders. There are also riffles along the east bank adjacent to steep banks providing cover and potential food production.

**Photo 3-14** Looking Downstream at the Road to Nowhere Bridge from the Mid-Section of Reach A1

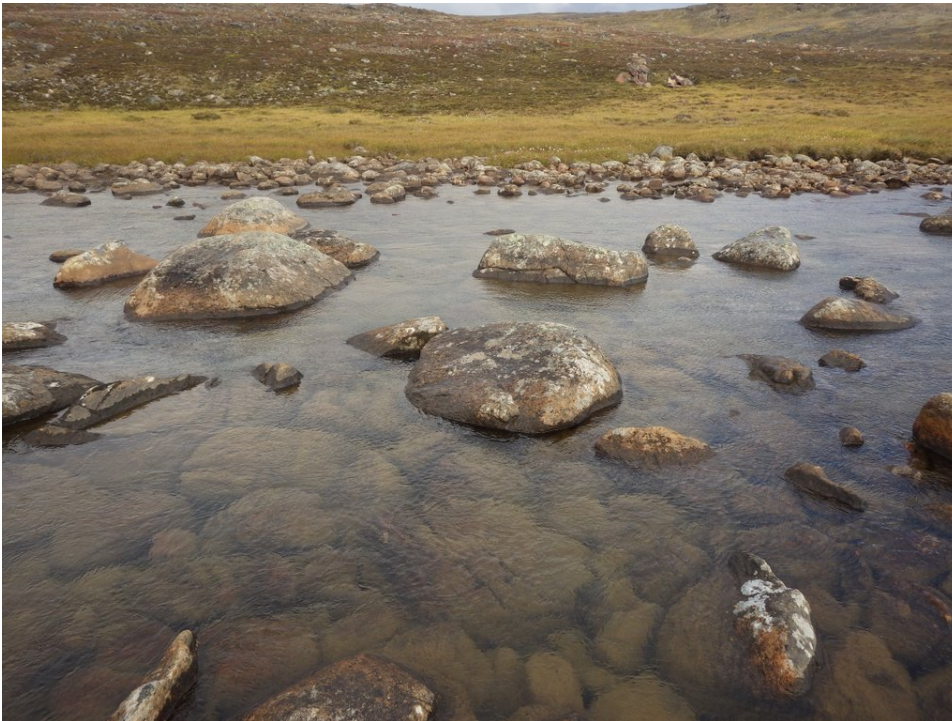
NOTE: Recorded depth at this transect was 1.38 m between the boulders

**Photo 3-15** Mid-Reach of A1 showing the Large Boulders and Deep Interstitial Spaces

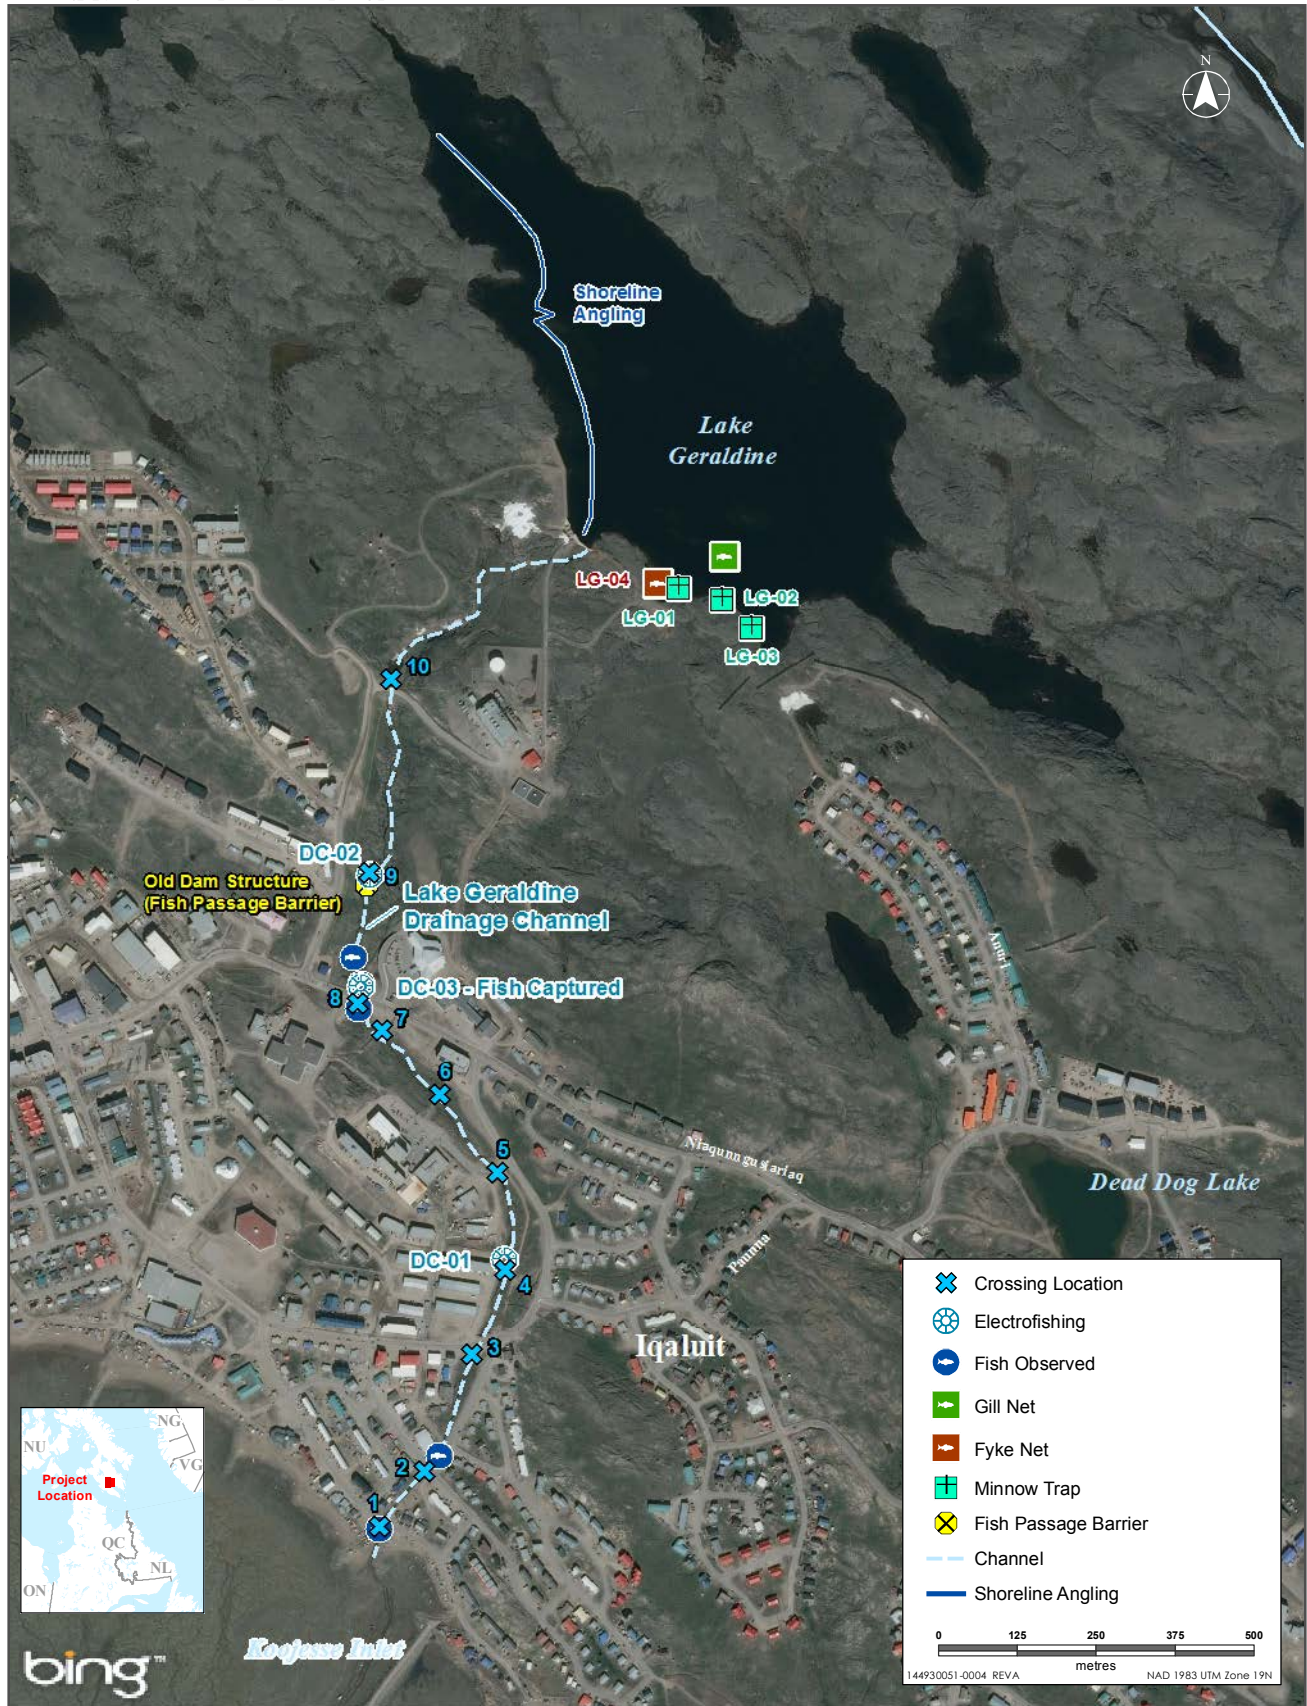
Feature No.	Feature	Location (in UTM 19 V)	Notes
1	Sinaa Road Crossing	524114.64 m E, 7068411.83 m N	Two circular culverts, 1,100 mm dia and 800 mm dia, no drop
2	Nipisa Street Crossing	524186.05 m E, 7068498.85 m N	Three 1,200 mm dia culverts, 14 m long with gabion wall headwall at inlet. Flow through one pipe only
3	Queen Elizabeth Road Crossing	524261.72 m E, 7068684.52 m N	Five pipes, three 1,650 mm dia oval culverts, with two 620 mm dia circular overflow pipes above them 0.22 m drop from culvert into 0.29 m pool may be barrier to small fish or at some flow levels
4	Pedestrian Crossing near Paunna Road	524313.69 m E, 7068819.42 m N	Two 1,550 mm dia culverts, 7 m long, half buried in the substrate
5	Astro Hill Road Crossing	524302.97 m E, 7068975.12 m N	Clear span bridge structure, 13 m wide over a channel with 7 m wide bankful Unstable bank on downstream left
6	Astro Hill Pedestrian Crossing	524210.46 m E, 7069099.66 m N	Two 1,300 mm dia culverts, 7 m long with one 400 mm dia overflow pipe

7	Overhead Pipe Crossing	524118.39 m E, 7069199.35 m N	Footings constructed of wooden cribs on rock riprap, encroaching on channel width
8	Road to Apex Crossing	524080.36 m E, 7069242.08 m N	Two 2,200 mm dia culverts, 22 m long
9	Old Dam Structure	524099.06 m E, 7069449.71 m N	Concrete dam, over 1 m drop. Complete barrier, no flow over structure—water flows through rock debris under structure
10	Saputi Road Crossing	524132.93 m E, 7069756.41 m N	Two 1,500 mm dia oval pipes, 80 m long, steep installation

Arctic char were also observed, but not captured, downstream of the sampling reaches, in a pool below the crossing on Sinaa Road and in the step-pool habitat above Nipisa Street (Figure 3-2).

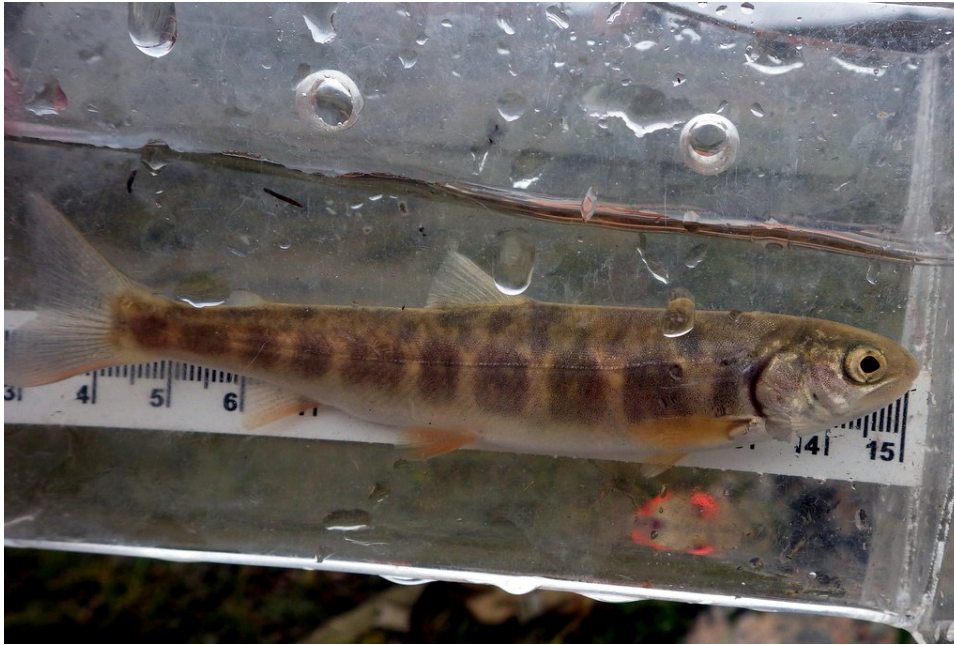
**Photo 3-16 Arctic Char Captured in the Lake Geraldine Drainage Channel (113 mm), August 30, 2016**

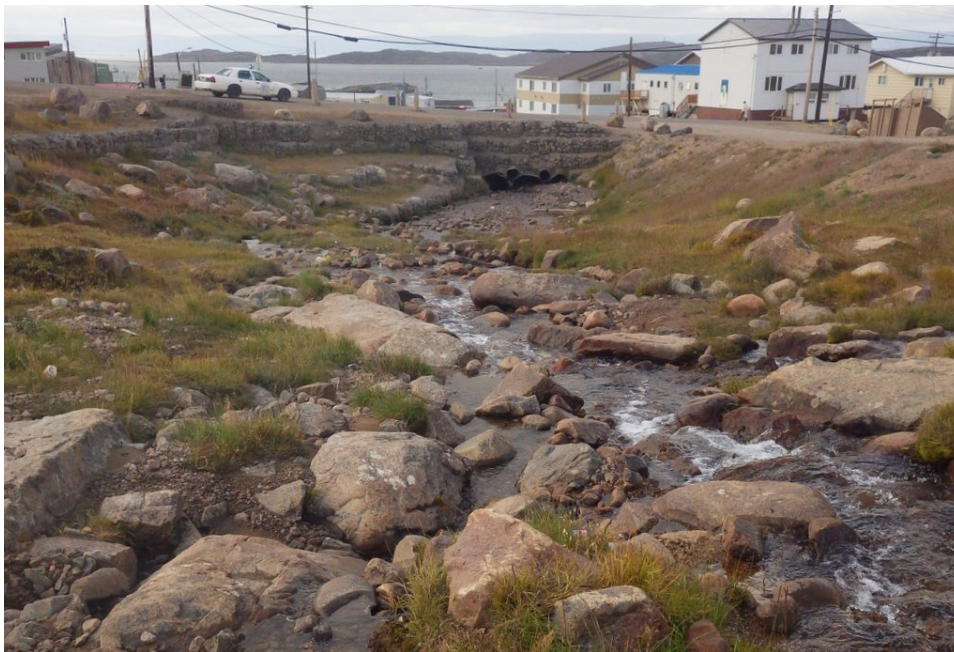
**Photo 3-17 Looking Downstream (Southwest) to Queen Elizabeth Road (Reach DC-01) at Step-Pool Morphology in the Lake Geraldine Drainage Channel**

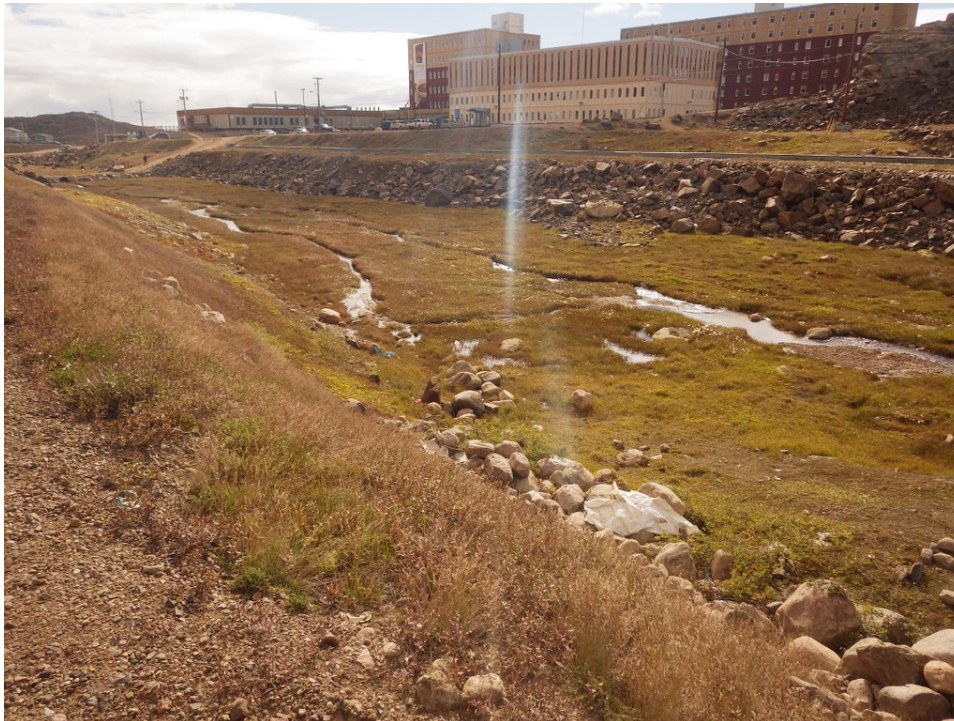
**Photo 3-18 Lake Geraldine Drainage Channel Looking Downstream (Southwest) at the Astro Hill Complex**

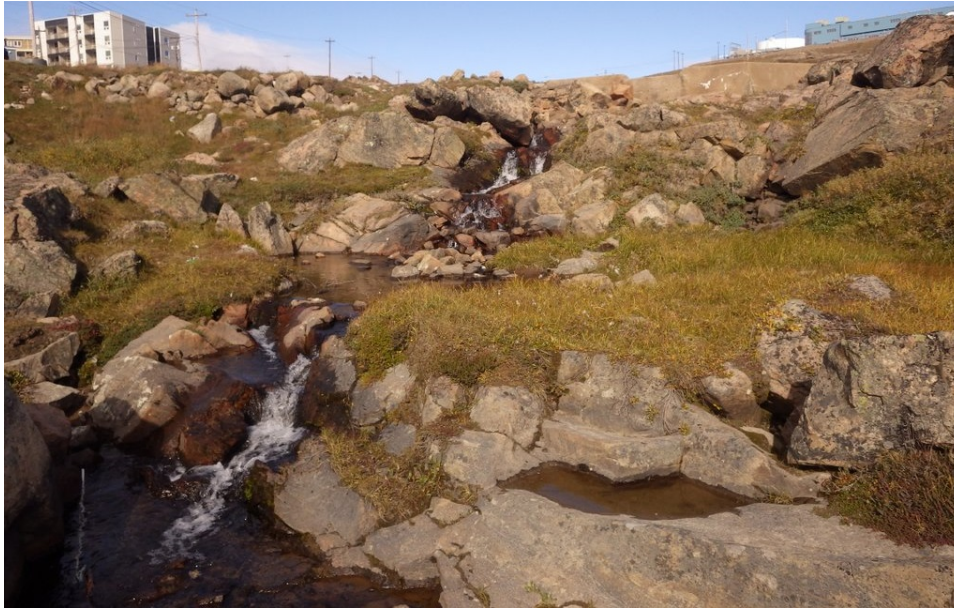
Upstream of the Road to Apex, the channel becomes steeper again, with step-pool morphology and small cascades creating scour pools and turbulent water cover. Arctic char were observed in these pools and two were captured at this location (Reach DC-03) while electrofishing. The channel is slightly narrower at 5 m, with a wetted width of 3 m. Water depths range from 0.08 to 0.27 m in the scour pools. Cobbles dominate the substrate with boulder features and grassed banks. Low shrubby vegetation overhangs some of the pool habitat. The channel upstream, becomes steeper and eventually a series of waterfalls and an old dam structure near the hospital create a complete fish passage barrier (Photo 3-19 and Photo 3-20).

**Photo 3-19 Small Waterfalls and Old Dam on the Lake Geraldine Drainage Channel Near the Hospital**

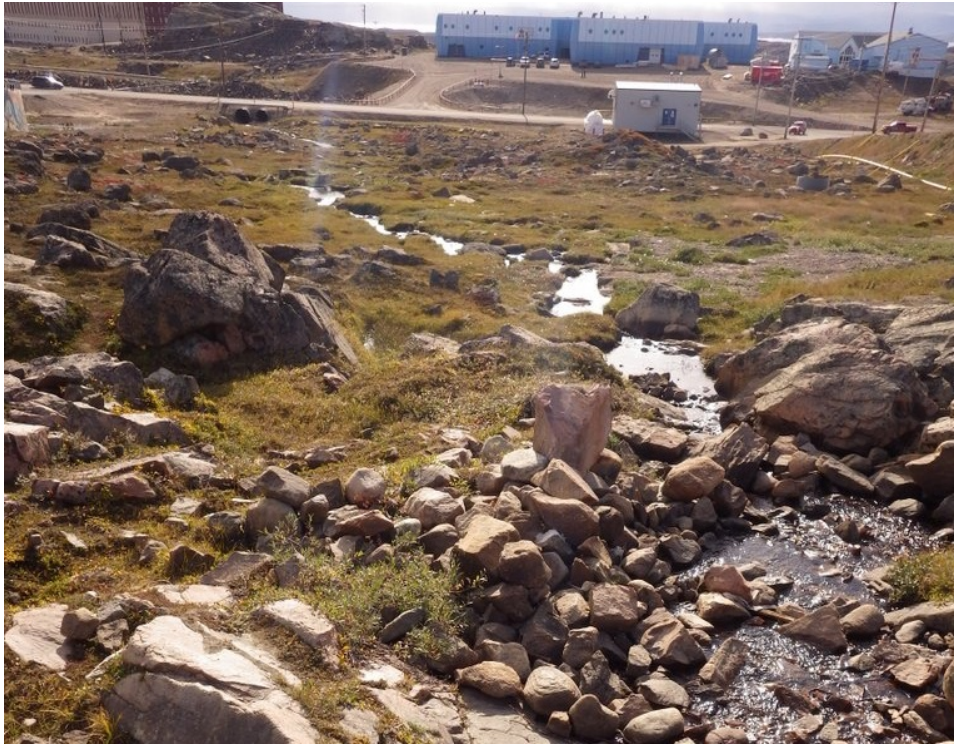
**Photo 3-20 Looking Downstream at Steep Step-Pool Channel to the Road to Apex from the Old Dam Structure**

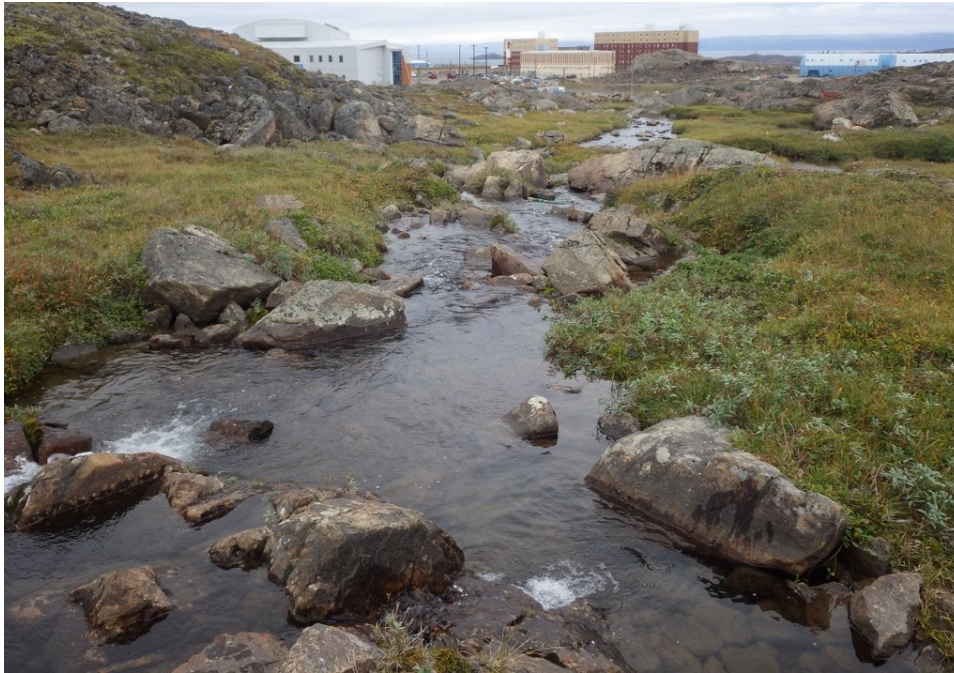
Above the old dam structure near the hospital, the channel ranges from 2 to 5 m wide, with more bedrock outcrops constricting the channel form and creating small drops (Photo 3-21). Water depths in pools below bedrock ledges were measured at 0.27 m near the transects. Substrates range from fines to boulders, with gravels and cobbles dominating. The channel flows through a narrow canyon, limiting the meanders and channel braiding.

**Photo 3-21 Looking Downstream on the Lake Geraldine Drainage Channel Towards the Hospital**
