**Fish and Fish Habitat Assessment  
of the Niaqunguk (Apex) River,  
Lake Geraldine, and the Lake  
Geraldine Drainage Channel**

*FINAL REPORT*

*Prepared for:*  
**City of Iqaluit**  
Iqaluit, Nunavut

*Prepared by:*  
**Nunami Stantec Limited**  
Rankin Inlet, Nunavut

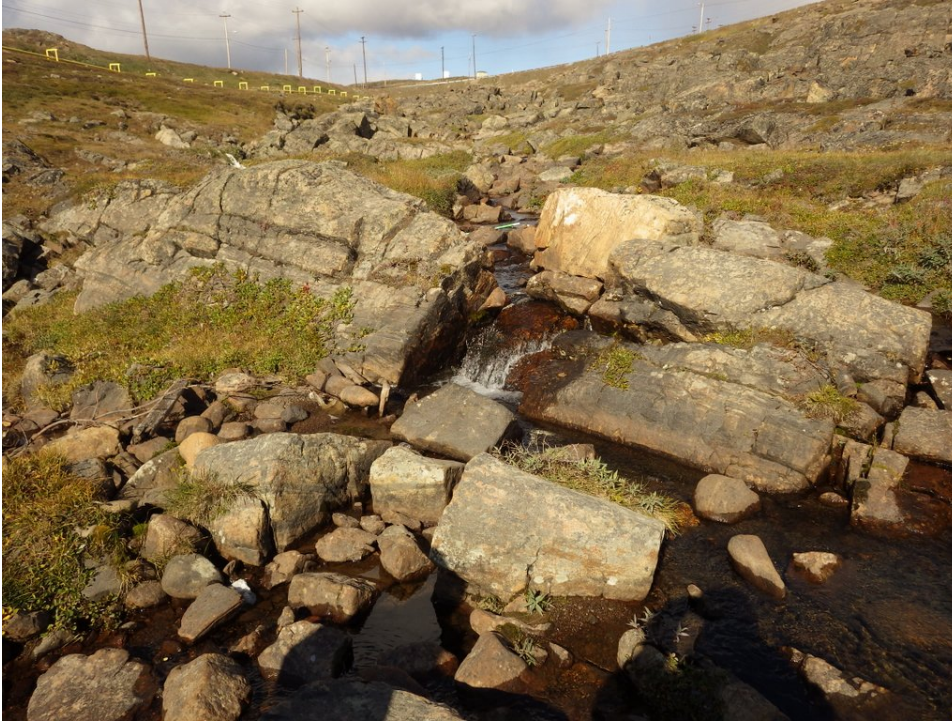
The Saputi Road crossing is another complete passage barrier and creates a small ponded area upstream of the road (Photo 3-22). A tributary flows from the west, entering the Lake Geraldine Drainage Channel at the pond upstream of Saputi Road. From the pond near the Saputi Road Crossing upstream to the dam, the channel flows through a large boulder field from the base of the dam on Lake Geraldine (Photo 3-23). Portions of this channel have no apparent surface flow. At high water levels, flows in the Drainage Channel come from the Lake Geraldine dam spillway (Photo 3-24).

**Photo 3-22 Looking Upstream on the Lake Geraldine Drainage Channel Towards Saputi Road**

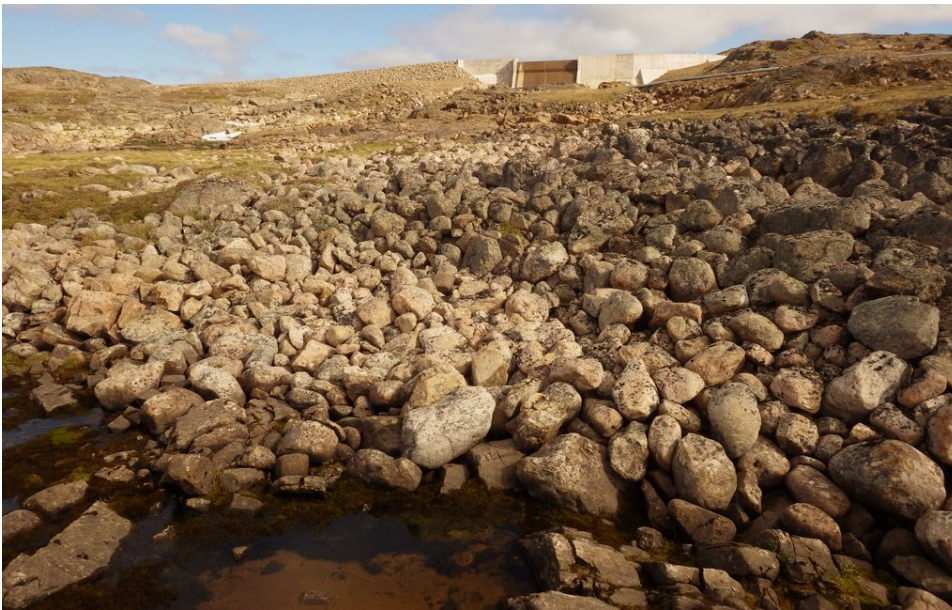
**Photo 3-23 Boulder Field Downstream of Lake Geraldine Dam**

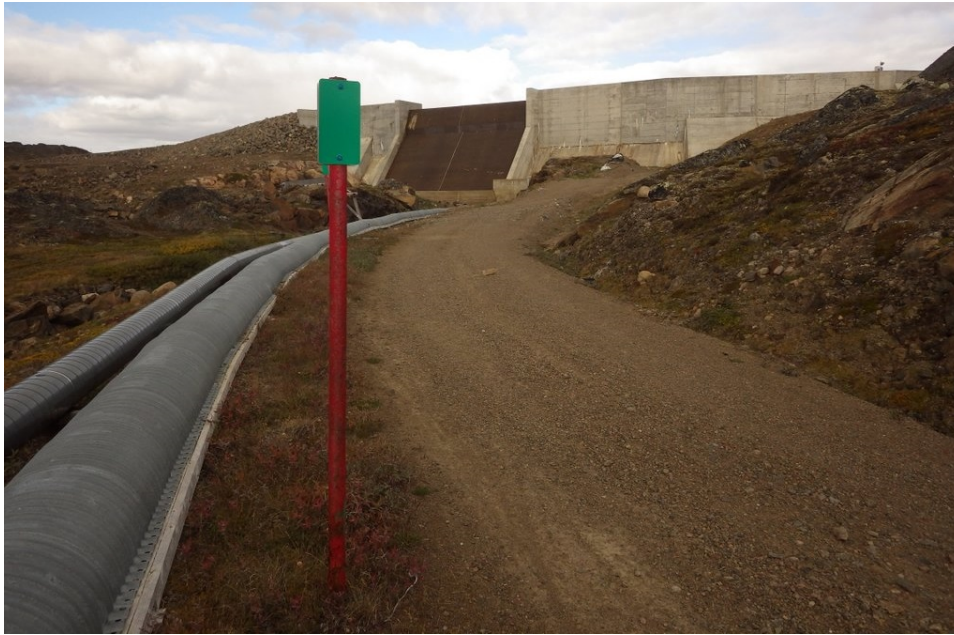
**Photo 3-24 Spillway on the Lake Geraldine Reservoir Dam**

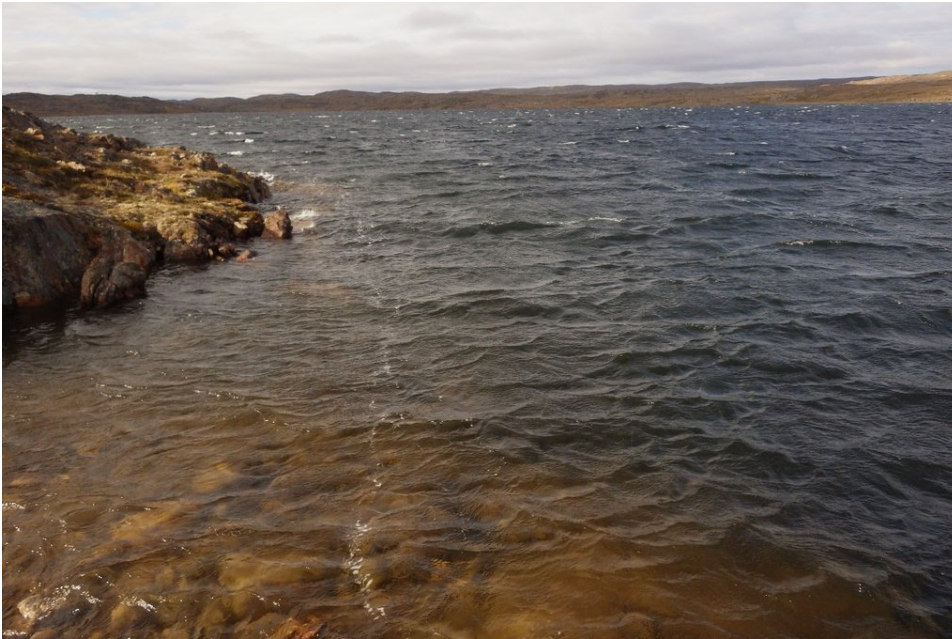
The habitat along the shore of Lake Geraldine consisted of exposed bedrock, boulders, and cobble substrates, with low shrubs and grasses on the banks. The shoreline along the west side of the lake drops off to a depth between 1 and 2 m rapidly from the bank. Photo 3-25 and Photo 3-26 show typical sections of the western Lake Geraldine shoreline. Amphipods, chironomids, and tricoptera larva were also observed in the shallow margins of the lake.

**Photo 3-25 Lake Geraldine Looking Northeast from South of the Dam; Note the Cobble/Boulder Substrate and the Steep Drop-Off**

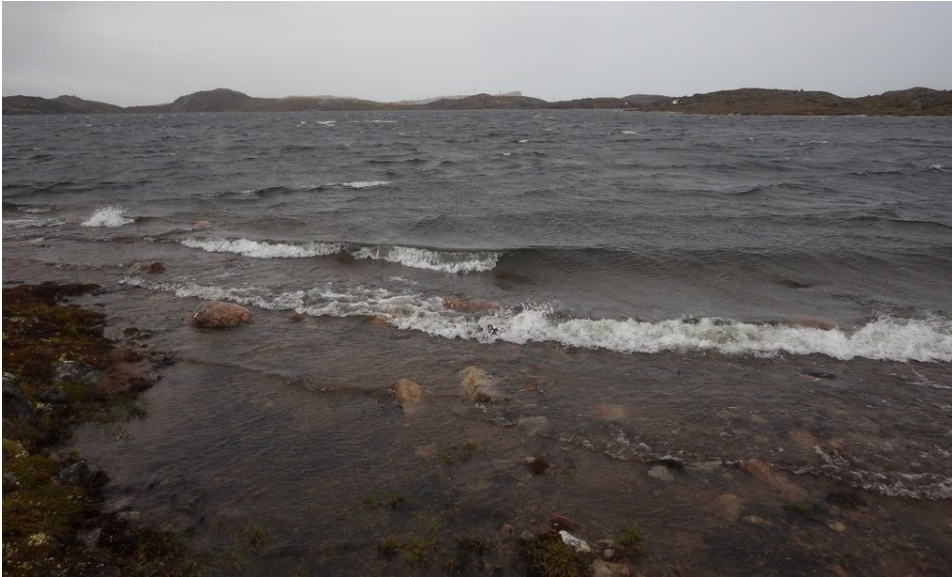
**Photo 3-26 Looking South across Lake Geraldine from the North Side; Note Smaller Gravel Substrate with Cobble and Boulders**

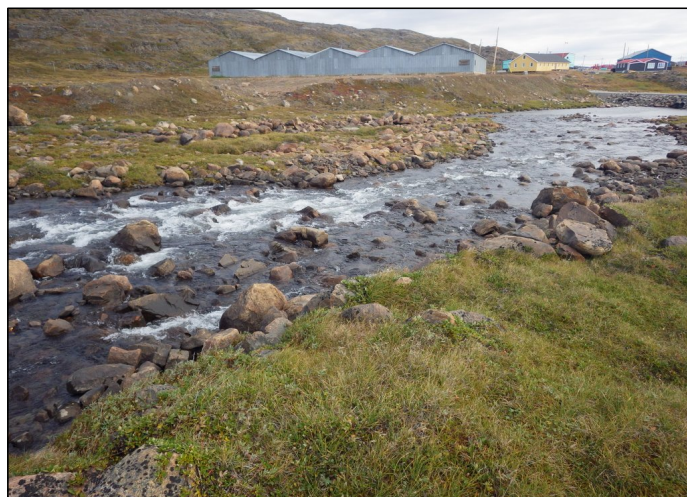
Photo 1: Looking downstream at bottom half of reach. Bypass Road in distance

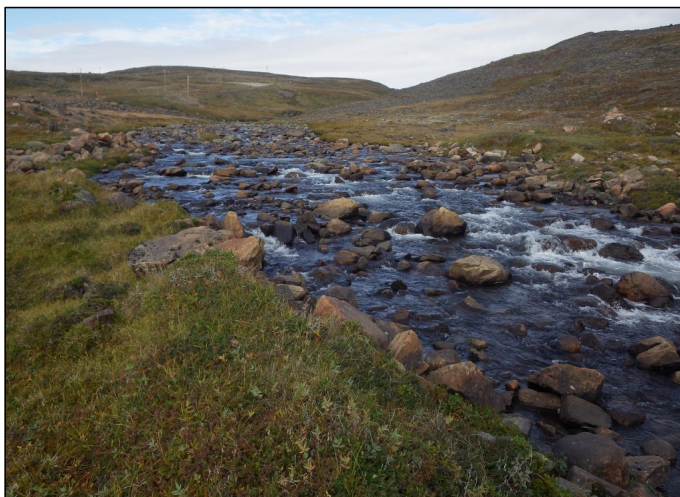
Photo 2: Looking upstream from center of reach.

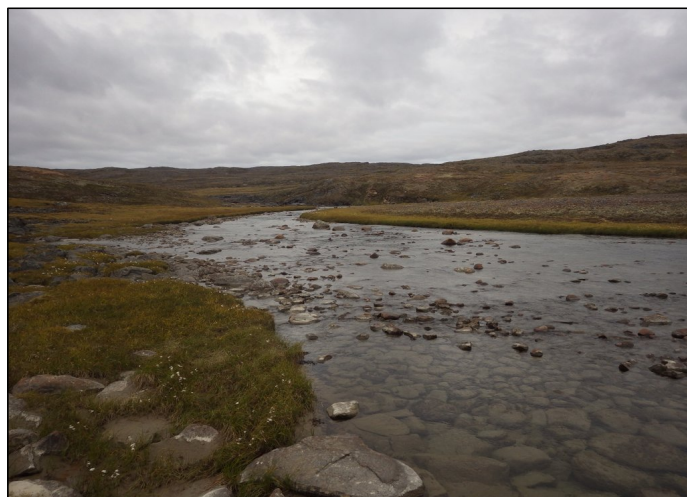
Photo 1: Looking upstream through A2

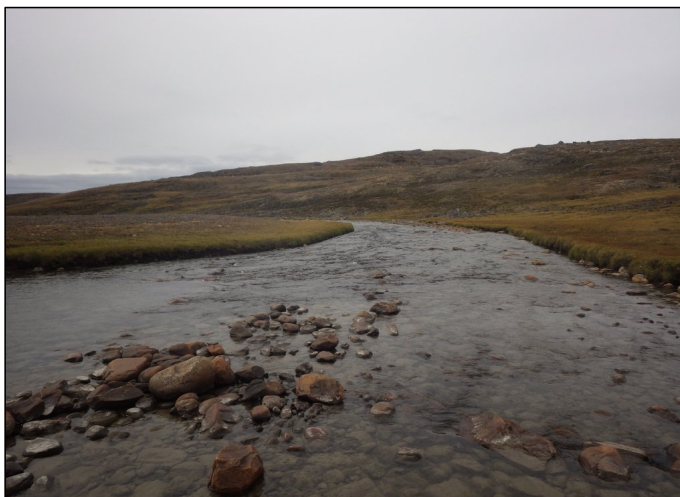
Photo 2: Looking downstream at reach A2 from the outlet of the Swimming Lake

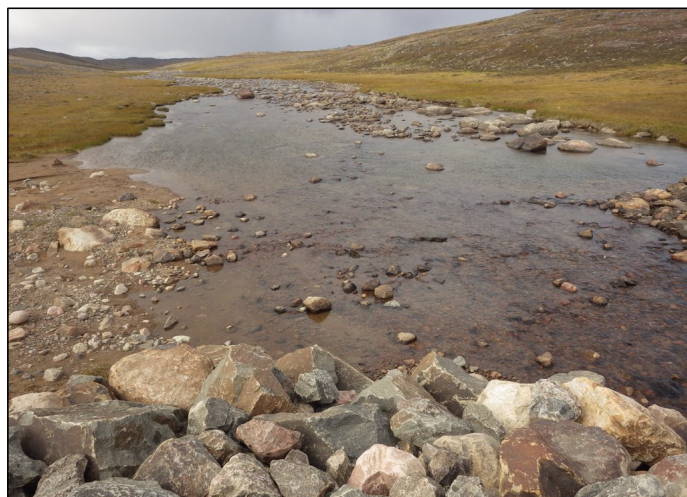
Photo 1: Looking upstream at A1 from the Road to Nowhere.

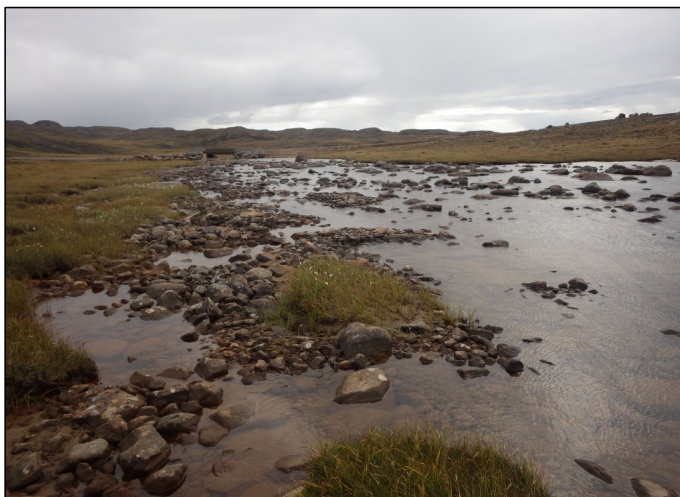
Photo 2: Looking downstream through A1 at the Road to Nowhere
