Geotechnical Investigation

Lift Station #1, Septage Receiving
Station and Lower Iqaluit Sewer
Upgrades
Iqaluit, Nunavut

Prepared for:
City of Iqaluit

February 2023

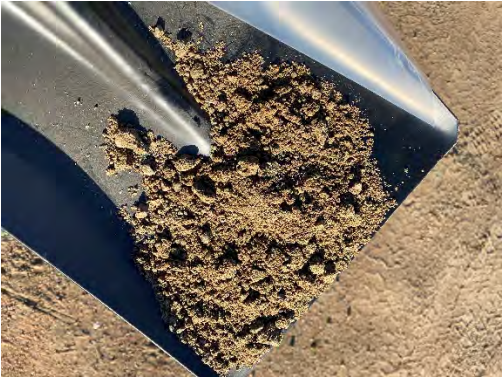
Borehole #	Sample Depth (m)	Soil Description	Image
BH22-01	0 to 0.6	Coarse grained soil Sand with gravel Brown & light grey

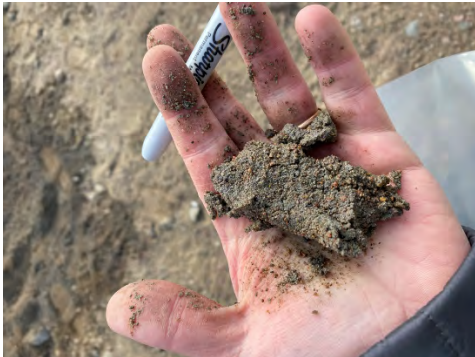
4.3 to 5.2	Coarse grained soil Silty sand Light grey Moisture (possible start of frost, difficult to determine with air track)

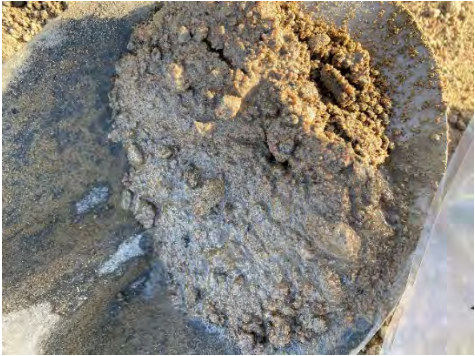
Borehole #	Sample Depth (m)	Soil Description	Image
	4.9 End of Borehole	Coarse grained soil Silty sand Light grey & red/brown Water or melted frost

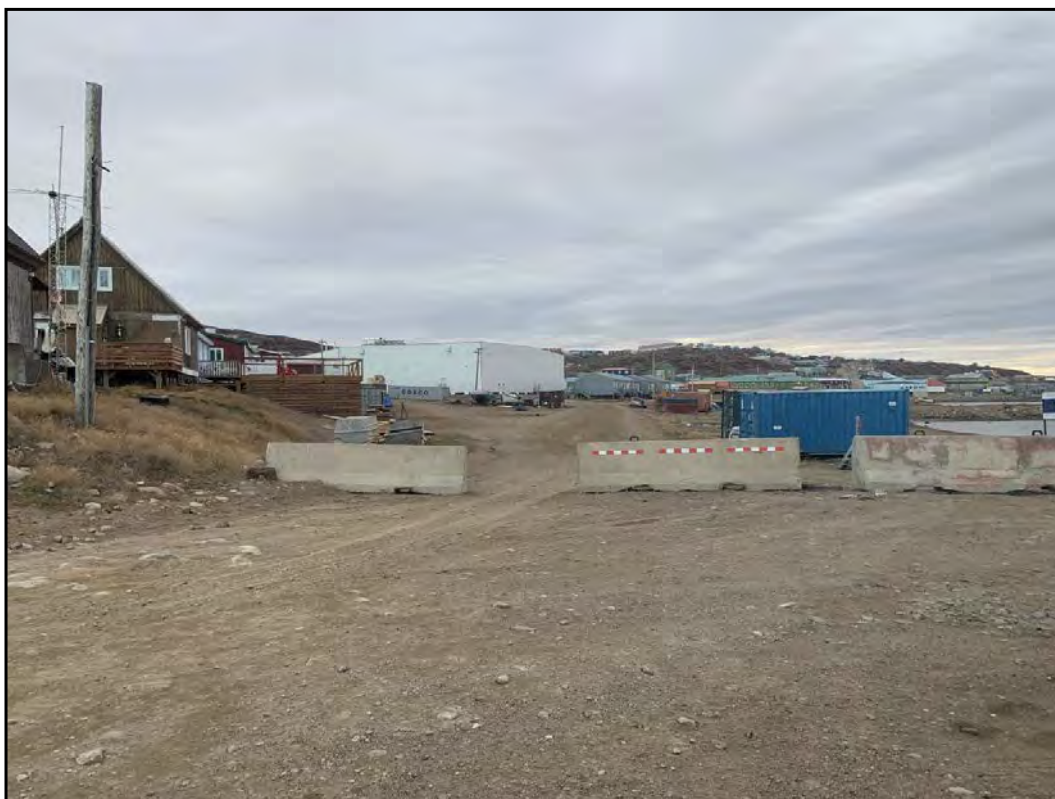
The north side of Lift Station No.1
