Project:	Lake Geraldine Dam Civil Improvements
RFT #	2022-RFT-028
Addendum #	2
# Of Pages	7
Date:	Tuesday May 17, 2022
Document ID:	P7201-313612880-86(1.0)

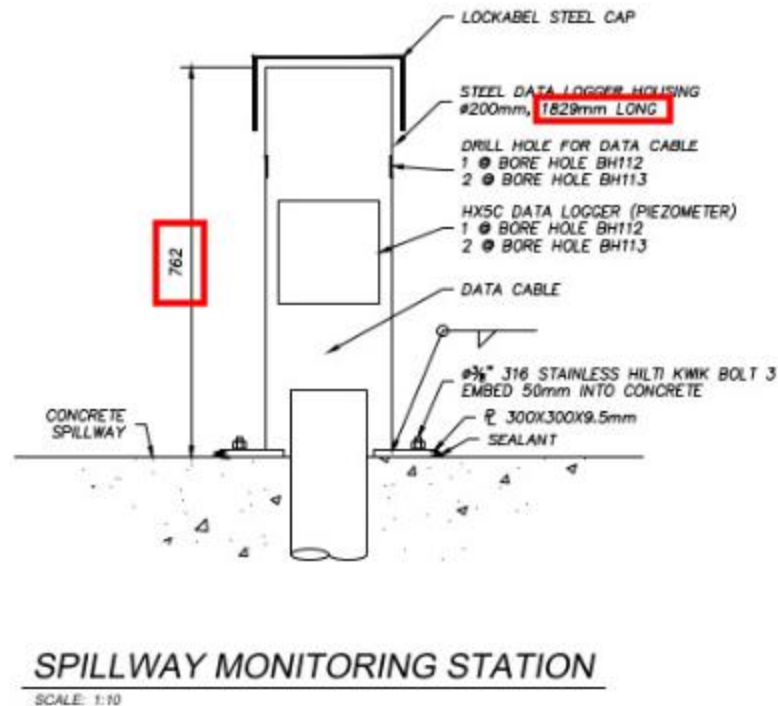
Question: In the spillway monitoring station drawing, the height of the data logger housing has two different values as highlighted in the drawing. Please specify which is to be used.

Response: Use the “762” mm value that is indicated on the left side of the detail. Please note that the monitoring stations at the base of the spillway shall have an angled base to accommodate the slopes surface of the concrete spillway, the steel casing should be installed so that it is in a vertical alignment.

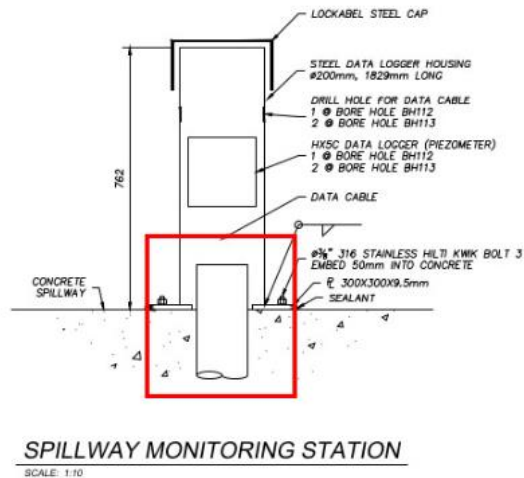
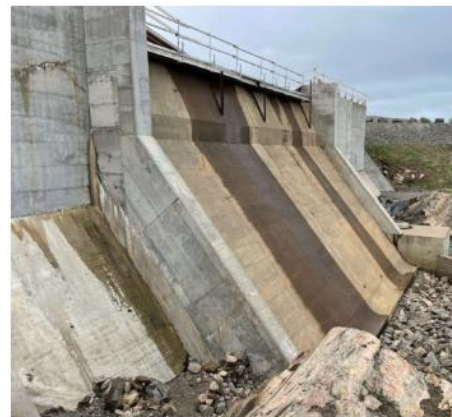
Question: The detail below shows the design for the monitoring stations on the dam. BH112 and BH113 are on the spillway. From the images below, please provide information on the item in red as this item is not seen in the spill way image provided.

Response: Borehole number B112 and 113 are located at the base of the spillway. Canadrill previously drilled the boreholes the boreholes in 2019 and installed the tubes for the piezometers. See photo 16A and 16B. The item circled in red is the portion of the tubes that extend above the surface of the spillway.

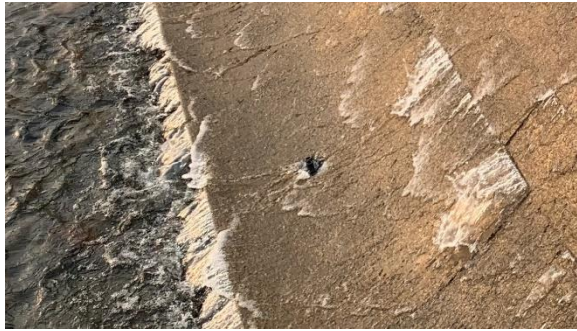
Photo 16A: Photo of BH113 at the south side of the spillway, note the tubes for the piezometers sticking out from the borehole

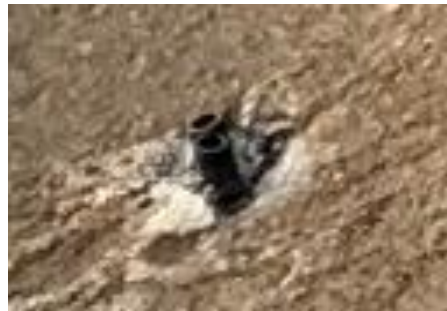
Photo 16B: Closeup of the existing tub for the piezometers
