June 2018

Airport Creek Photos

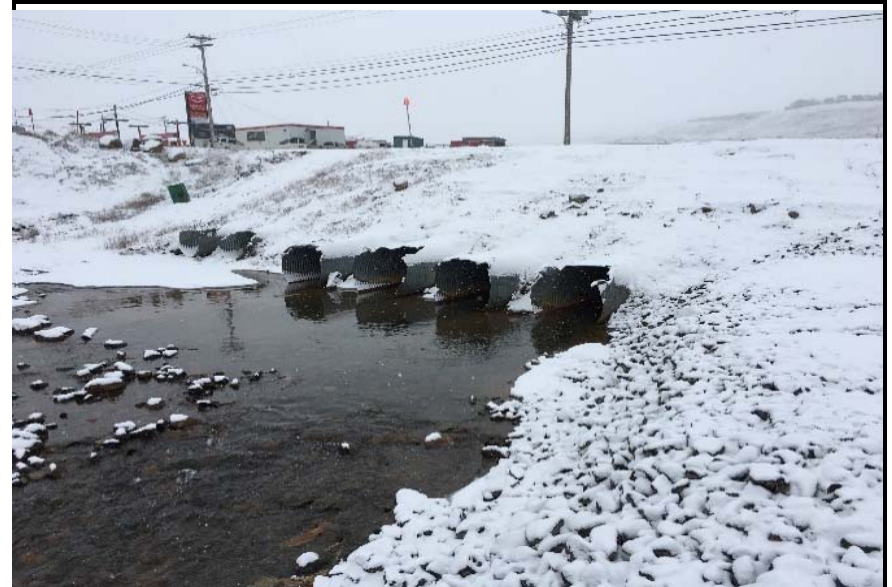
South of Crossing 3 (4 x 1200 mm dia. and 2 x 1000 mm dia.) - Early Fall

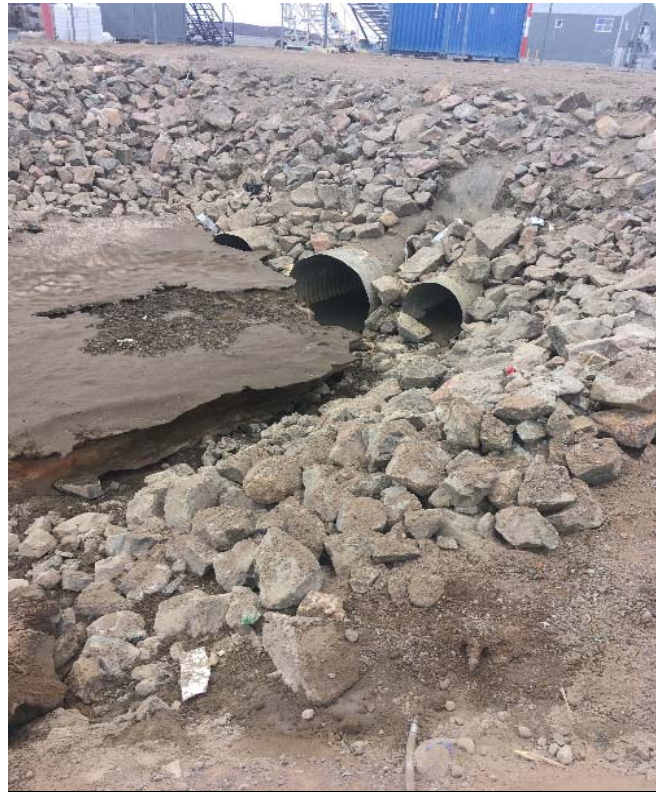
East of
Crossing 8 (2
x 1000 mm
dia. and 1 x
1600 mm
dia.) - Snow
about to melt

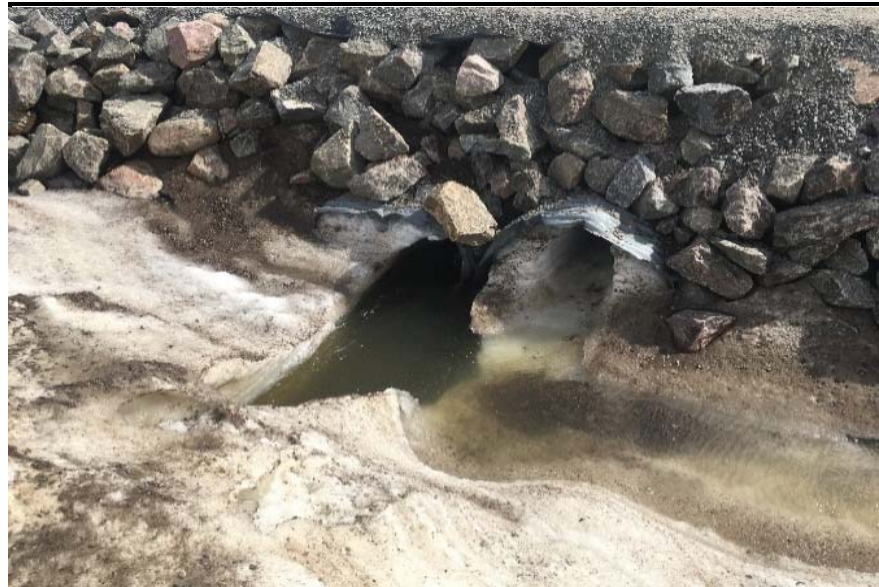
Cluster 1 (4 x 9400 mm dia.) taken from north side of
road - Blocked due to snow

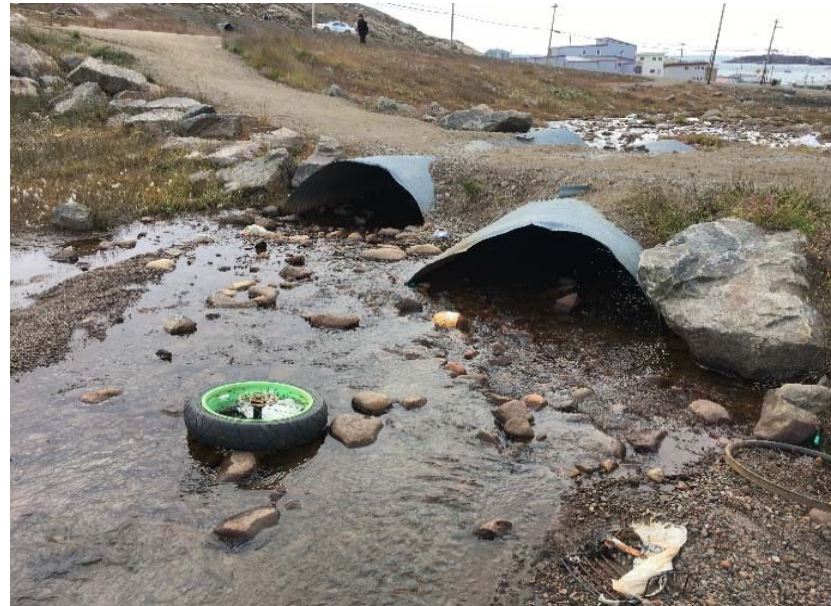
Upstream of Crossing 4 (2 x 1350 mm dia.) - Tire seen in the stream, pipes half buried in the substrate

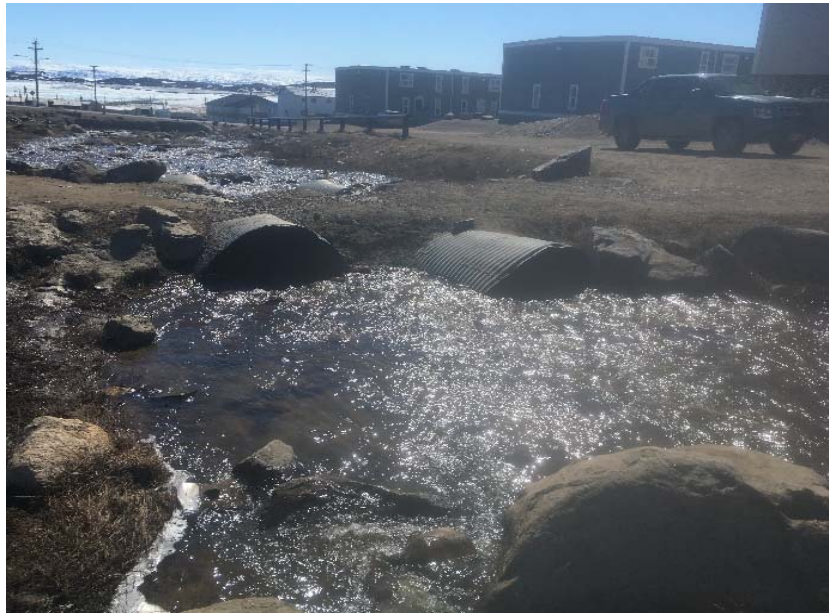
Crossing 4 (2 x 1350 mm dia.) looking South

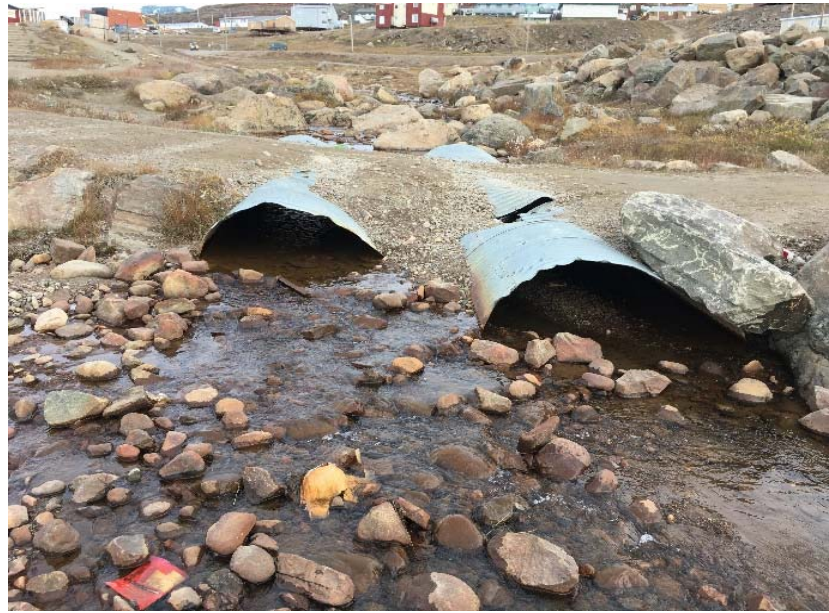
Downstream of Crossing 4 (2 x 1350 mm dia.) -
Garbage in the stream

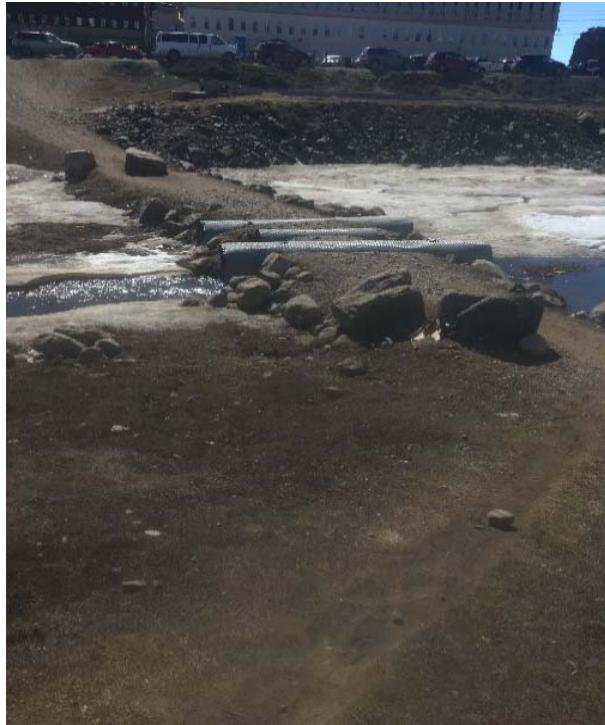
Crossing 6
looking
South West -
2 x 1300 mm
dia., 7 m
long with
one 800 mm
dia. dia
overflow
pipe

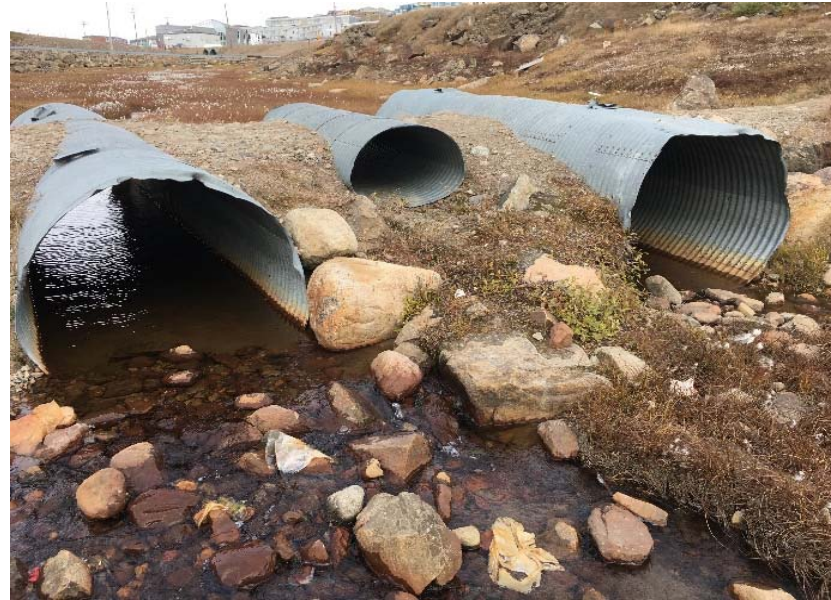
Downstream of Crossing 6 - 2 x 1300 mm dia., 7 m
long with one 800 mm dia. dia overflow pipe

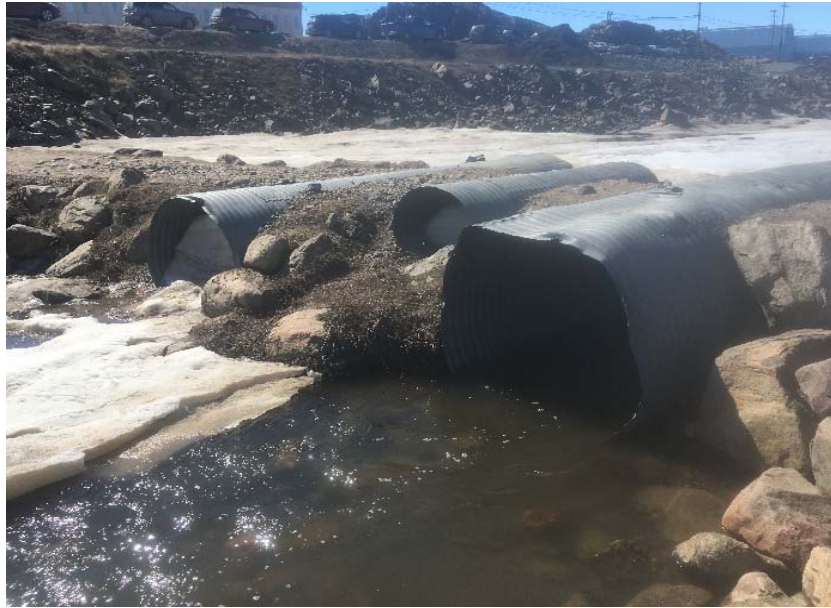
Crossing 6 (2 x 1300 mm dia. and 1 x 800 mm dia. overflow) looking South West - Blocked due to snow

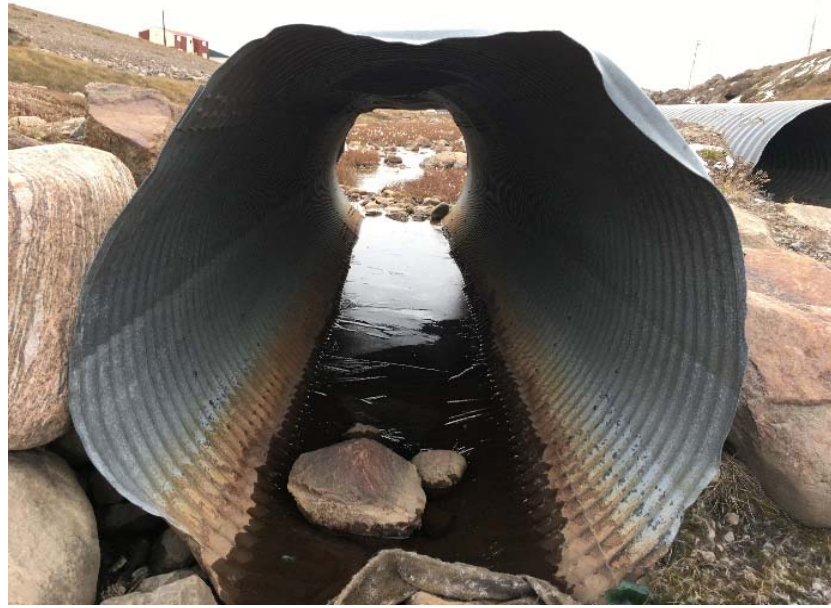
Upstream of Crossing 6 (1300 mm dia.) - Deflected Pipe

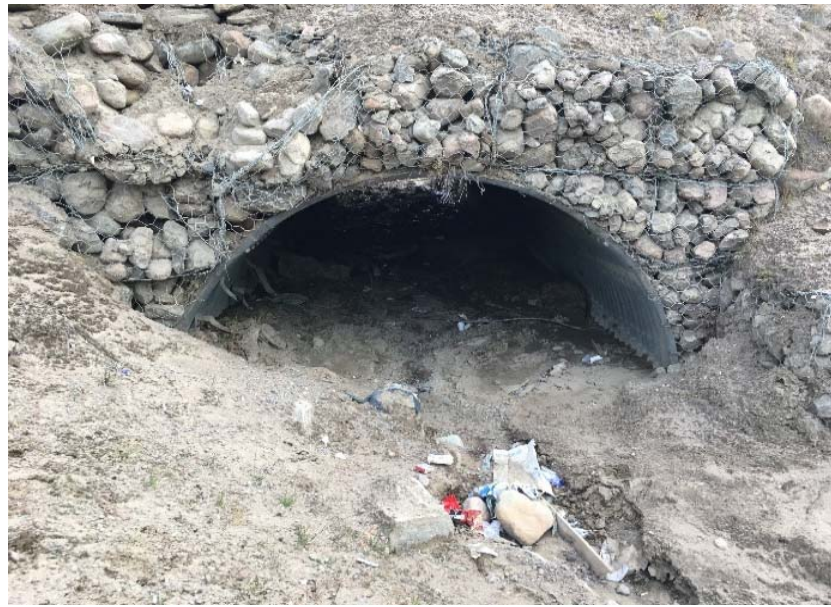
Downstream of Crossing 7 (3200 mm dia.) - Garbage
infront of pipe

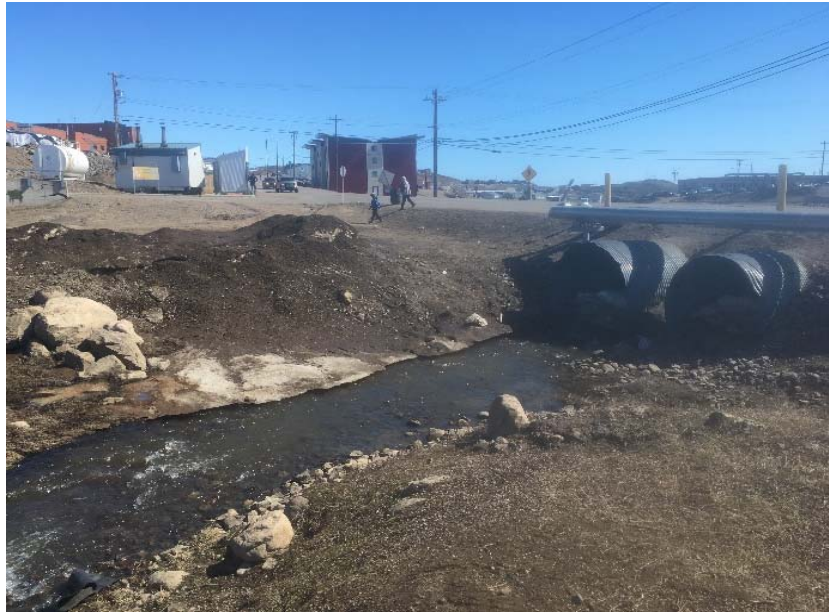
North of Crossing 8 (2 x 1950 mm dia. - 22m long)
looking Southeast

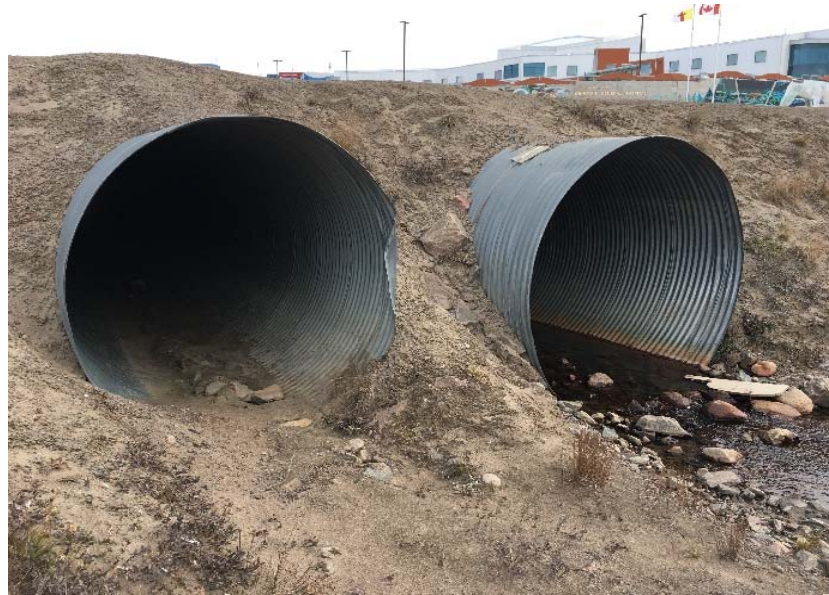
Downstream of Crossing 8 (2 x 1950 mm dia.)

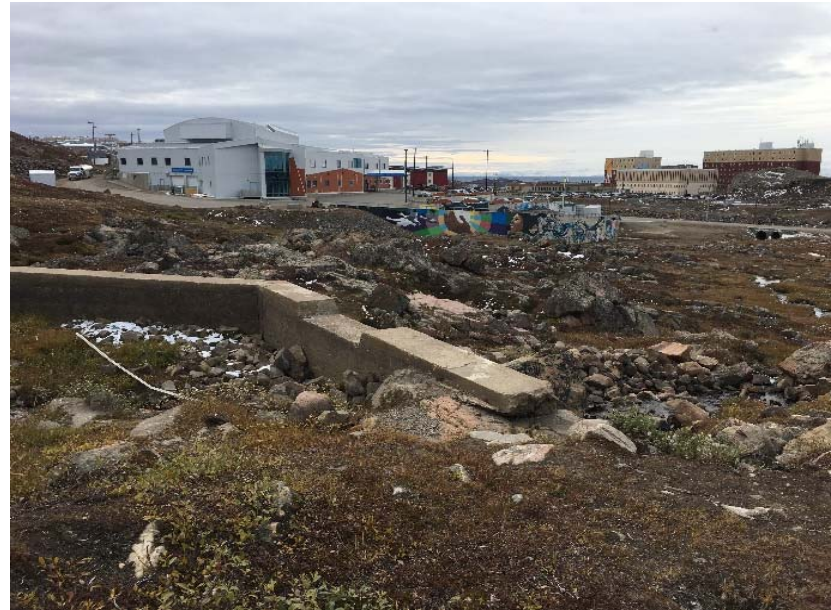
Downstream of Crossing 9 -Concrete dam, over 1 m drop.
Complete barrier, no flow over structure, water flows
through rock debris under structure

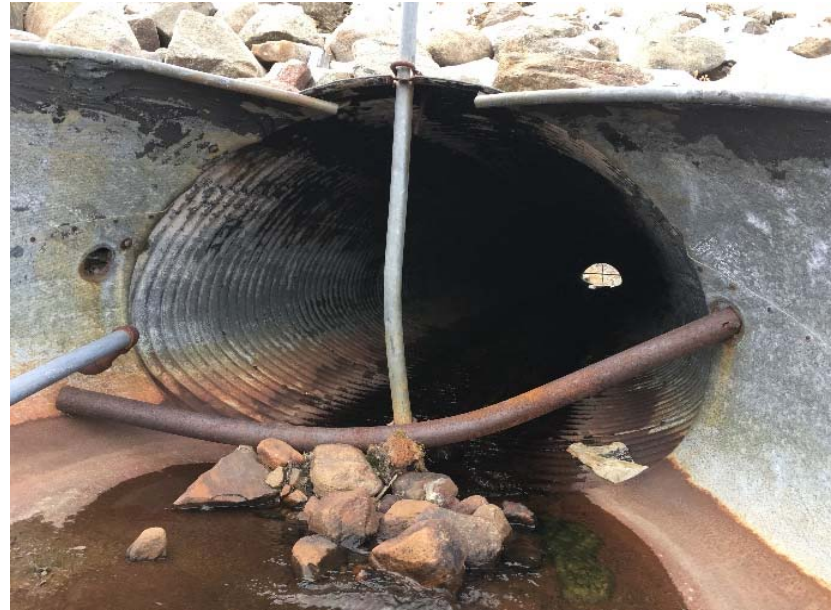
Upstream of Crossing 10 (1350 mm dia.) - Bars in
the pipe
